REPORT ON
DETAILED
ROAD SAFETY AUDIT
OF FIVE ROAD SECTIONS
(500 KM)

ROAD SAFETY AUDIT REPORT FY 2017-2018

Road Design & Safety Circle
Roads & Highways Department
Government of the People's Republic of Bangladesh
SARM Associates and HeptaTech Limited JV

Detailed Road Safety Audit of Road Sections of Joydebpur – Mymensingh (N3), Kanchpur- Daudkandi (N1) and Chattogram – Cox's Bazar (N1), Kashinathpur – Rajshahi (N6) and Dhaka – Aricha (N5) (Total 500 km) National Highway During FY 2017 -2018

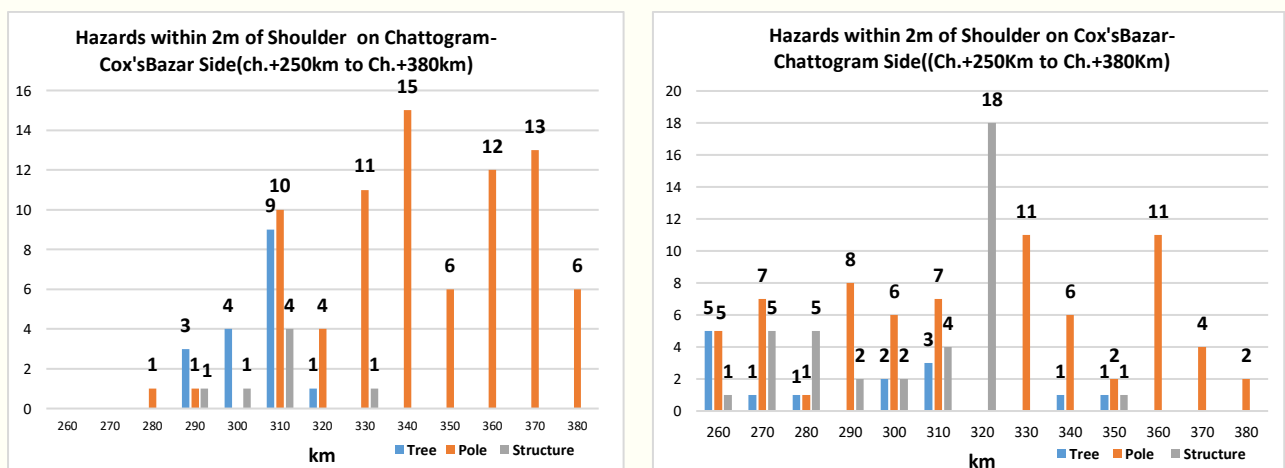
Figure 5.3: Hazards within 2m of Shoulder on Chattogram-Cox'sBazar Highway (N1) (Both Sides)

- Combining both sides, surveyed road of N1 consisted 31 trees and 149 poles within 2m from hard shoulder edge.
- Average 1 roadside hazard on every 1.25km and maximum 23 hazards on every 10km were identified on Chattogram- Cox'sBazar Highway. Along the Cox'sBazar to Chattogram side, average 1 roadside hazard on every 0.8km and maximum 18 hazards on every 10km were identified.

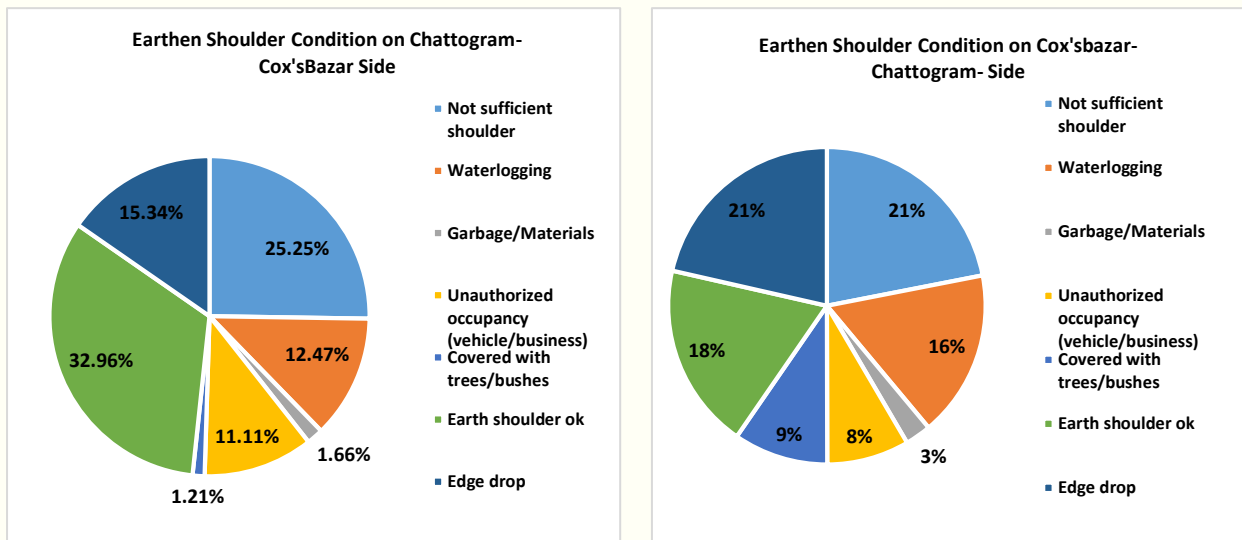
Figure 5.4: Earthen Shoulder Condition on Chattogram-Cox'sBazar Highway (N1) (Both Sides)

- On Chattogram-Cox'sBazar highway, 33.4 km (25.5%) verge/earthen shoulder was either missing or less than standard dimension of 1m for any emergency traffic movement. 16.5km (12.47%) was found waterlogged, 1.6km (1.21%) was covered by bushes and 16.9km (12.77%) was occupied by parked vehicles, materials and garbage. A total of 43.6km (32.96%) earthen shoulder was found sufficient (at least 1m width) but 20.3km (15.34%) had highly risky edge drop (more than 3-inch height) which were creating traffic vulnerability.

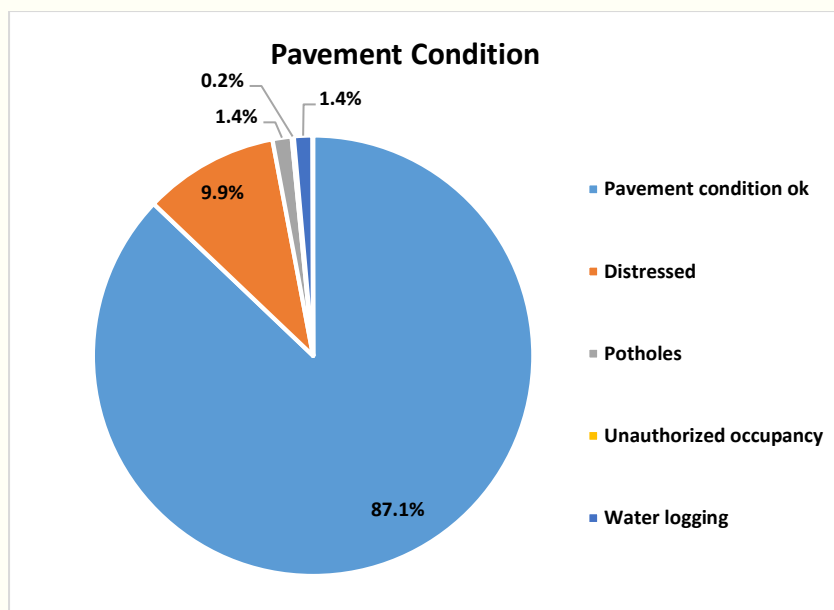
Figure 5.5: Pavement Condition on Chattogram-Cox's Bazar Highway (N1)

- 141.1 km (87.1%) of the pavement of 131km was workable whereas 13.1km (9.9%) was distressed 1.8 km (1.4%) pavement had potholes (N.B: ANNEXURE-A) which were creating serious vulnerability.
- 1.85km pavement found waterlogged. (N.B: ANNEXURE-A)

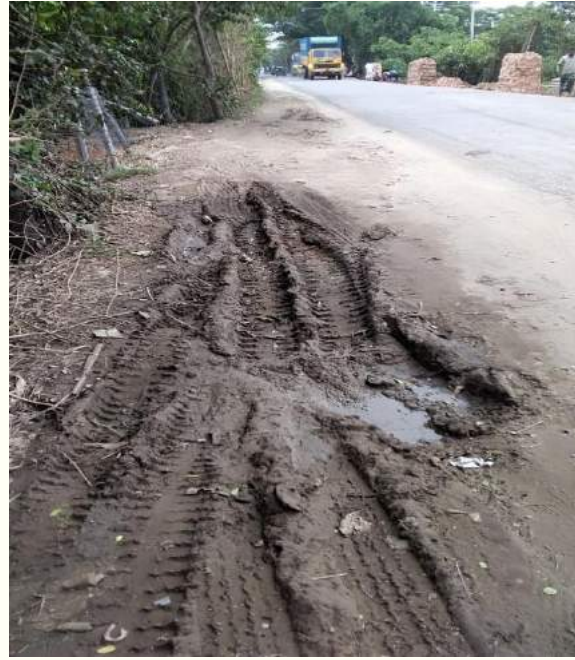
Defective shoulder due to rain within Ch.+252.5 to Ch.+255

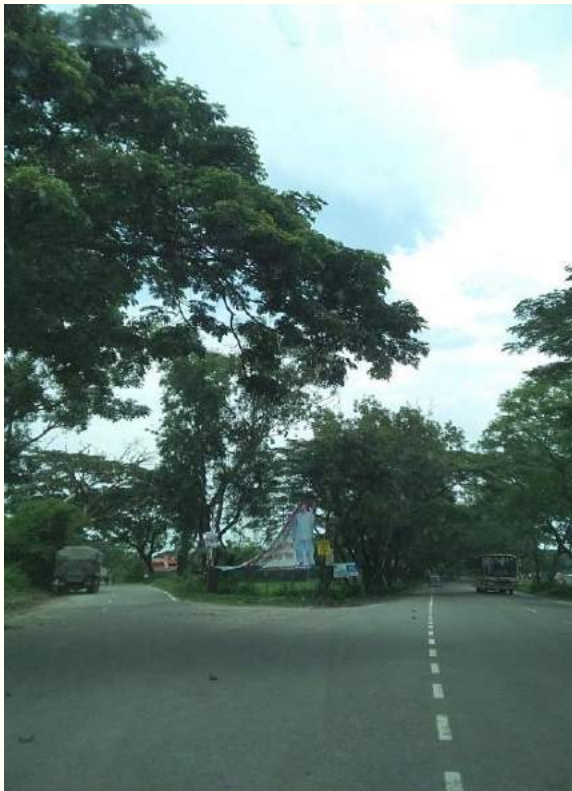
Y-intersection without warning sign within Ch.+255 to Ch.+257 causing high risk

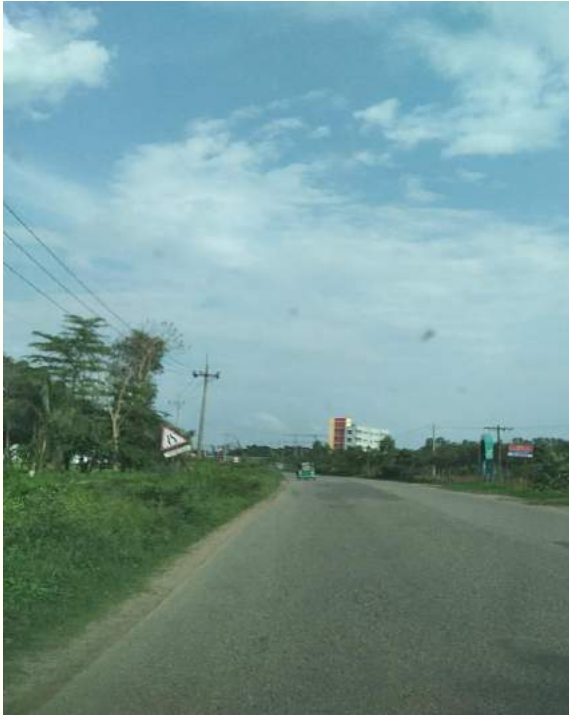
Defective road sign at Ch.+269 to Ch.+271

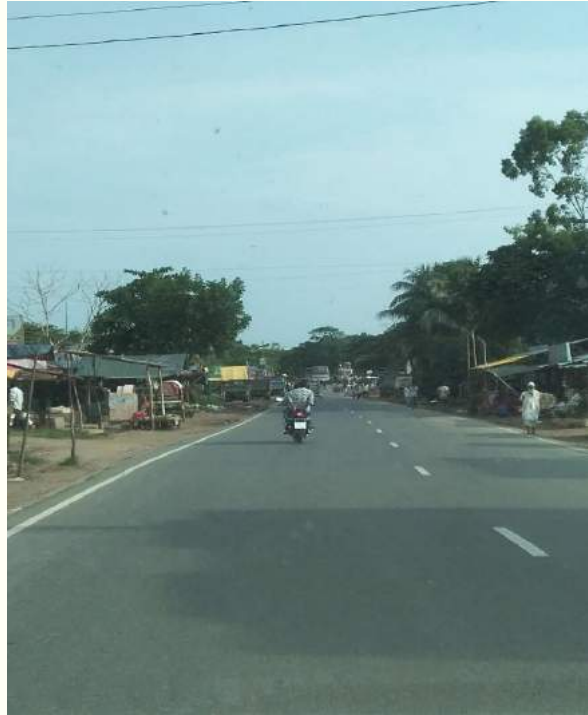
Unauthorized roadside business within clear zone at Ch.+ 271 to Ch.+272

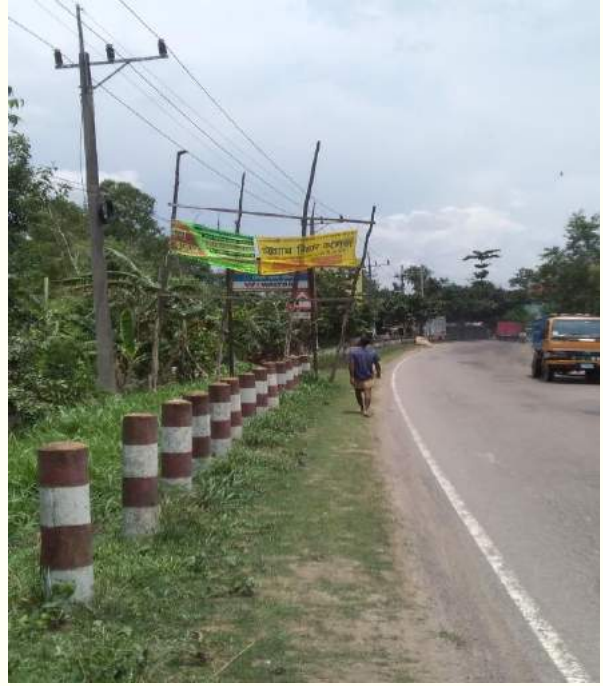
Inadequate shoulder within Ch.+293 to Ch.+295

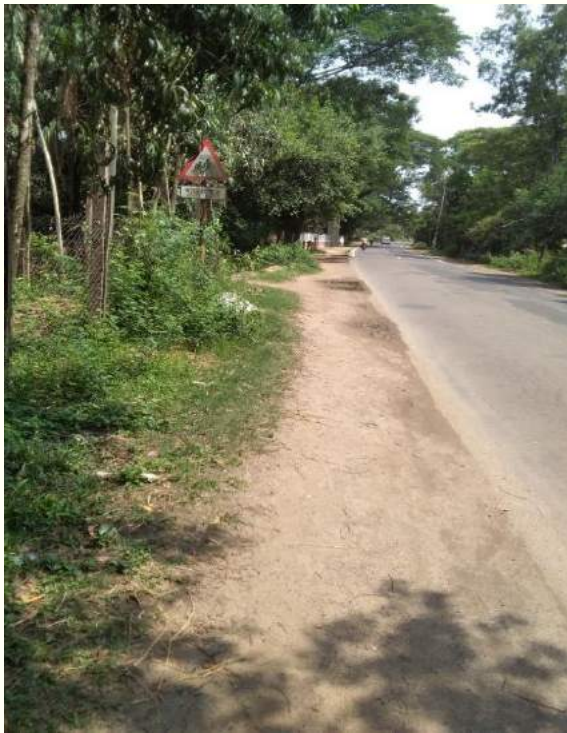
Less visible road sign at Ch.+295 to Ch.+297

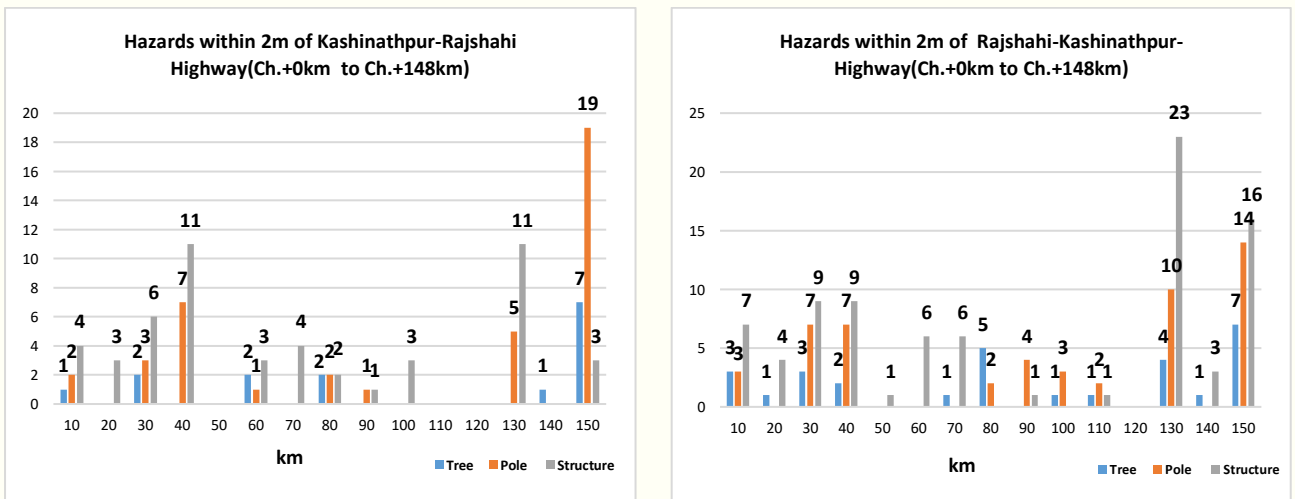
Figure 5.9: Hazards within 2m of Kashinathpur - Rajshahi Highway (N6) (Both Sides)

- Combining both sides, surveyed road of N6 consisted of 44 trees and 92 poles within 2m from hard shoulder edge.
- Average 1 roadside hazard on every 1.40km and maximum 29 hazards on every 10km were identified on Kashinathpur to Rajshahi Highway. On the other side, on Rajshahi - Kashinathpur Highway, average 1 roadside hazard on every 0.8km and maximum 37 hazards on every 10km were identified.

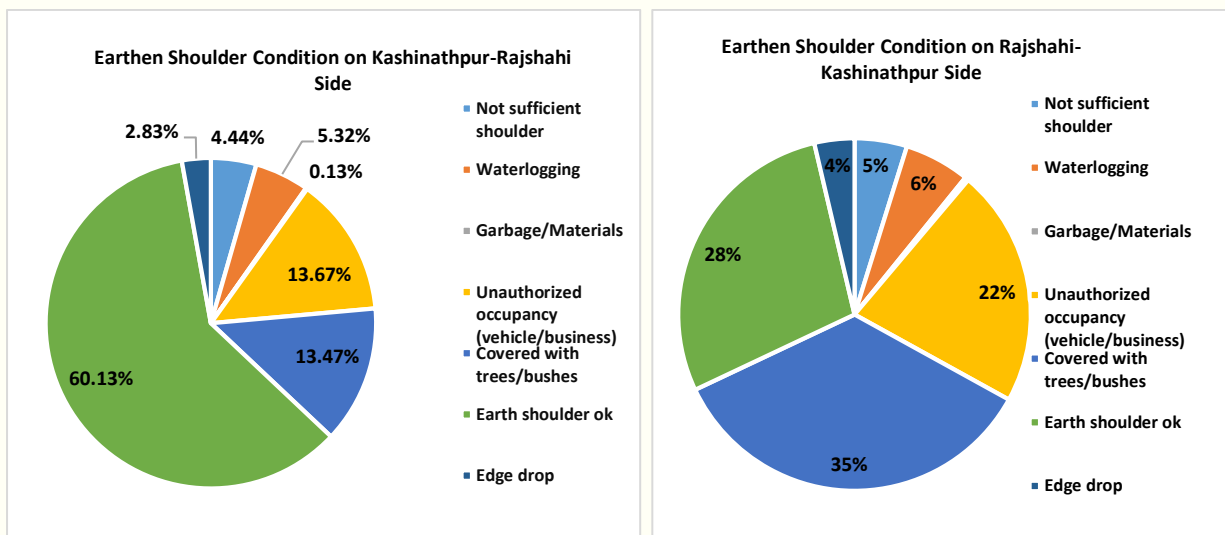
Figure 5.10: Earthen Shoulder Condition on Kashinathpur - Rajshahi Highway (N6) (Both Sides)

- On Rajshahi-Kashinathpur Highway, 7.2km (5%) earthen shoulder was either missing or insufficient for any emergency traffic movement. 9km (6%) was waterlogged, 52.3km (35%) was covered by bushes and 33.2km (22%) was occupied by parked vehicles, materials and garbage. Out of total, 131km earthen shoulder, 42.4km (28%) was sufficient but 5.5km (4%) had risky edge drop which were creating traffic vulnerability.
- Immediate measure required chainages of roadside hazards are given in ANNEXURE-A.

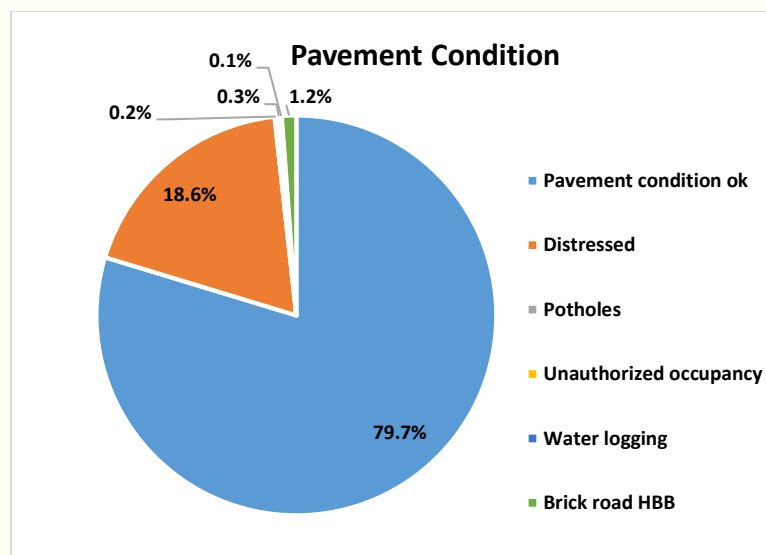
Figure 5.11: Pavement Condition on Kashinathpur - Rajshahi Highway (N6)

- Among 146.9km pavement 118 km (79.7%) was workable whereas 26.5km (18.6%) was distressed.1.8 km (1.4%) pavement had potholes(N.B: ANNEXURE-A) which were creating serious vulnerability.
- 1.14km pavement found waterlogged (N.B: ANNEXURE-A), 4.2km was illegally occupied by vehicles, unauthorized maintenance work etc.
- 17km was made of Harrington brick road instead of flexible pavement.

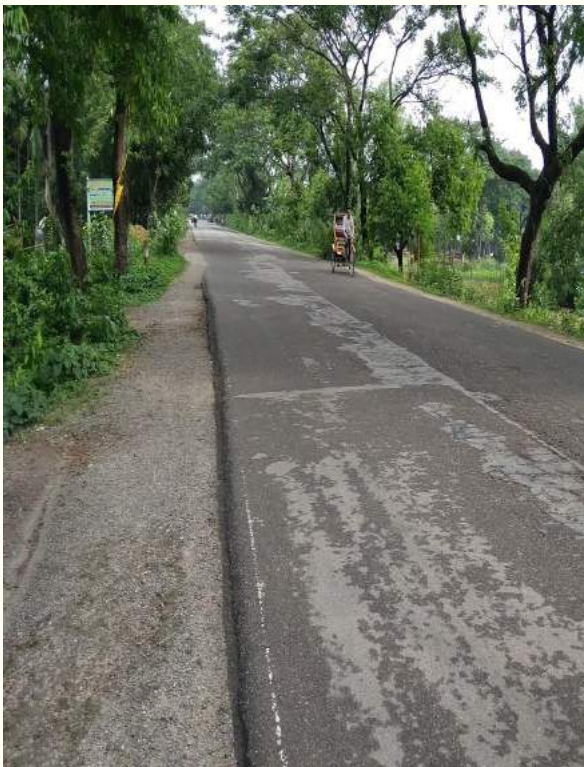
Shoulder within Ch.+46 to Ch.+48 at a risky condition

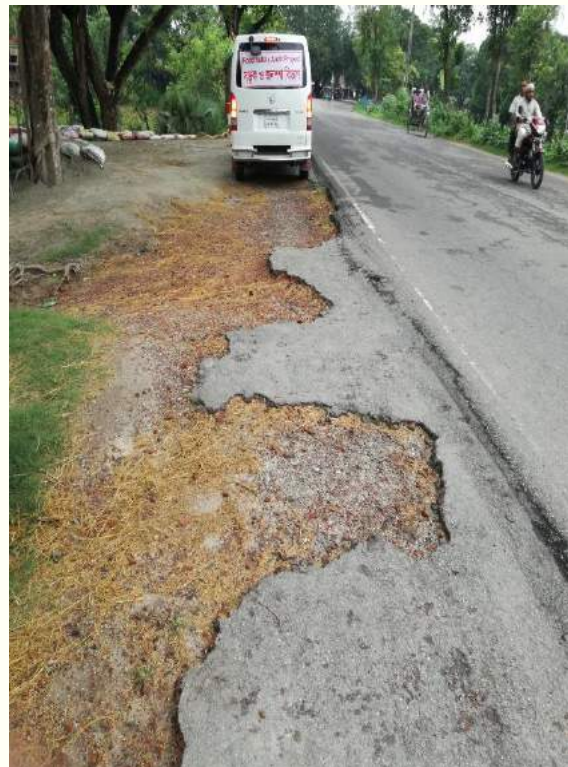
Defective shoulder at Ch.+48 to Ch.+50

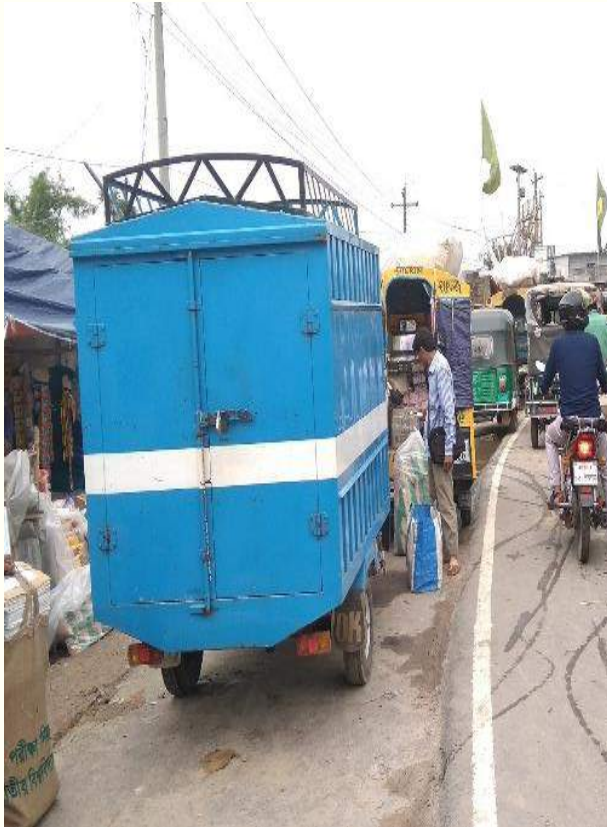
Unauthorized roadside activities within Ch.+50 to Ch.+52

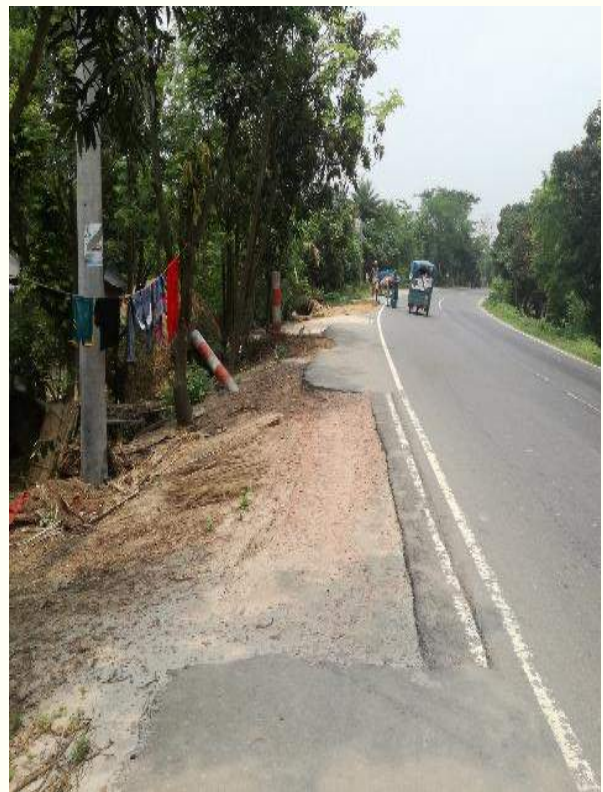
Defective and risky shoulder at Ch.+ 84 to Ch.+86

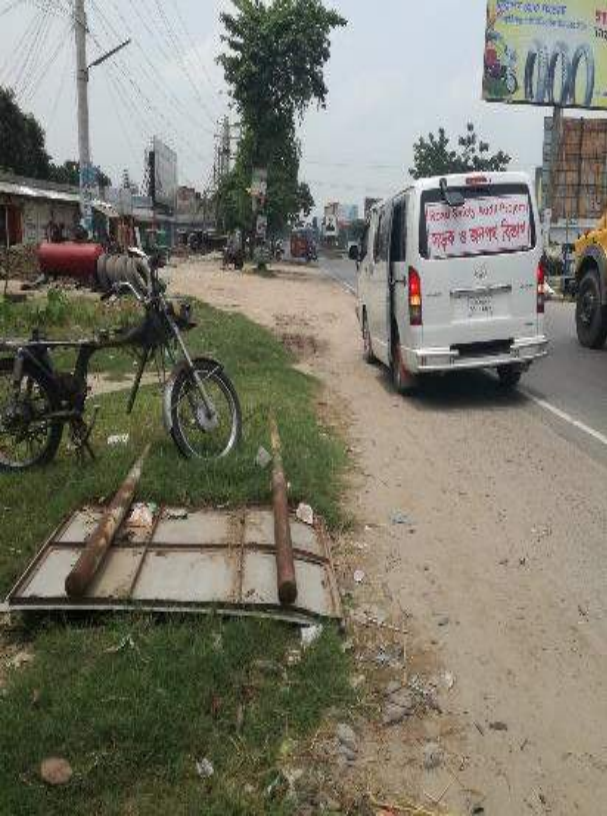
Broken sign within Ch.+84 to Ch.+86

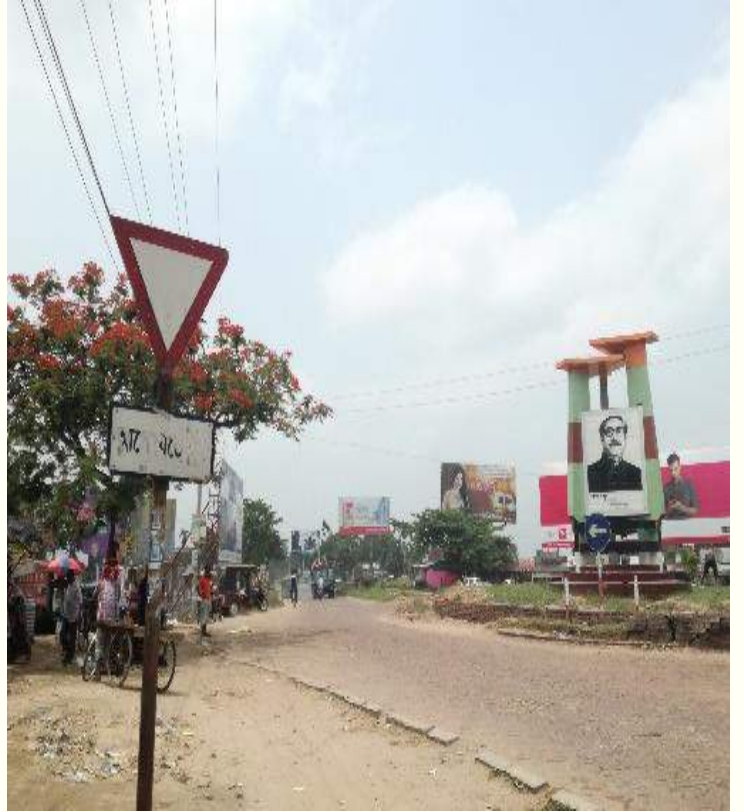
Faded sign within Ch.+84 to Ch.+86

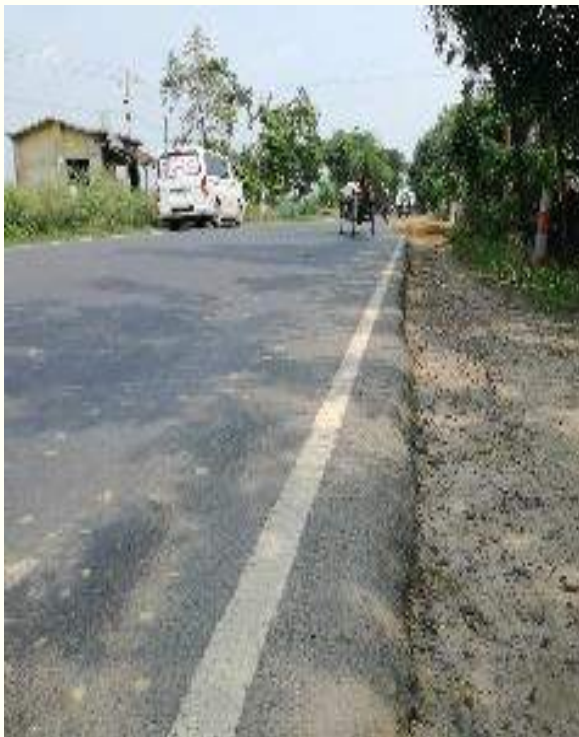
Defective shoulder within Ch.+74 to Ch.+76 causing risk

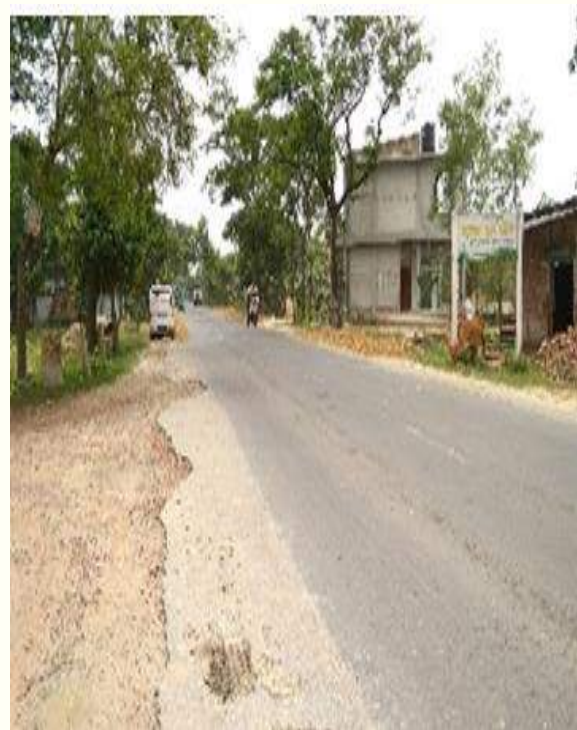
Broken and risky within Ch.+106 to Ch.+208

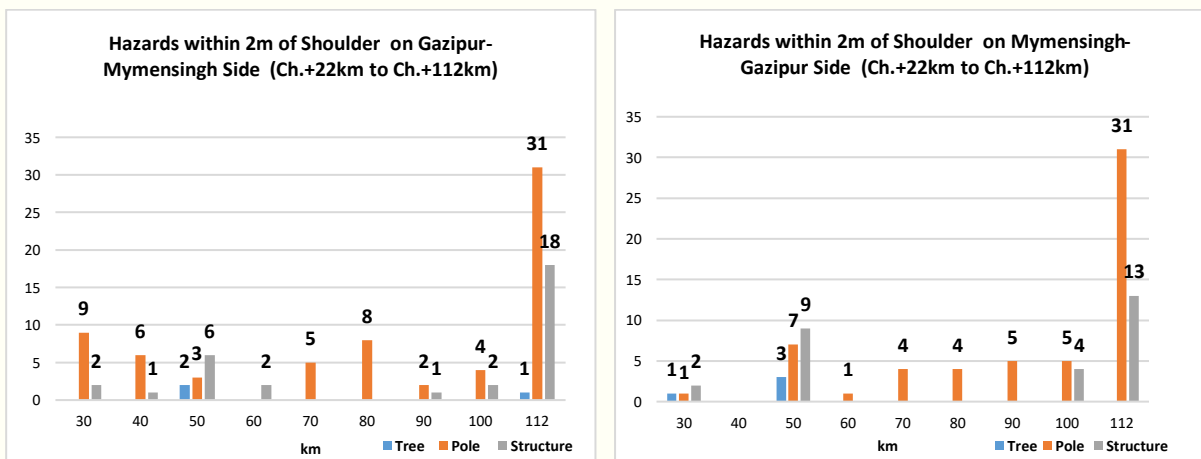
Figure 5.15: Hazards within 2m of Shoulder on Gazipur-Mymensingh Highway (N3) (Both Sides)

- Combining both sides, surveyed road of N3 consisted of 2 trees and 117 poles within 2m from hard shoulder edge.
- Average 1 roadside hazard on every 0.9km and maximum 50 hazards on every 12km were identified on Gazipur to Mymensingh Highway. Along the Mymensingh to Gazipur side, average 1 roadside hazard on every 1.25km and maximum 43 hazards on every 10km were identified. Maximum road hazard was at the built-up area of Mymensingh city.

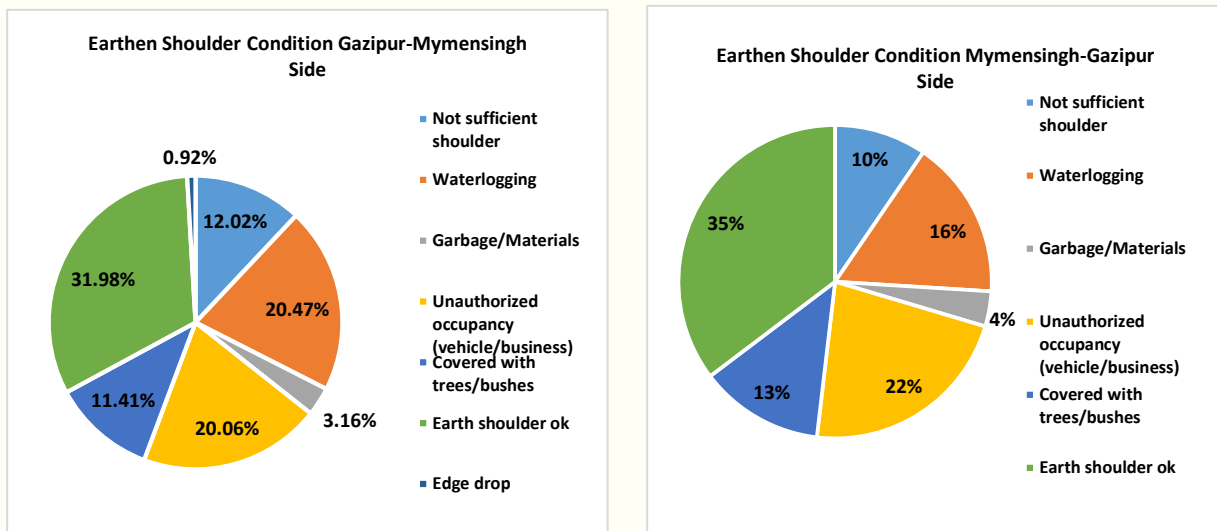
Figure 5.16: Earthen Shoulder Condition on Gazipur-Mymensingh Highway (N3) (Both Sides)

- On Mymensingh-Gazipur Highway, 8.84km (10%) earthen shoulder was either missing or less than standard dimension of 1m for any emergency traffic, 18.1km (16%) was waterlogged, 14.7km (13%) was covered by bushes and 29.4km (26%) was occupied by parked vehicles, materials and garbage. Out of total 131km earthen shoulder, 39.6km (35%) was sufficient.
- Immediate measure required chainages of roadside hazards are given in ANNEXURE-A.

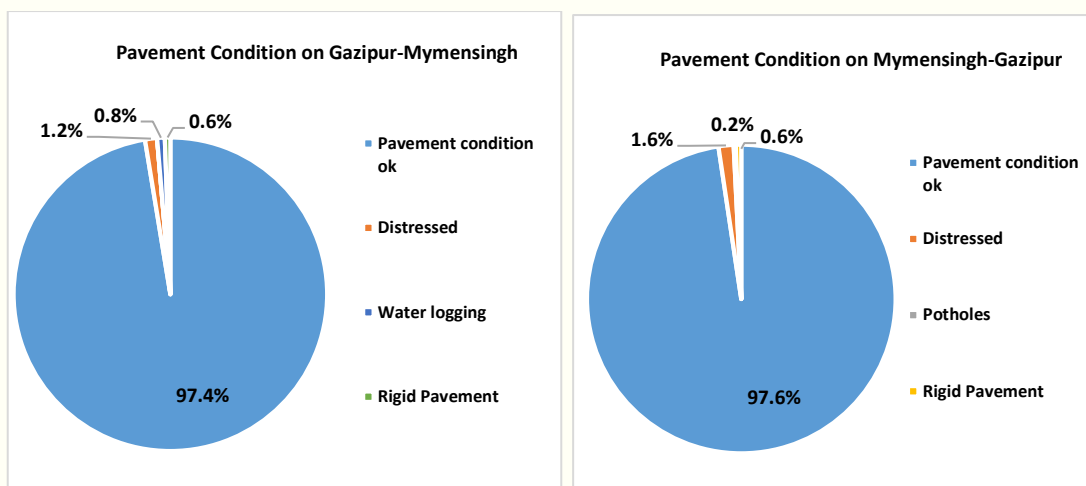
Figure 5.17: Pavement Condition on Gazipur-Mymensingh Highway (N3)

- From Gazipur to Mymensingh Highway, among 88.4 km of the pavement, 86.1km (97.4%) was workable whereas 1.06km (1.2%) was distressed, 0.7 km (0.8%) pavement had waterlogging (N.B: ANNEXURE-A) which were creating serious vulnerability. On the other side, from Mymensingh to Gazipur Highway, among 88.4km the pavement of 86.3km (97.6%) was workable whereas 1.4km (1.6%) was distressed 0.2 km (0.2%) pavement had potholes (N.B: ANNEXURE-A) which were creating serious vulnerability.

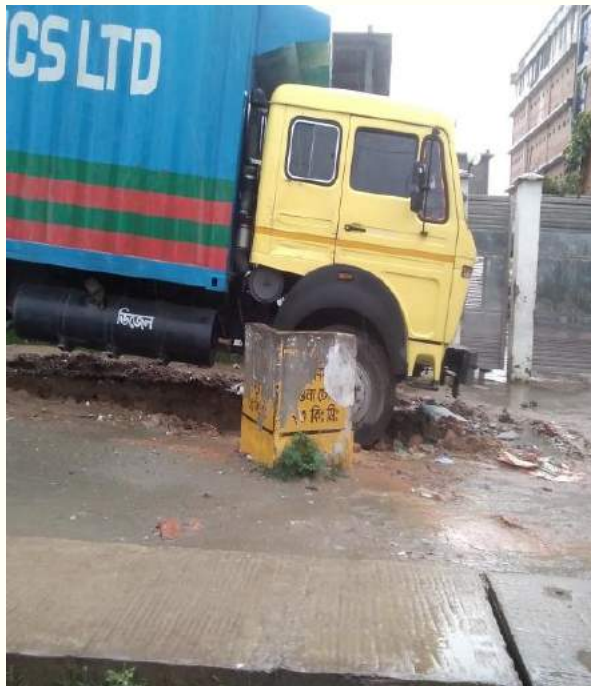
Hazardous km post installed on roadside area within Ch.+25.8 to Ch.+27.8

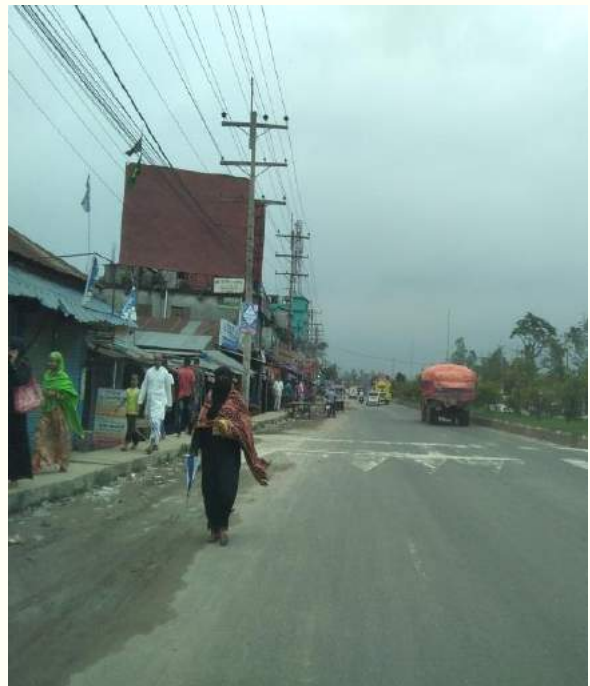
Faded risky pedestrian crossing within Ch.+27.8 to Ch.+29.8

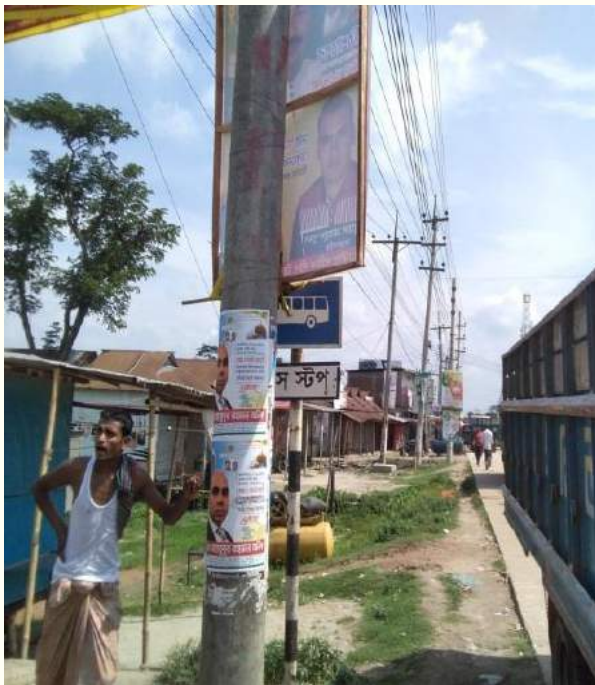
**Improper placement of sign within
Ch.+93.5 to Ch.+95.5**

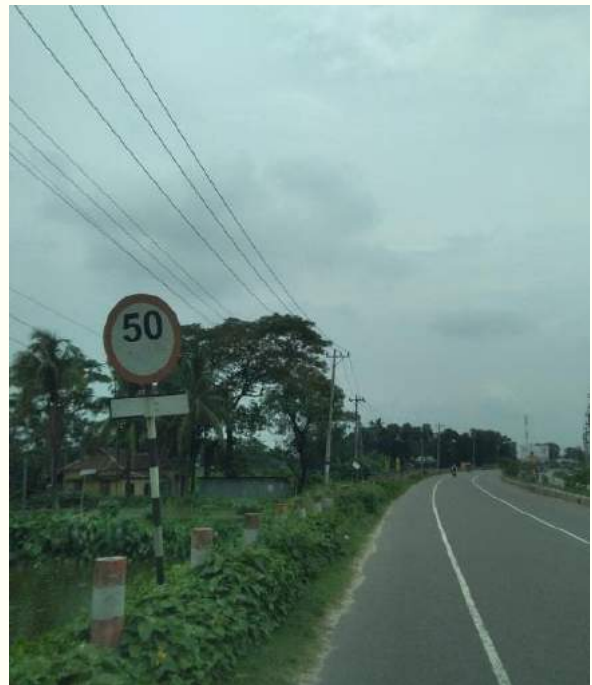
**Roadside bushes & wrong marking on curve
within Ch.+95.5 to Ch.+97.5**

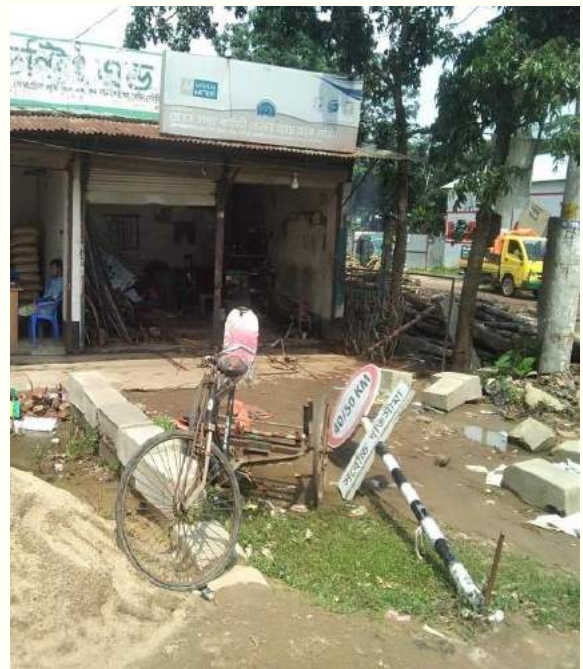
Disturbed & broken sign within Ch.+53.6 to Ch.+55.6

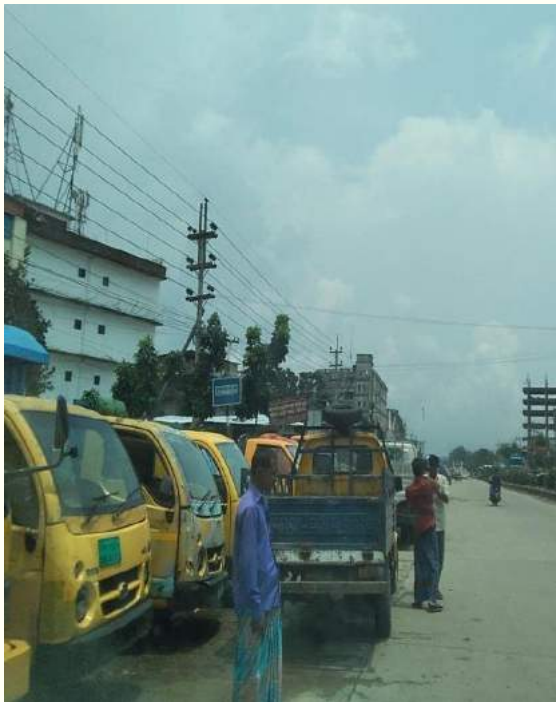
Illegal parking within Ch.+55.6 to Ch.+57.6

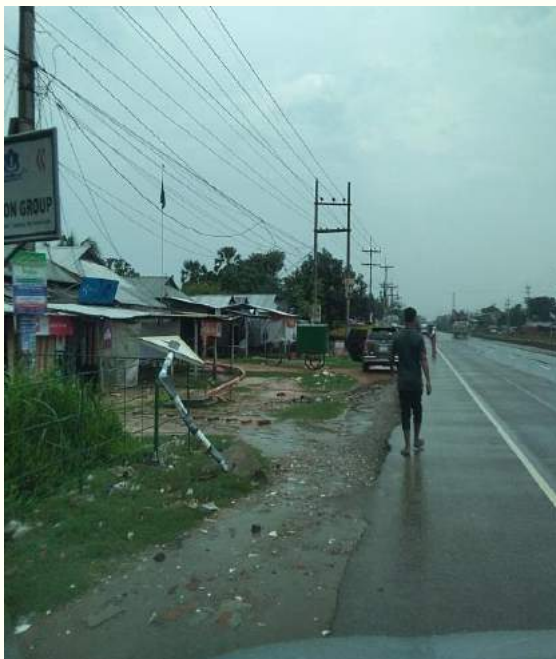
Disturbed & broken sign within Ch.+57.6to Ch.+59.6

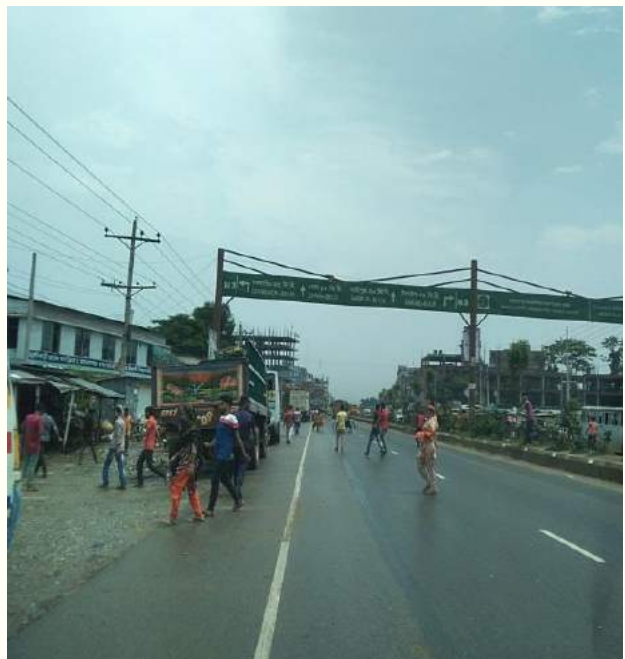
Illegal pedestrian crossing at Ch.+57.6 to Ch.+59.6

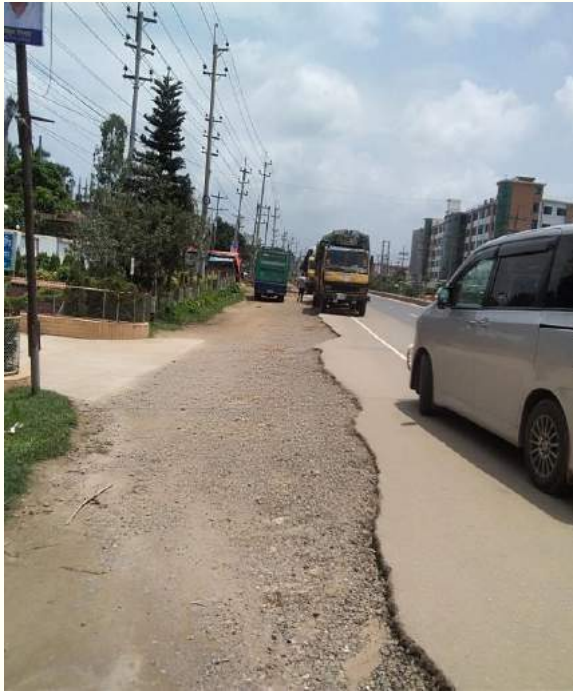
Broken hard shoulder within Ch.+65.6 to Ch.+67.5

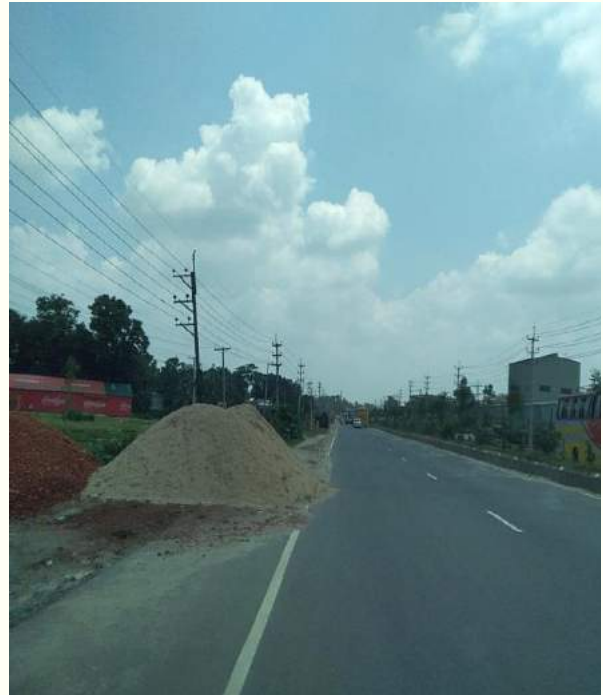
Unauthorized occupancy by construction materials within Ch.+67.5 to Ch.+69.5

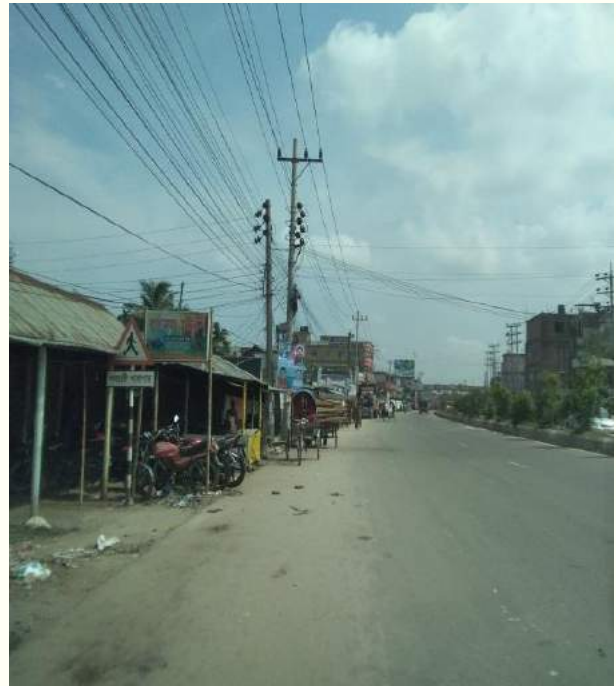
Improper placement of sign & unauthorized occupancy within Ch.+89.5 to Ch.+91.5

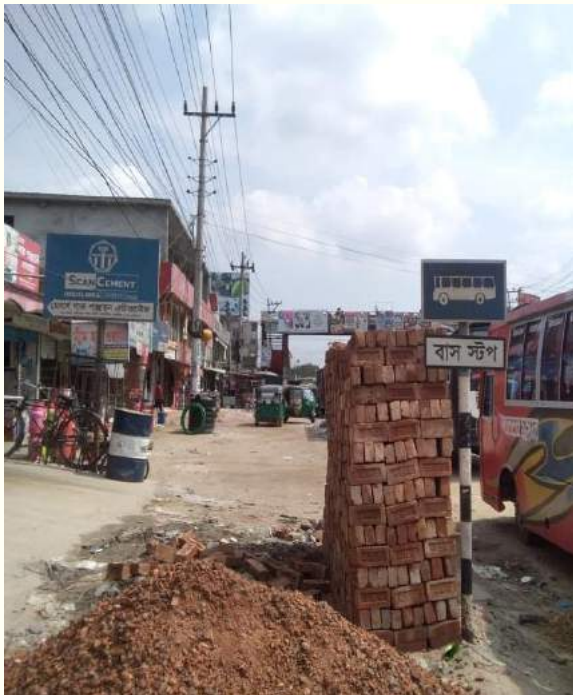
Construction materials kept on roadside area illegally within Ch.+89.5 to Ch.+91.5

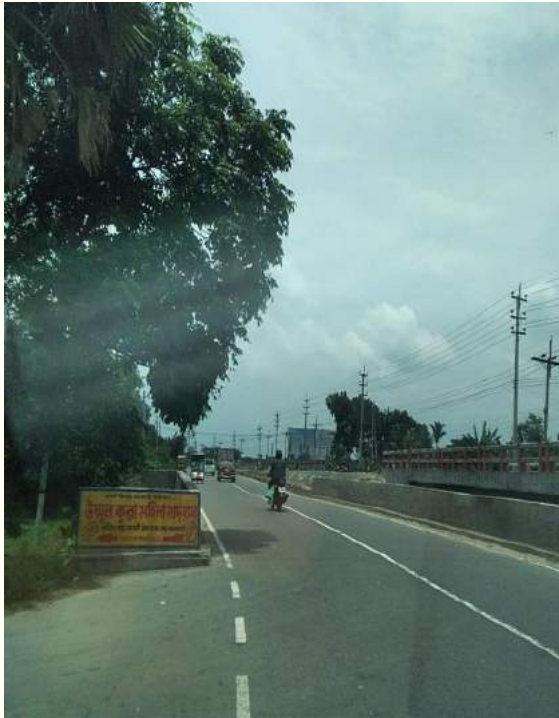
Unauthorized hazardous roadside structure within Ch+101.5 to Ch+103.5

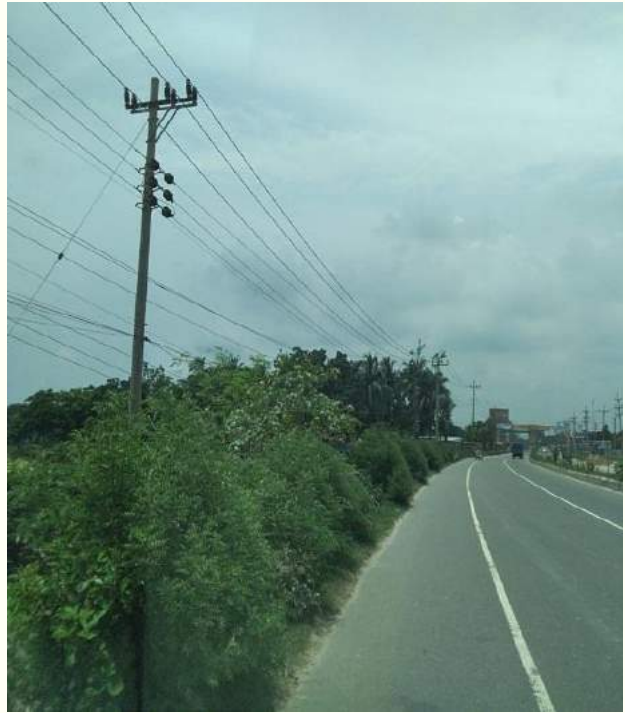
Roadside bushes & wrong marking on curve within Ch+103.5 to Ch+105.5

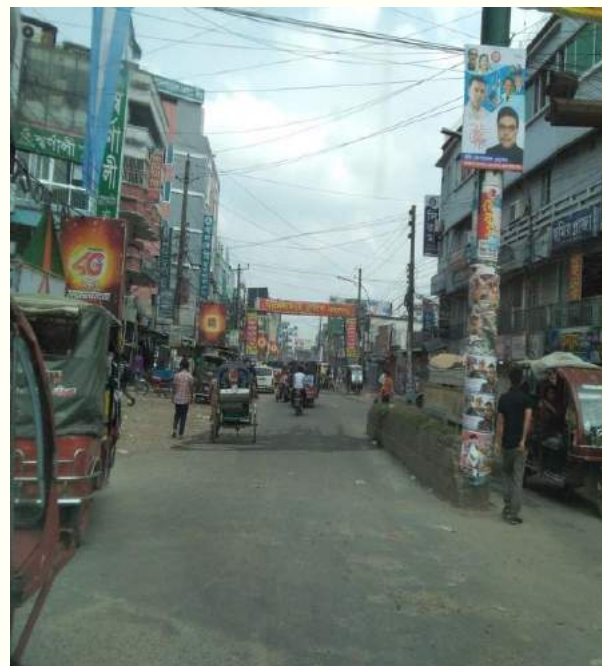
Hazardous pole & faded road marking within Ch.+107.5 to Ch.+109.5

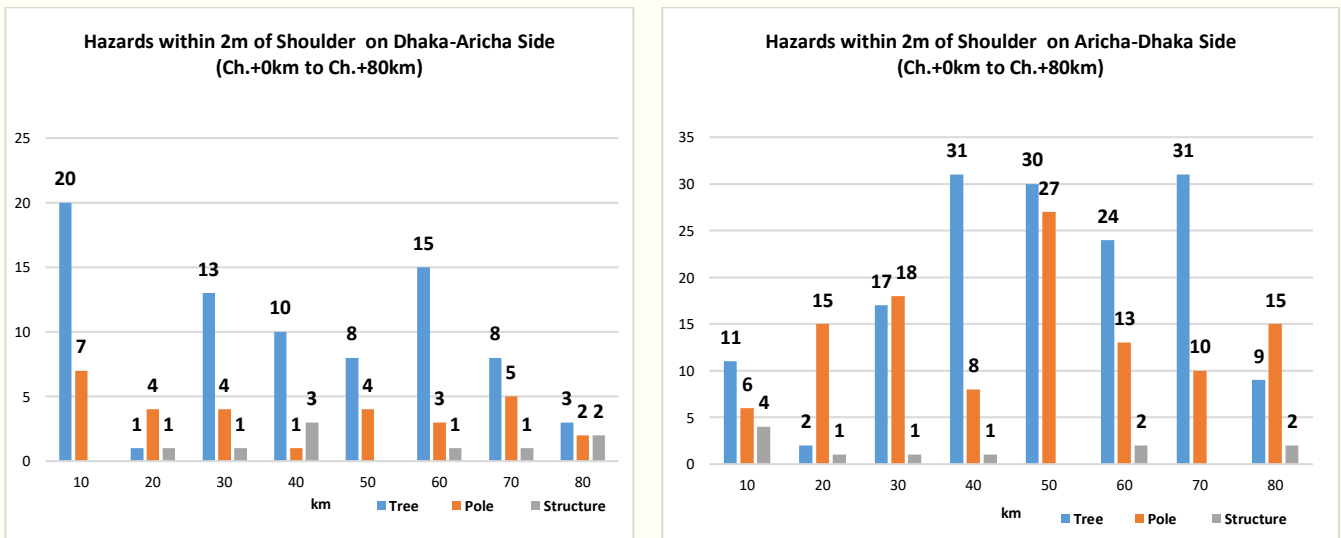
Figure 5.21: Hazards within 2m of Shoulder on Dhaka-Aricha Highway (N5) (Both Sides)

- Combining both sides, surveyed road of N5 consisted of 233 trees and 142 poles within 2m from hard shoulder edge.
- Average 1 roadside hazard on every 0.6km and maximum 27 hazards on every 10km were identified on Dhaka-Aricha Highway. Along the Aricha to Dhaka side, average 1 roadside hazard on every 0.3km and maximum 57 hazards on every 10km were identified.

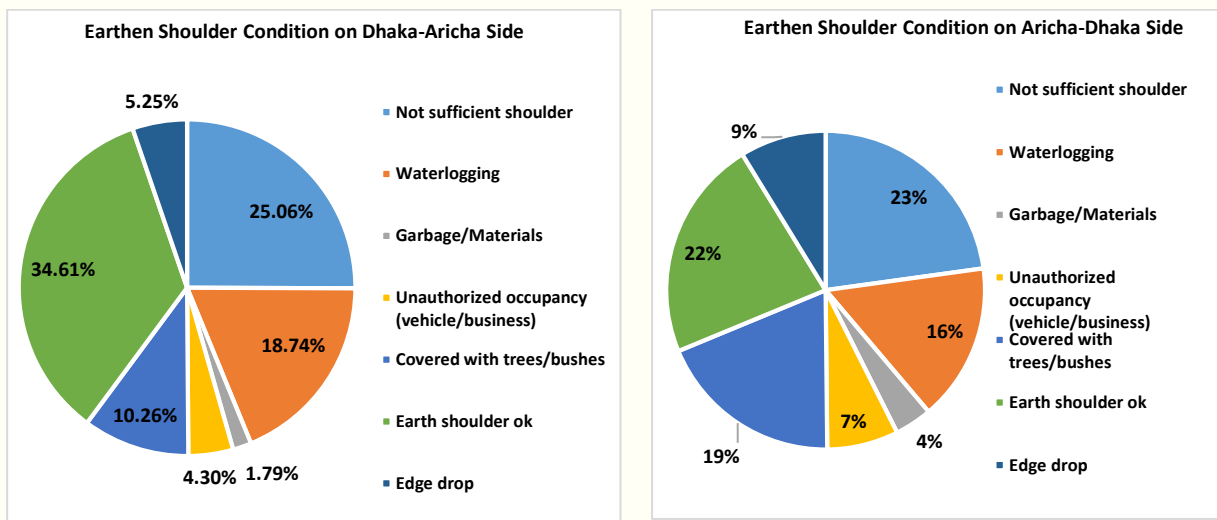
Figure 5.22: Earthen Shoulder Condition on Dhaka-Aricha Highway (N5) (Both Sides)

- On Dhaka-Aricha Highway, 19.6 km (25.06%) verge/earthen shoulder was either missing or less than standard dimension of 1m for any emergency traffic movement. 14.7km (18.74%) was found waterlogged, 8km (10.26%) was covered by bushes and 4.7km (6.09%) was occupied by parked vehicles, materials and garbage. A total of 27.1km (34.61%) earthen shoulder was found sufficient (at least 1m width) but 4.11km (5.25%) had highly risky edge drop (more than 3-inch height) which were creating traffic vulnerability.

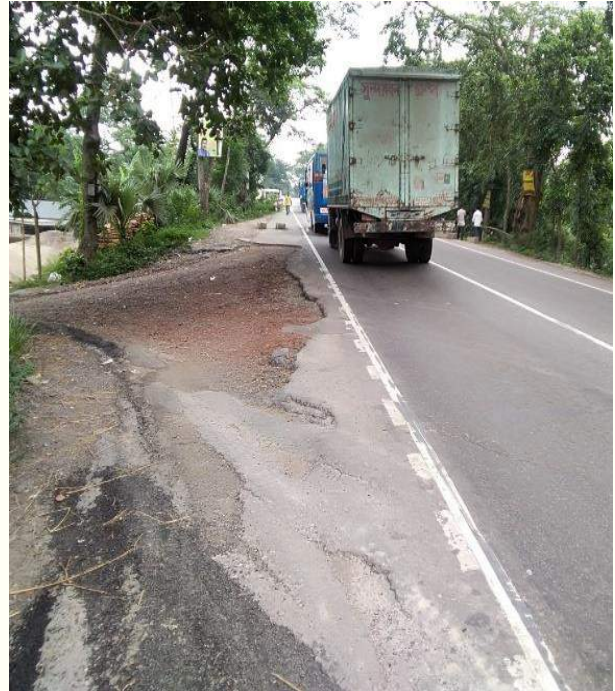
Defective roadside area within Ch.+42 to Ch.+44

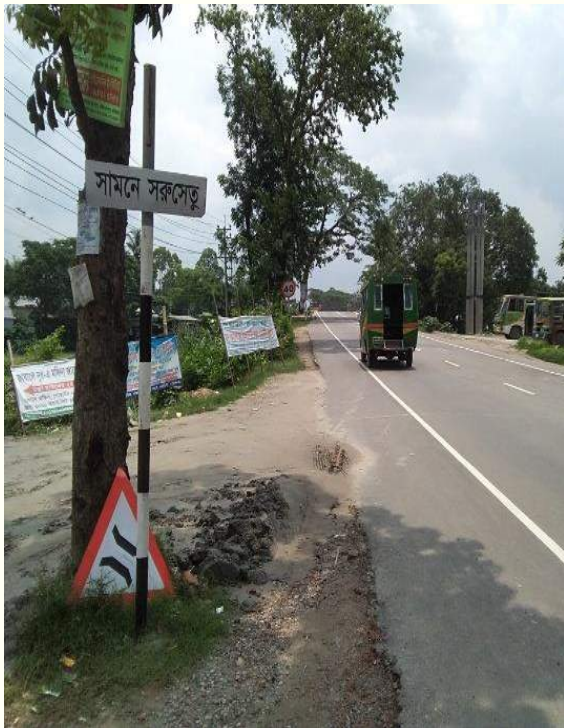
Disturbed road sign within Ch.+42 to Ch.+44

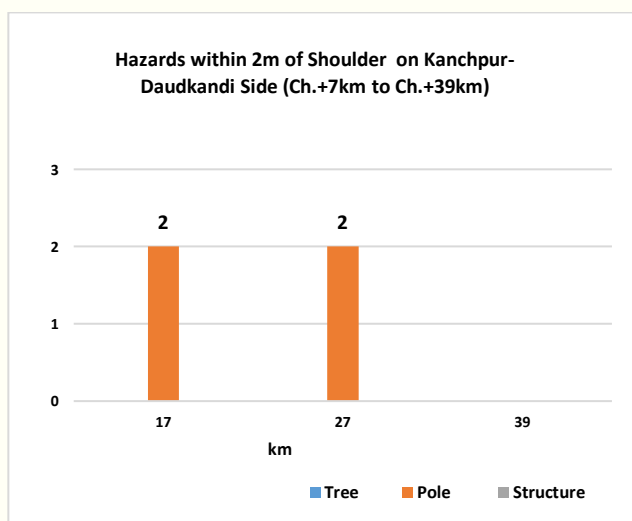
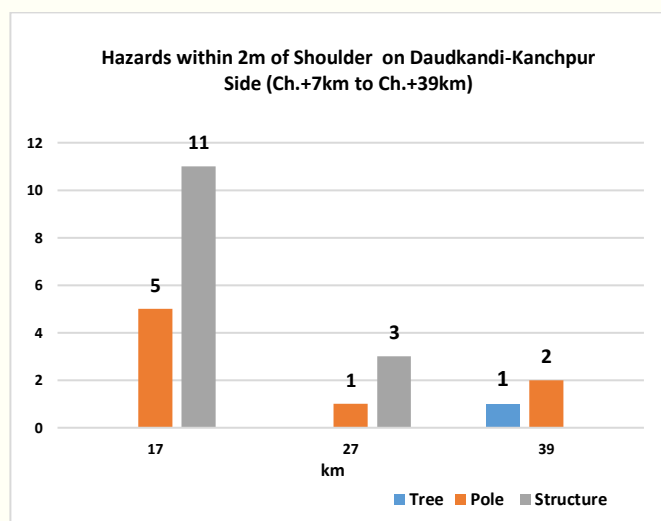
Figure 5.27: Hazards within 2m of Shoulder on Kanchpur-Daudkandi Highway (N1)
(Both Sides)

- Roadside hazards are those temporary /permanent structures along the road which might increase crash severity if hit by vehicle. Audit team considered 2m width after the pavement and counted permanent / temporary structures, trees (diameter more than 6cm) and steel poles.
- There was no temporary/permanent structure on left side during journey from Kanchpur to Daudkandi. On Daudkandi to Kanchpur, temporary structures occupied 1.4km (4.4%).
- Combining both sides, surveyed road of N1 consisted of 1 tree and 12nos poles within 2m from hard shoulder edge.
- Average 1 roadside hazard on every 0.1km and maximum 2 hazards on every 10km were identified on Kanchpur to Daudkandi Highway. Along the Daudkandi to Kanchpur side, average 1 roadside hazard on every 0.75km and maximum 16 hazards on every 10km were identified. Maximum roadside hazards were at the built-up area of Daudkandi city area.
