REPORT ON
DETAILED
ROAD SAFETY AUDIT
OF FIVE ROAD SECTIONS
(500 KM)

ROAD SAFETY AUDIT REPORT FY 2017-2018

Road Design & Safety Circle
Roads & Highways Department
Government of the People's Republic of Bangladesh
SARM Associates and HeptaTech Limited JV

Detailed Road Safety Audit of Road Sections of Joydebpur – Mymensingh (N3), Kanchpur- Daudkandi (N1) and Chattogram – Cox's Bazar (N1), Kashinathpur – Rajshahi (N6) and Dhaka – Aricha (N5) (Total 500 km) National Highway During FY 2017 -2018

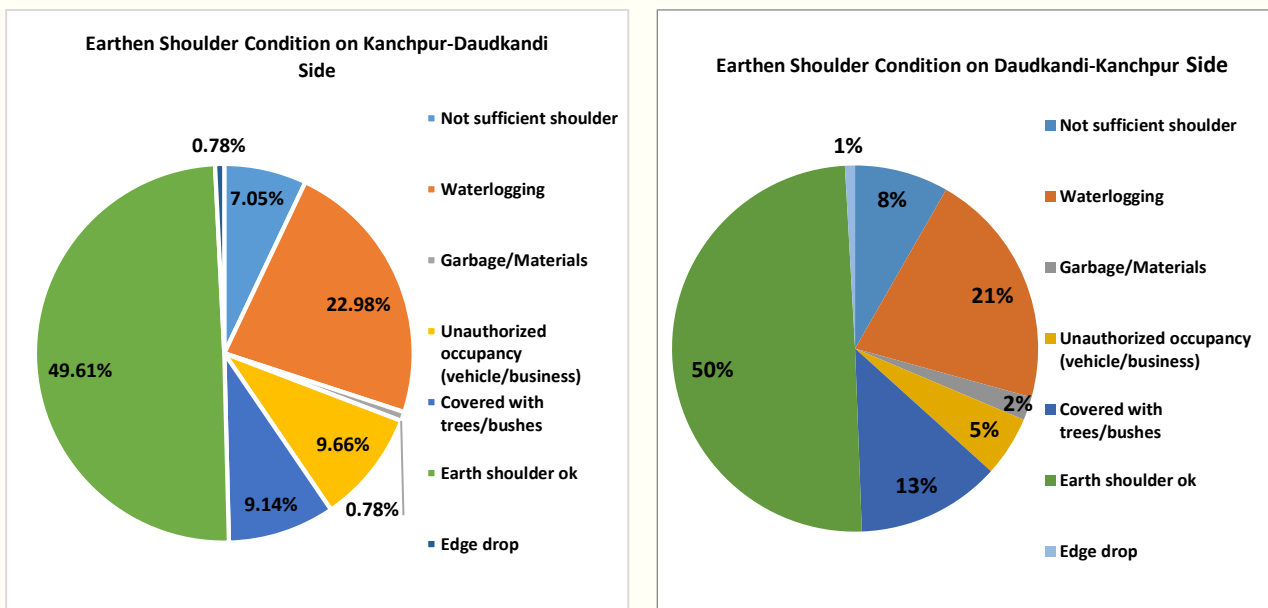
Figure 5.28: Earthen Shoulder Condition on Kanchpur-Daudkandi Highway (N1) (Both Side)

- On Kanchpur-Daudkandi Highway, 2.7 km (8.4%) earthen shoulder was either missing or less than standard dimension of 1m for any emergency traffic movement. 6.1km (19.1%) was found waterlogged, 0.9km (2.8%) was covered by bushes and 3km (9.3%) was occupied by parked vehicles, materials and garbage. A total of 19km (59.4%) earthen shoulder was found sufficient (at least 1m width) but 0.03km (0.9%) had highly risky edge drop (more than 3-inch height) which were creating traffic vulnerability.

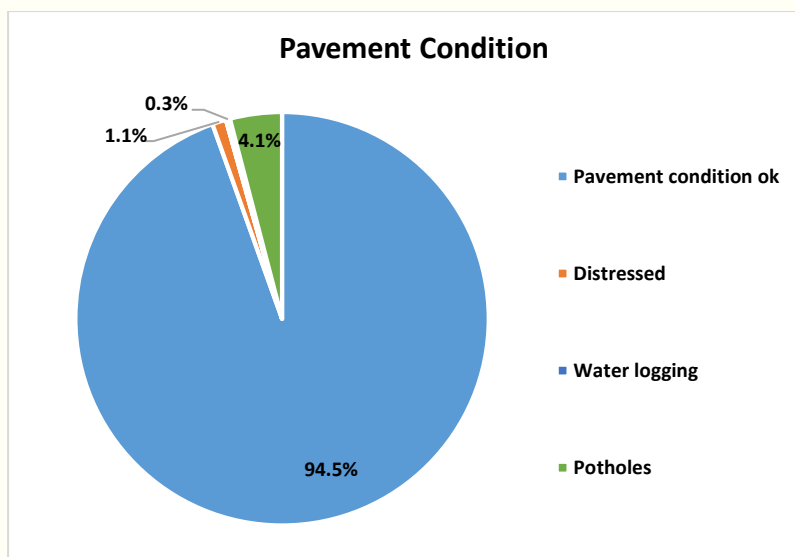
Figure 5.29: Pavement Condition on Kanchpur-Daudkandi Highway (N1)

- From Kanchpur to Daudkandi Highway, 30.4km (97.8%) of the pavement of 31.1km was workable whereas 0.1km (0.3%) was distressed, 0.2 km (0.6%) pavement had waterlogging (N.B: ANNEXURE-A), 0.4km (1.3%) pavement had potholes (N.B: ANNEXURE-A), which were creating serious vulnerability.

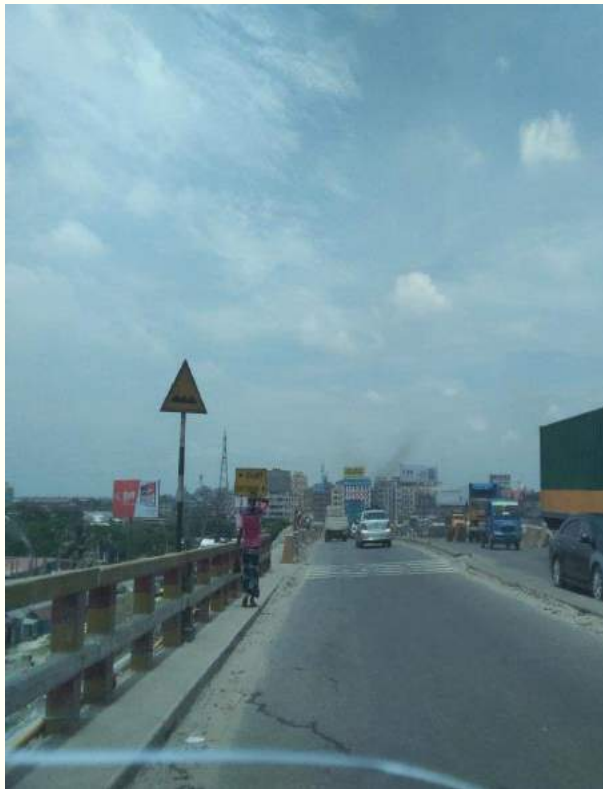
Improper bridge facilities within Ch.+7 to Ch.+9

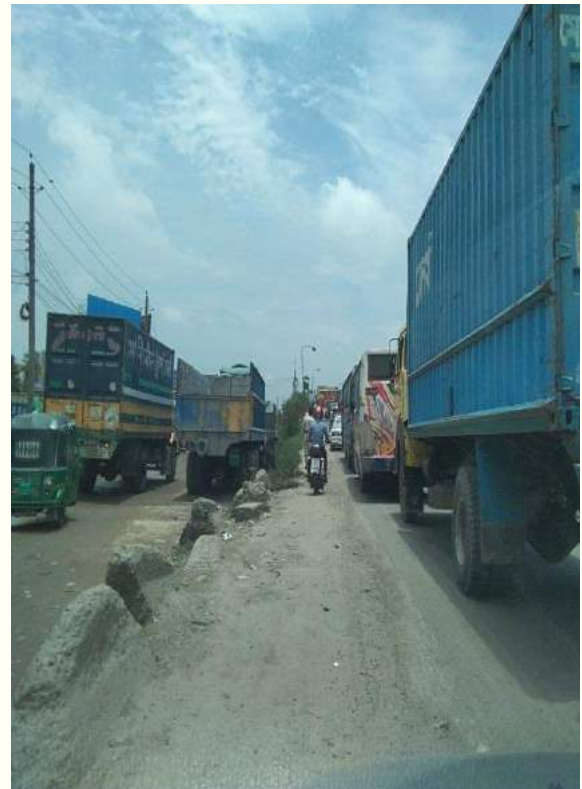
Risky and broken blocks on middle road Ch.+ 9 to Ch.+11

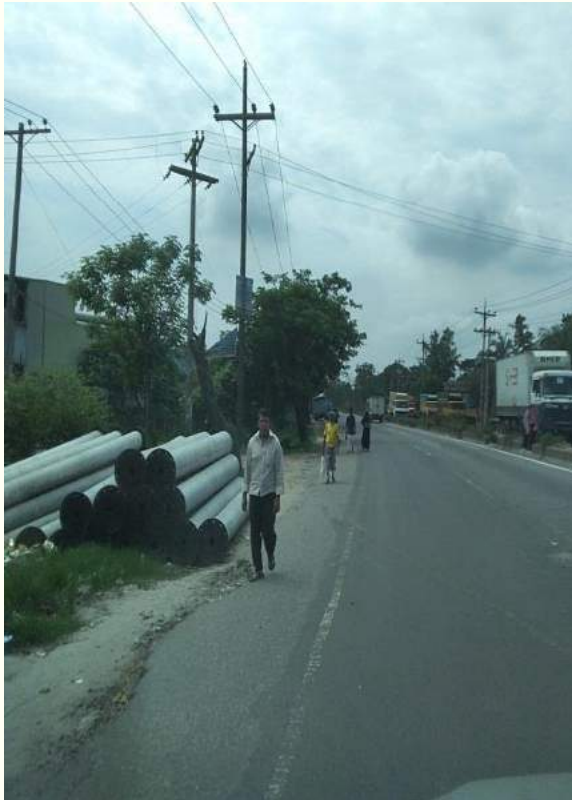
Unauthorized roadside activities within Ch.+13 to Ch.+15

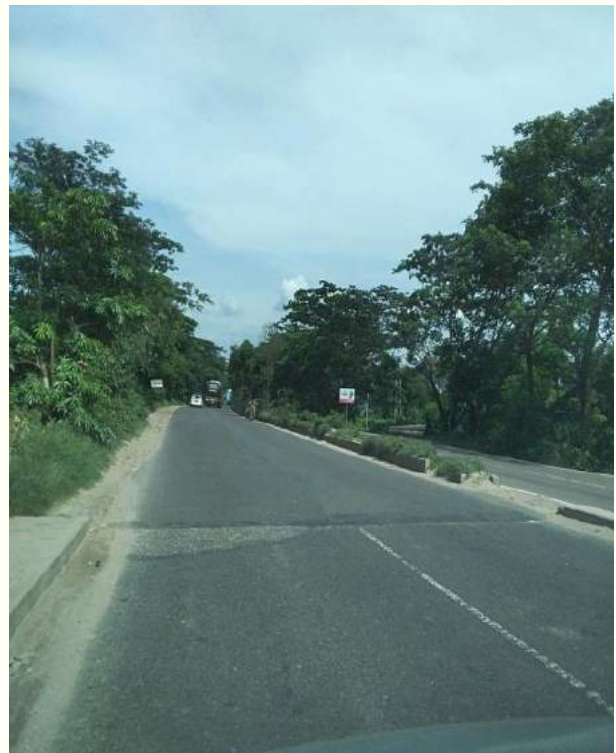
Poor and broken median within Ch.+15 to Ch.+17

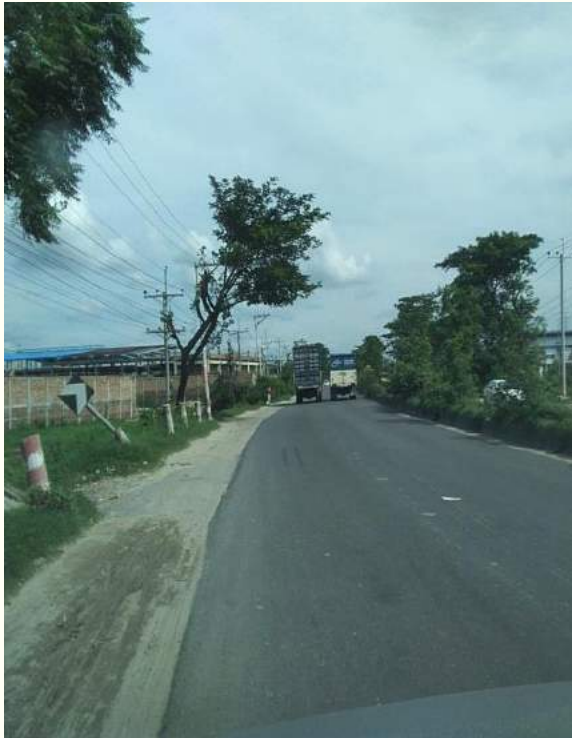
Disturbed sign within Ch.+17 to Ch.+19

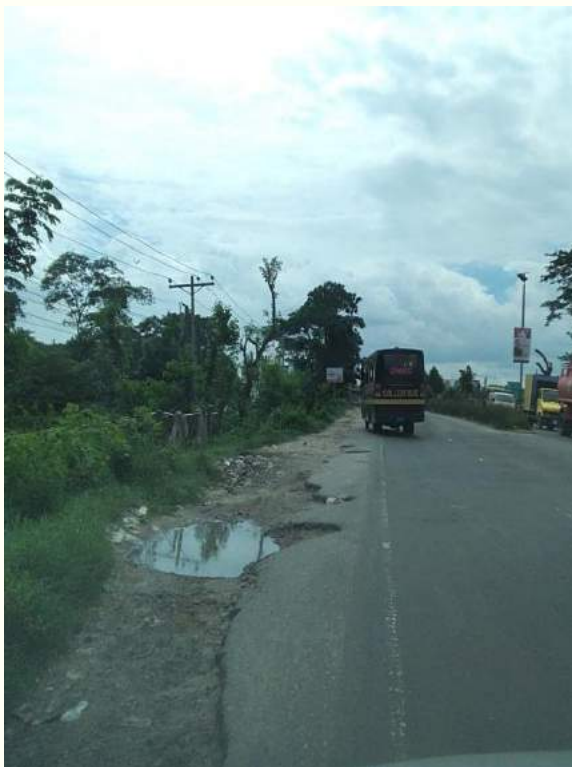
Broken shoulder and waterlogging within Ch.+19 to Ch.+21

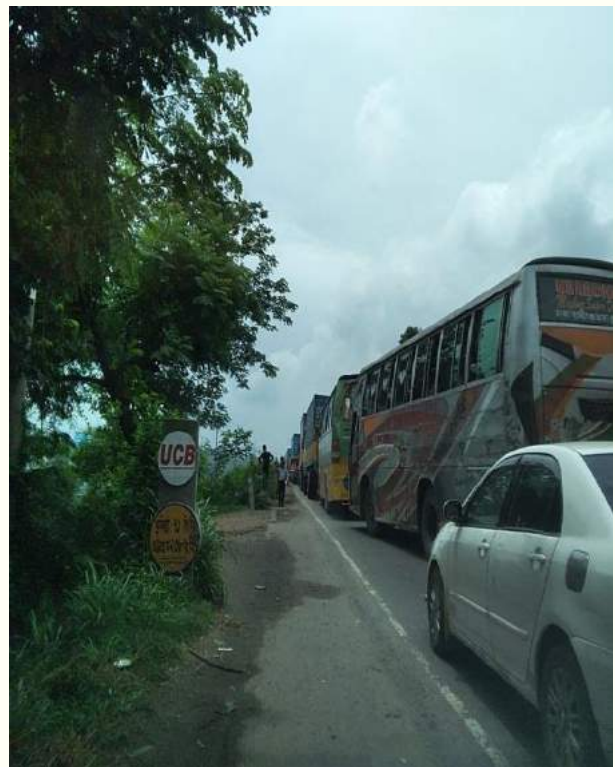
km post within clear zone at Ch.+21 to Ch.+23

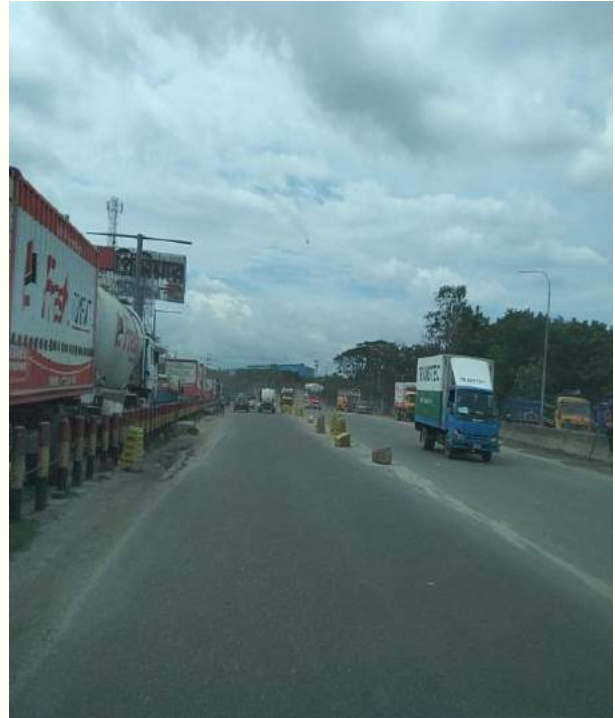
Hazardous median blocks within Ch.+23 to Ch.+25

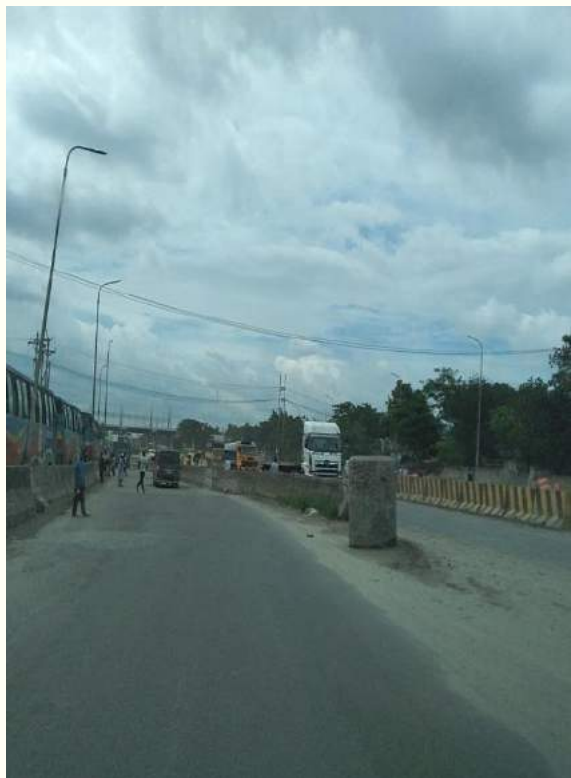
Hazardous concrete block within Ch.+23 to Ch.+25

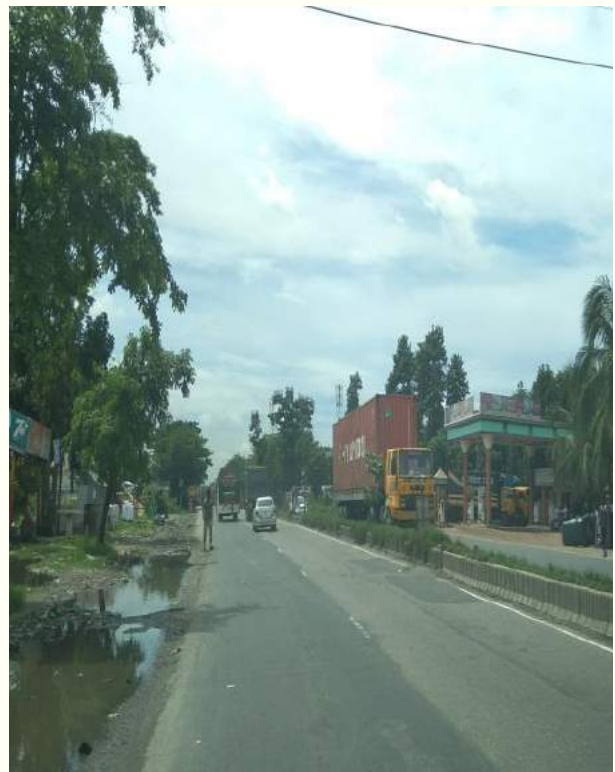
Waterlogged roadside within Ch.+25 to Ch.+27

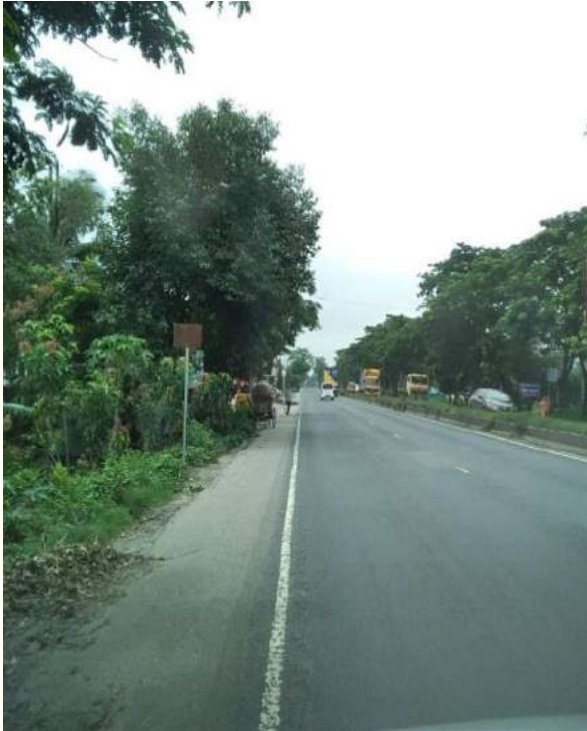
Damaged road sign within Ch.+33 to Ch.+35

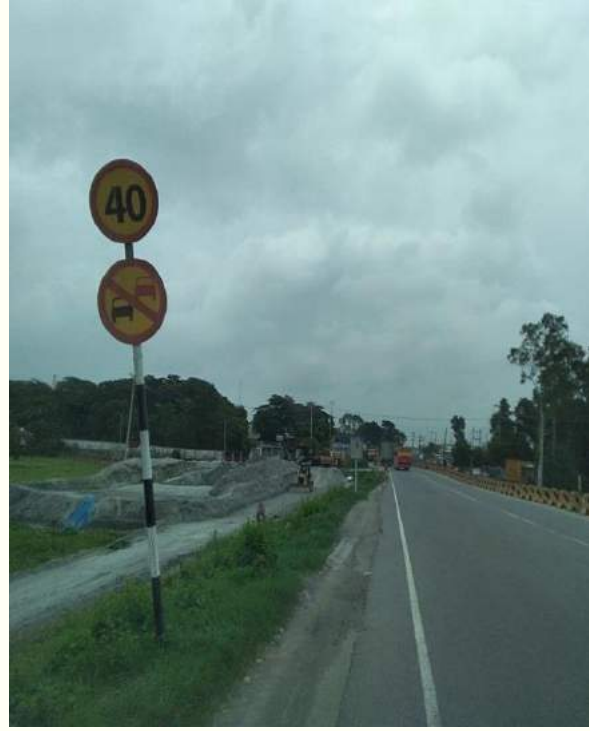
Wrongly colored road sign within Ch.+35 to Ch.+37

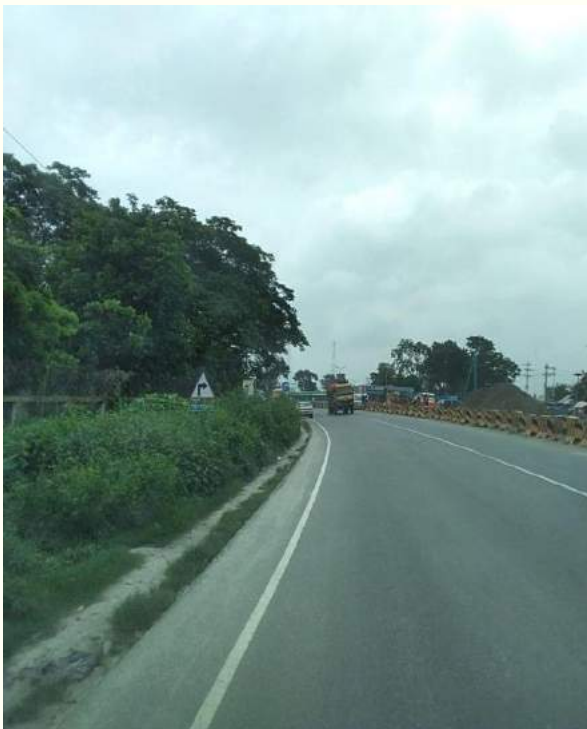
Improper placement of sign within Ch.+35 to Ch.+37

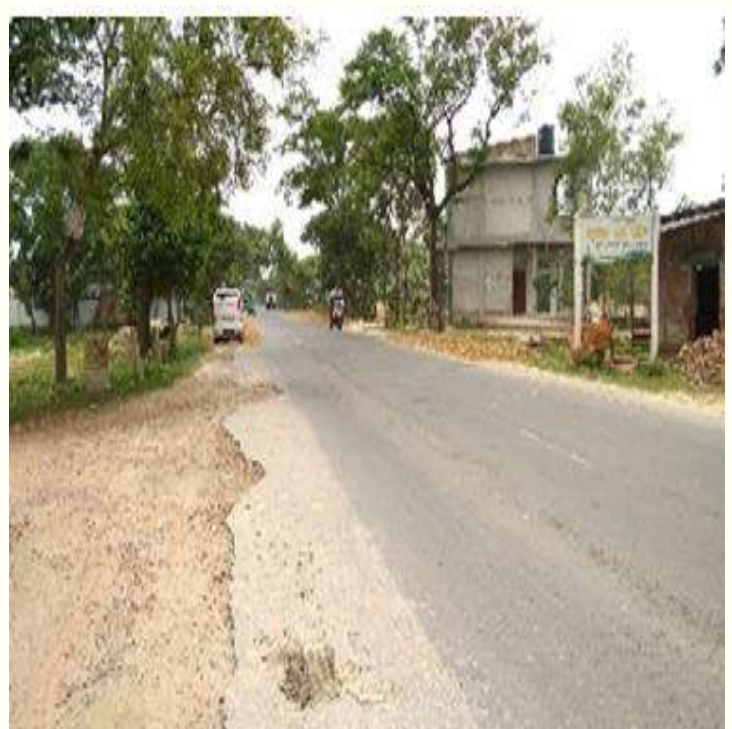
Broken shoulder within Ch.+106 to Ch.+208

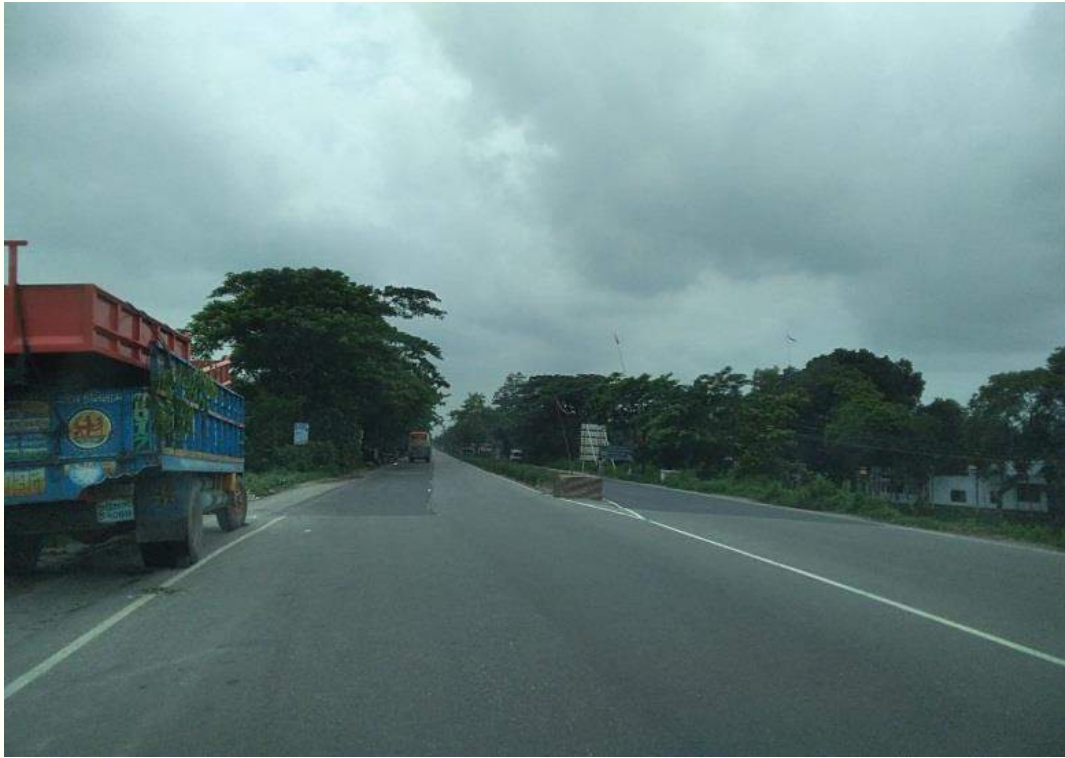
Hazardous median protection block within Ch.+35 to Ch.+37

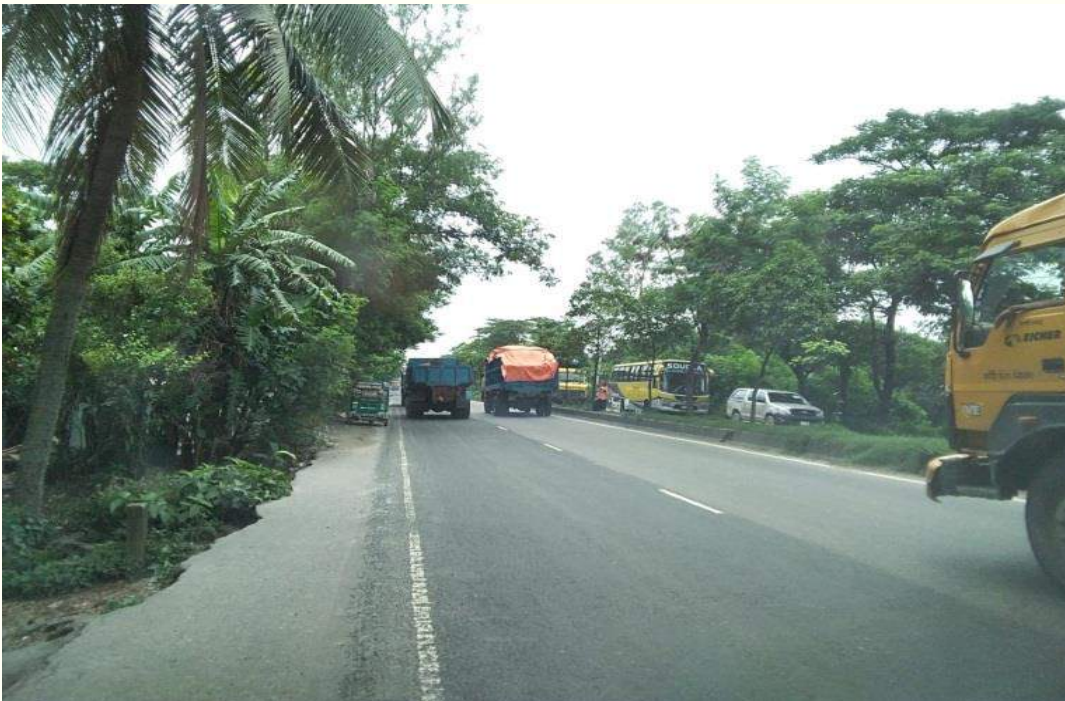
Risky edge drop within Ch.+35 to Ch.+37
