IMPACT OF GEOTECHNICAL PROPERTIES ON BANK FAILURE MECHANISM AT DAULATDIA FERRY GHAT OF PADMA RIVER OF BANGLADESH

Keywords: Bank failure, Daulatdia ferry ghat, Geotechnical properties, Padma River.

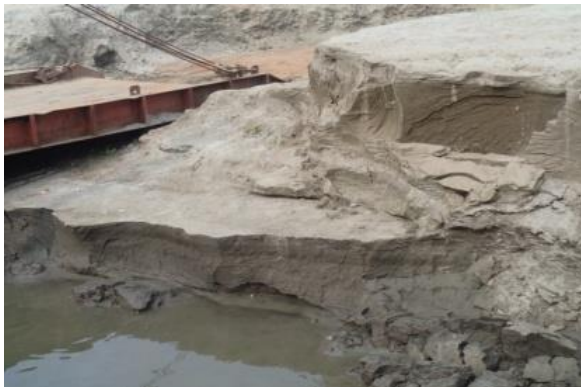
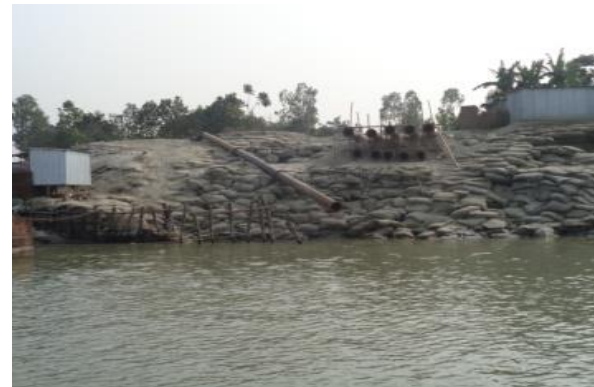
Fig.1: Daulatdia ferry ghat of Goalonda upazilla in Rajbari district

River bank failure is a common phenomenon in Bangladesh. The failure process due to devastating flood and excessive rainfall accelerating the failure process resulting in immense damage of agriculture and infrastructures every year. The people suffered unbearable miseries wherever the river bank failure occurred. Daulatdia ferry ghat of Goalonda upazila in Rajbari district is such a bank failure prone river bank which has been shown in **Fig. 1**.

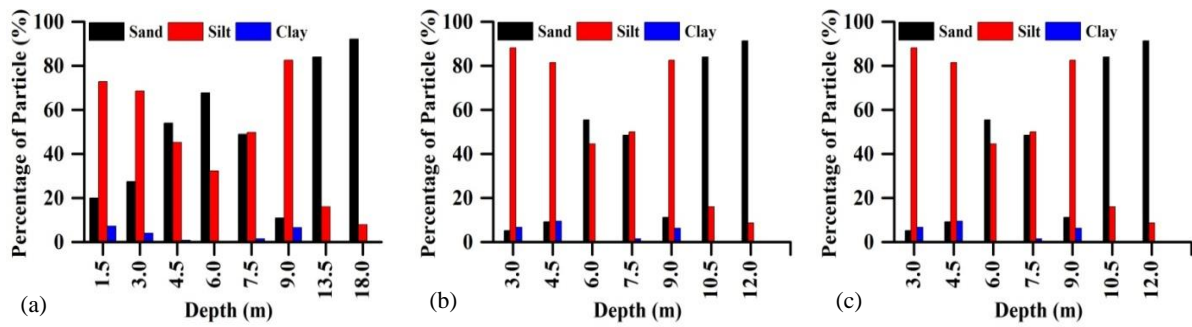
Fig. 5. Percentages of Particle of soil vs. depth graph of a) BH#1 and location (N-2631241 & E-784402), b) BH#2 and location (N-2631237 & E-784349), c) BH#3 and location (N-2631205 & E-784152) of Char Bahirdia at Daulatdia side.

From the graph it has been observed that cohesive soil layer is occasionally observed along the whole 22 m depth of exploration were non-cohesive layer. The SPT values are 3 to 38 for cohesive soils where the SPT values are 3 to 39 for non-cohesive soils. The consistency of cohesive soils varies from soft to hard and the plasticity is medium. The clay particle varies (4 to 9) %, silt particle varies (69 to 88) % and sand particle varies (5 to 27) % for cohesive soils. In the case of non-cohesive soils, it is observed that the clay particle varies (0 to 1) %, silt particle varies (8 to 83) % and sand particle varies (49 to 92) %. It was found that the soil layers were dominating the site through its non-cohesive characters. The density index of non-cohesive soils varied from very loose to dense and the plasticity is non-plastic. The cohesion varies from (3 to 6) kN.m⁻² and the angle of internal friction varies from (5 to 20) degree. The permeability varies from (10⁻⁵ to 10⁻⁴) mm.s⁻¹ for cohesive soils and (10⁻³ to 10⁻²) mm.s⁻¹ for non-cohesive soils. The specific gravity varies from 2.646 to 2.770 for cohesive soils and 2.623 to 2.670 for non-cohesive soils.

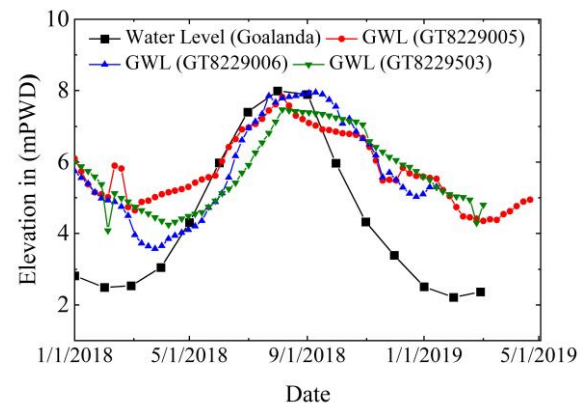
Fig. 7. Graph showing the surface water level (SWL) of Goalanda ghat and ground water level (GWL) of 3 stations of Goalanda ghat, Rajbari with period.

From Fig. 7 it has been observed that the low flood level at Daulatdia side has generally been varied from 2.5 mPWD to 3.0 mPWD and high flood level varied from 8 mPWD to above in 2018-19. The elevation at Daulatdia side is adjacent to the bank line is 7.0 mPWD, 6.0 mPWD. It would become submerged at monsoon. From the low flood level, the bank

slope height from bank line remains 5.0 mPWD and 4.0 mPWD. In these bank lines, the layering of the bank material is non-cohesive sand mixed with silt particles.

On the other hand, the stratification of the materials from the bank line 5.0 mPWD to the ground surface consists of cohesive layer wherever SILT particles are dominant. The soil strata from the bank line 4.0 mPWD to the ground surface consist of variation of cohesive and non-cohesive soil layer. Where cohesive soil layers dominate SILT particles together with CLAY and SAND particles.

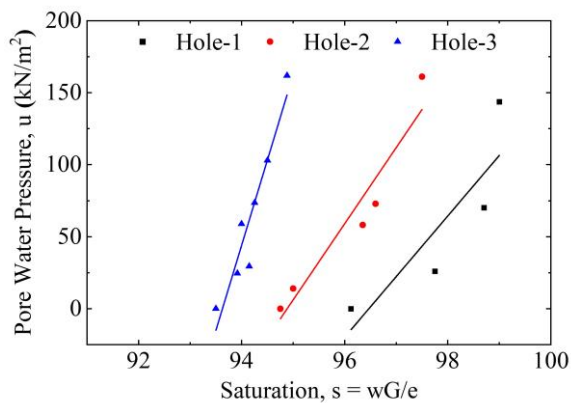
Fig. 8. Graph showing the saturation and pore pressure at Char Bahirdia of Daulatdia side of Padma River.

The pore water pressure has been plotted with its respective saturation in **Fig. 8**. The data have been considered here on the month of February 2018. From the figure it is observed that the pore water pressure has been increased with the increases of saturation. It is mentioned that the data would be changed monthly as the location is situated on the river bank and the distance of the holes adjacent to the bank line. The saturation becomes full when the soil is submerged. The saturation has been increased here from 93% to 99% in accordance with its soil properties as it depends on specific gravity as well as void ratio of the soils and its density. Their corresponding pore water pressures have been increased from 0 to 177 kN.m⁻² accordingly. Here the small variation of saturation has occurred due to its soil layers and properties and its ground water level as well as location.

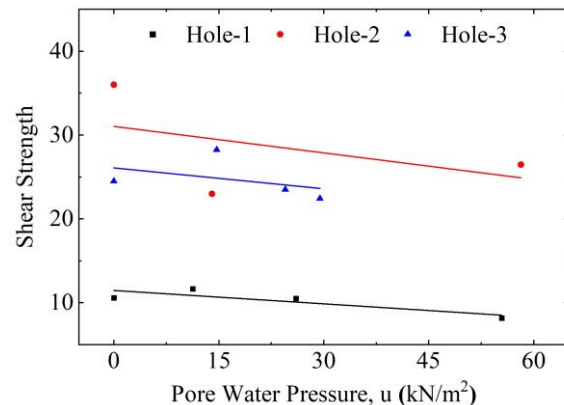
Fig. 9. Graph showing the effect of pore pressure on shear strength at Char Bahirdia of Daulatdia side of Padma River.

Shear strength has been plotted with corresponding pore pressure in **Fig. 9**. From the graph it is observed that shear strength has been decreased with the increases of pore water pressure in all the holes. The shear strength of the soils of BH#1 is less than that of BH#2 and BH#3. The shear strength of the BH#3 has been varied to a certain limit and the strength is more in hole no. 2. Here it is noticed that reduced level was not existed at the alike coordinate and ground water level varies due to water surface water level. That's why the soil strength is not homogeneous, however, the location was identical. It is also observed that waves are created by ferry, launch and trawler boat traffic near the two bank lines at Daulatdia side.

Geotechnical information is always very important for any type of construction work on it. Therefore, it is very much essential and recommended to investigate the geotechnical properties of the river bank prior to any bank protection works. The soil properties at the study area indicate that soil strengthening is required for bank protection works. The findings of the present study are expected to help a lot to the concerned authorities in undertaking any construction work at the study area. It needs special attention as the water level has become varied in this river. It is also recommended that wave action is to be considered at the design of the ferry ghat protection works.
