Fourth Primary Education Development Program (PEDP-4)

# Semi-Annual Environmental Monitoring Report-XI

Jan '2025 – Jun '2025

A Combined Report on the Environmental Safeguard Issues During the Construction of School Buildings and Wash Blocks Under PEDP-4

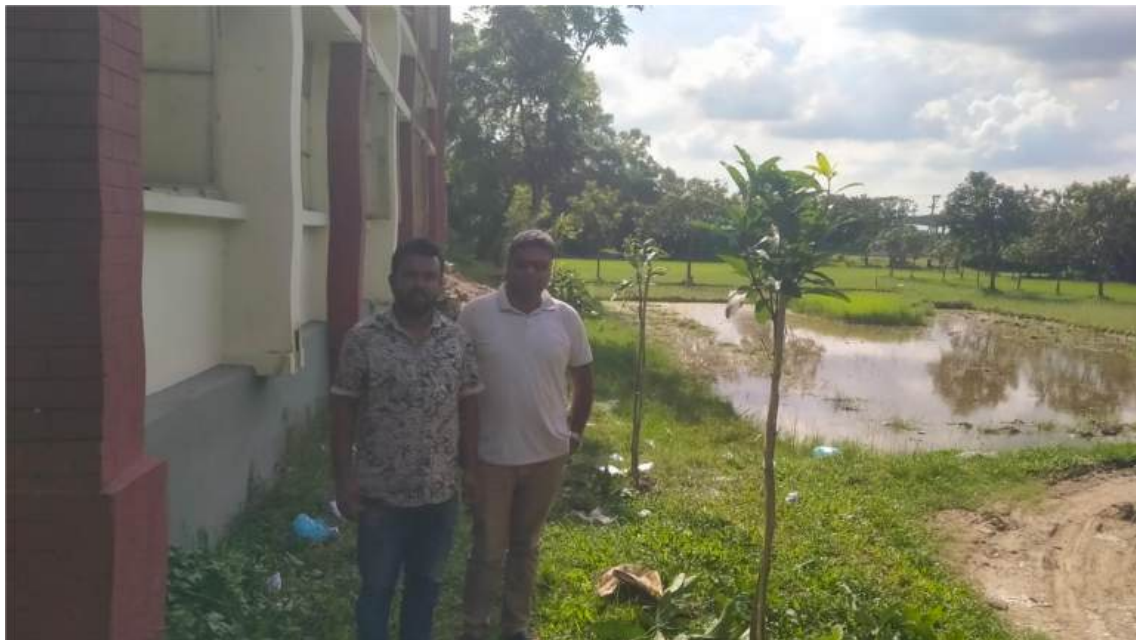
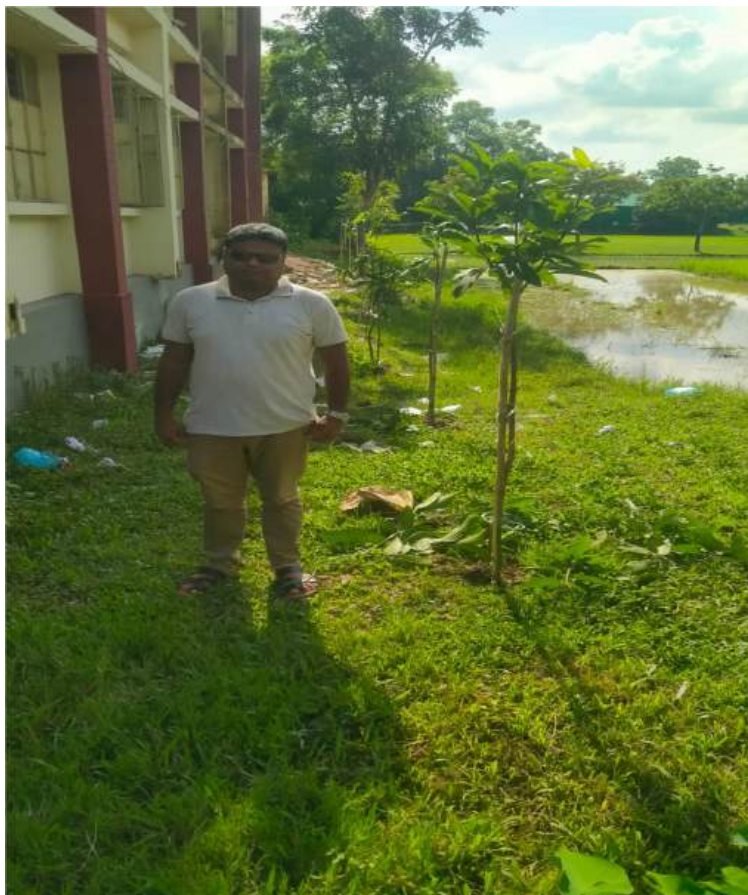
After completion of the school buildings, suggestions are given to the contractors and SMC for planting saplings in the blank spaces to make the school buildings environment friendly. As evidence some saplings plantations are highlighted in the picture below:

Picture: Gazipur GPS at Sreepur Upazila of Gazipur district

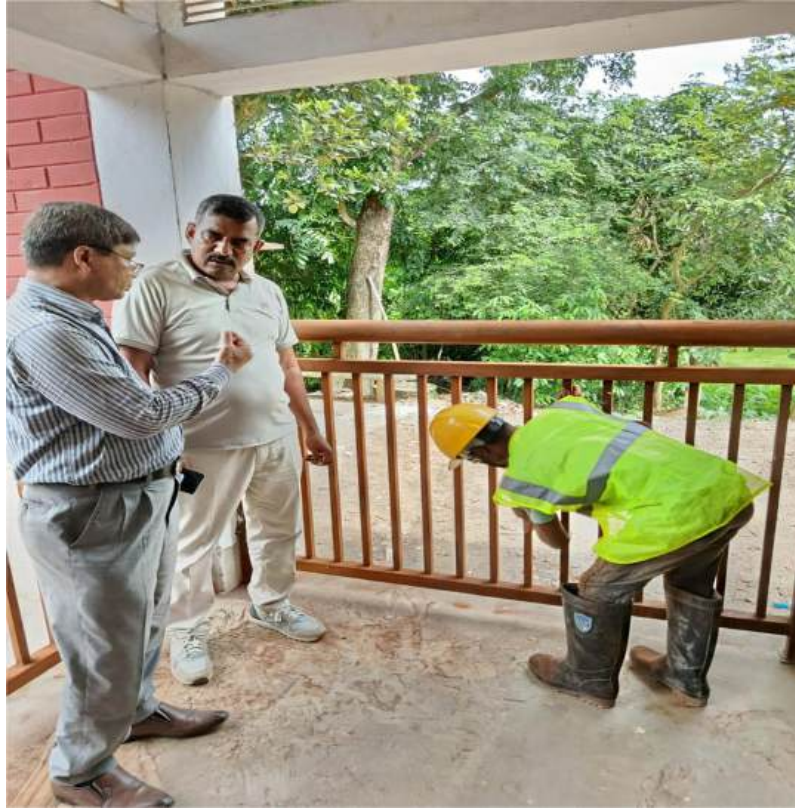
Picture: Environmental Specialist with contractor checking the painting process in Sylhet district

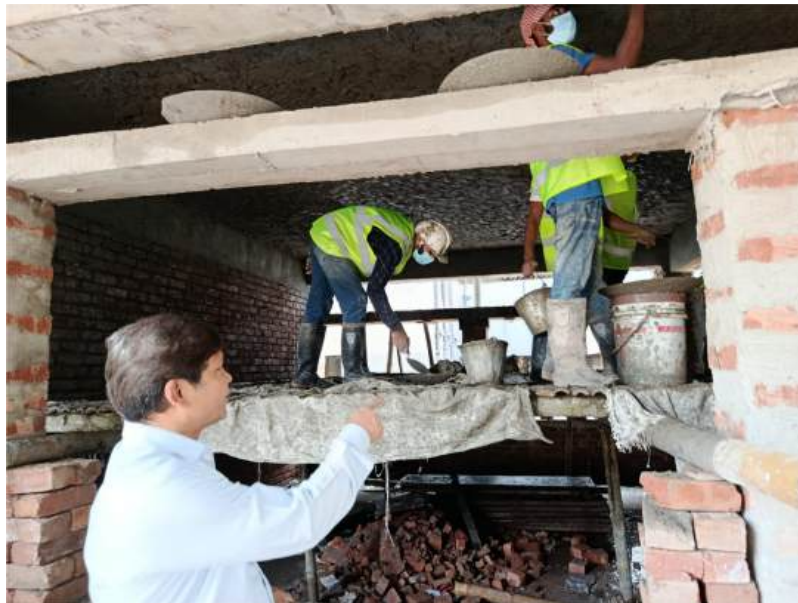
**Picture: Environmental Specialist monitoring the NAPE building**

**39. NAPE building:** Environmental Specialist, Concerned Engineers, PEDP4 staff visit the construction works of NAPE building as and when necessary. During the reporting period a several times NAPE building is visited and constructive suggestions are provided by the PEDP-4 and LGED staff to minimize the environmental negative impacts which are producing for the construction works of NAPE building. Environment and social safeguard issues are discussed through seminars, symposia, workshops and meetings. Sometimes, contractors, committee members, Upazila Engineer, Sub-Assistant Engineers, and PEDP staffs jointly visited the NAPE building. Different topics of environment and social safeguard issues were discussed in the visiting time.

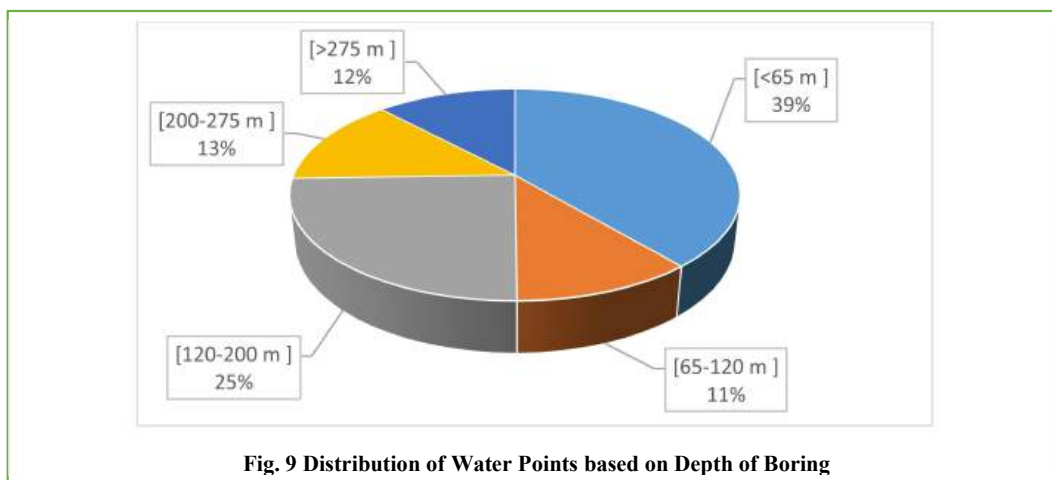
[25] DPHE installed tube wells of varying depth in different primary schools of Bangladesh considering the geological formation of respective district/upazilla. Although the depth of tube well

depends on the suitable water layer, all the tube wells installed in the reporting tenure can be broadly categorized into five distinct types based on the depth of tube well. Fig.8 depicts the classification of tube wells based on depth. As shown in Table 5, a total of 852 nos. of water points were installed under PEDP-4 during the reporting tenure. It is clear from Fig.9 that 39% of tube wells were installed at a shallow depth (<65m) and the Tube wells installed between 65m to 275m are deep tube wells that occupy (61%) of all the installed water points.

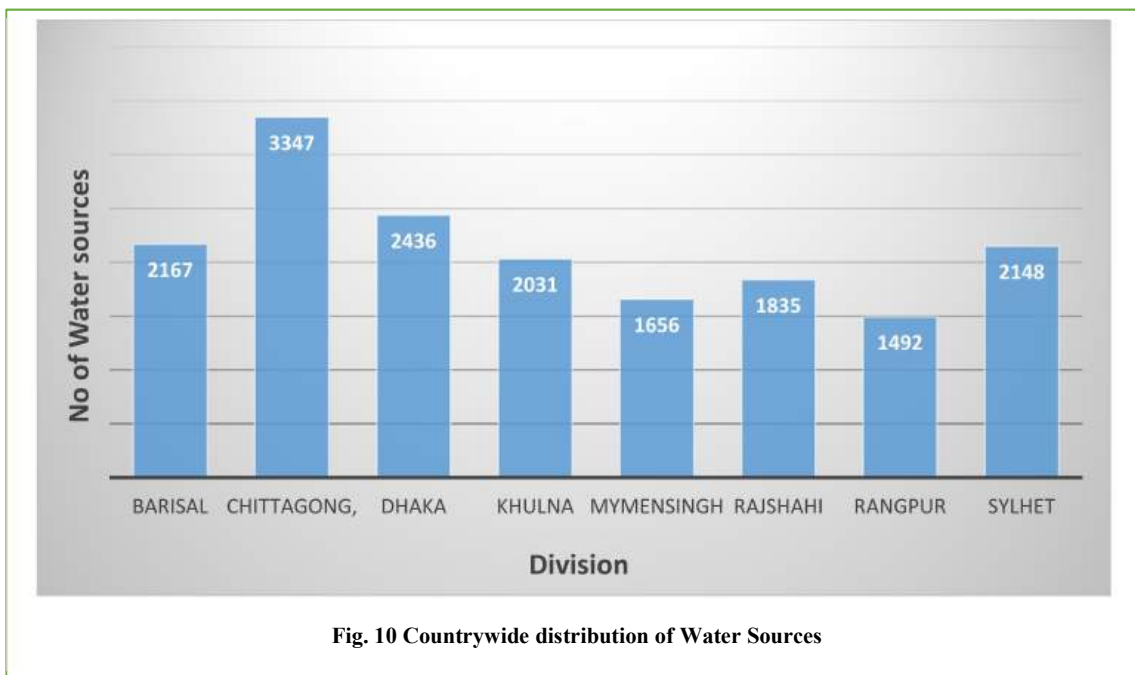
[26] Countrywide distribution of water sources and wash blocks were analyzed and division wise categorization for water sources and wash blocks is depicted in Figs. 10 and 11 respectively. It is fact that, tube well ensures safe drinking water for the school children as well as for the teachers. Fig.10 shows the equity in distribution of water sources. Among the total installed water points, the highest number was installed in the Chattogram division followed by Dhaka and Sylhet division while the minimum number of water points was installed in the Rangpur division. This is as per the need assessment criteria and the approved list issued by DPE based on approved IPG.

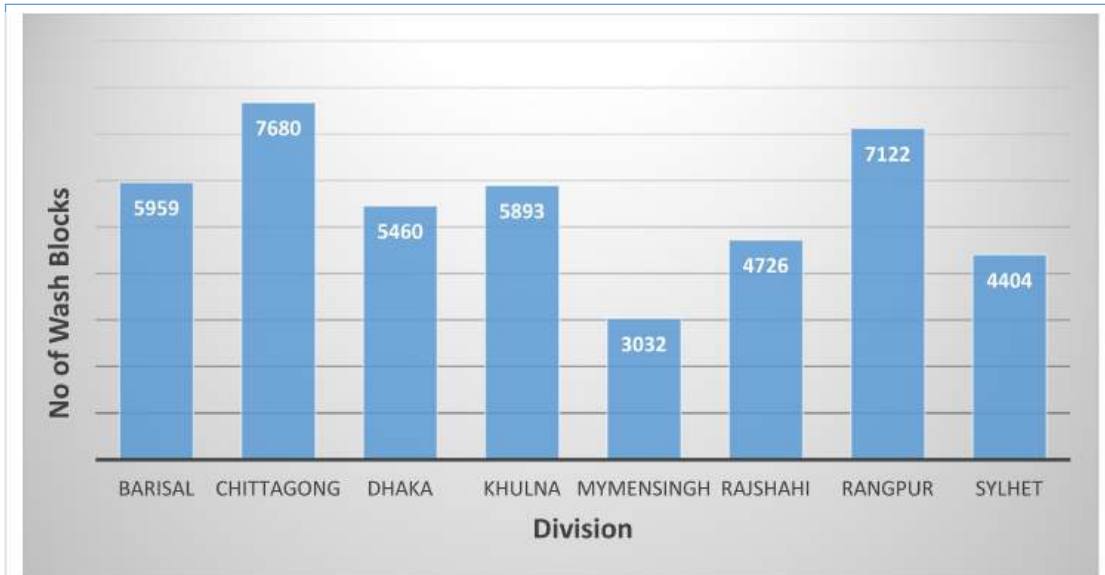
Fig. 11 Countrywide distribution of Wash Blocks

[28] Fig.11 reflects the countrywide distribution of wash blocks depending on the number of districts and upazillas in each division. The maximum number of wash blocks were constructed in the Chattogram, Rangpur, Barishal, and Khulna divisions as these divisions cover the maximum districts. The lowest number of wash blocks (3032) was constructed in the Mymensingh division.

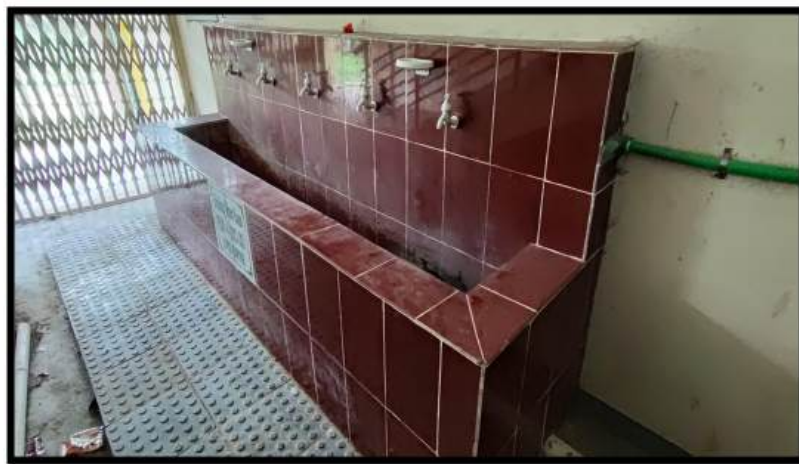
**Fig. 13 Five Outlet Water Collection Basin**

- [1] Pipe out used water to the existing drains (if any).
- [2] Use of 5-ring soaks well to drain out basin water where the surface drain is absent.
- [3] Construction of 5 user water collection basin having 50mm dia. PVC washout pipe. Fig. 13 Shows a newly constructed 5-outlet hand washing basin under PEDP-4.

Because, DPHE local office took the initiative in solving the drainage issue, it has been observed that the water logging problem is insignificant compared to that in PEDP-3. However, it is revealed that out of 852 water sources about 1.64% had the problem of water logging. The reasons observed are mainly lack of cleanliness which created blockage of drainage pipe by wastes like paper, tree leaves, mud, etc. It is hence suggested that SMC needs to look after this issue and run a regular cleanliness program in the water collection basins and drains.

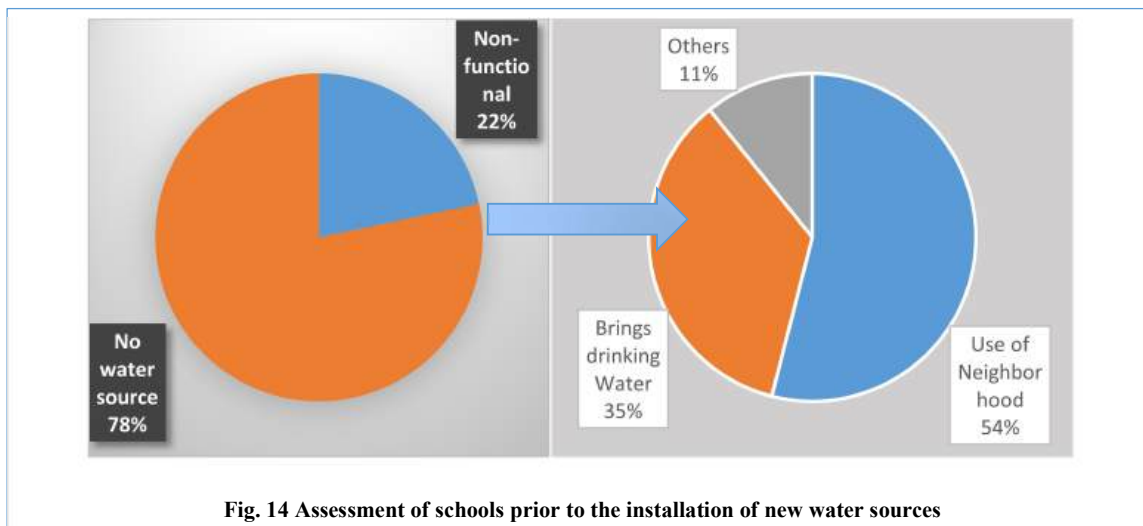
Fig. 14 Assessment of schools prior to the installation of new water sources

[32] During preliminary survey it was found that, out of 852 schools 78% did not have their own active water option. 54% of them used the facility of their neighborhood. Though 22% schools have their own tube wells, yet those tube wells were found as non-functional or did not provide sufficient water during dry season. From this information during the preliminary screening, DPHE took initiative in solving the above problem by installing new tube wells (approved list of which schools were duly provided by DPE) with submersible pump but at different depth as appropriate to the site geology.

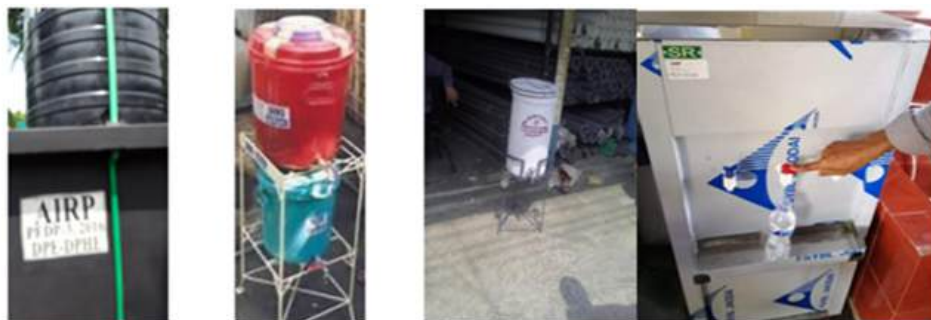
**Fig. 16 Different Suggested Improved Filtration Technologies**

[37] In cases where arsenic/iron/chloride is found beyond allowable BDS standard in installed water sources, DPHE adopts other approved alternate water options. DPHE goes for options like deep tube well of greater depth, ring well, pond sand filter, rain water harvesting, Reverse Osmosis Filter, AIRP, Small box type AIRP etc. whichever is feasible. In some cases, if all the options in hand fails, i.e., boring in greater depth becomes impossible, arsenic is found even in deep tube well and none other option is feasible, DPHE has started implementing 'SONO Filter' as well. DPHE upazilla offices will arrange and install the said filter in those water sources whichever is feasible, convenient, and justified. In addition, water from those sources will be further tested and declared safe if found well below the BDS standard of drinking water. Fig. 16 shows some of the suggested filtration technologies. Pictures of the RO filter is shown in Appendix-15.

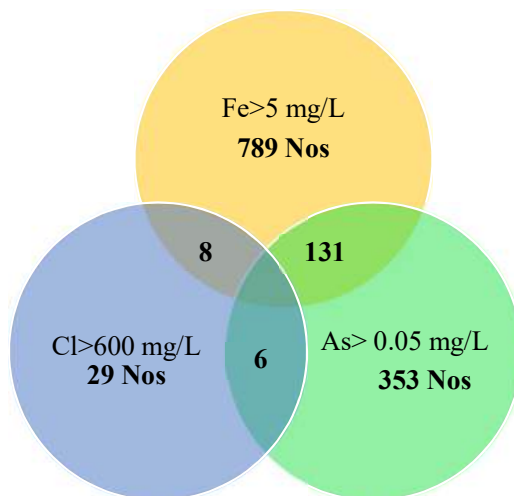
Fig. 17 Water Quality screening result at a glance

[39] In addition, as per the RDPP of September 2024, DPHE has started conducting water quality monitoring of 65,566 water points with the aim of providing arsenic, Iron, and chloride-free safe drinking water in the primary schools of Bangladesh. It has been decided that 100% of the tests will be conducted in the DPHE zonal laboratory. Among this, 15,566 water points have undergone water quality screening and the remaining 50,000 are currently under testing. It was found that out of 15,566 water points, 8.45% (1,316) had new arsenic, chloride, and iron contamination. Fig. 17 show Water Quality screening result at a glance.

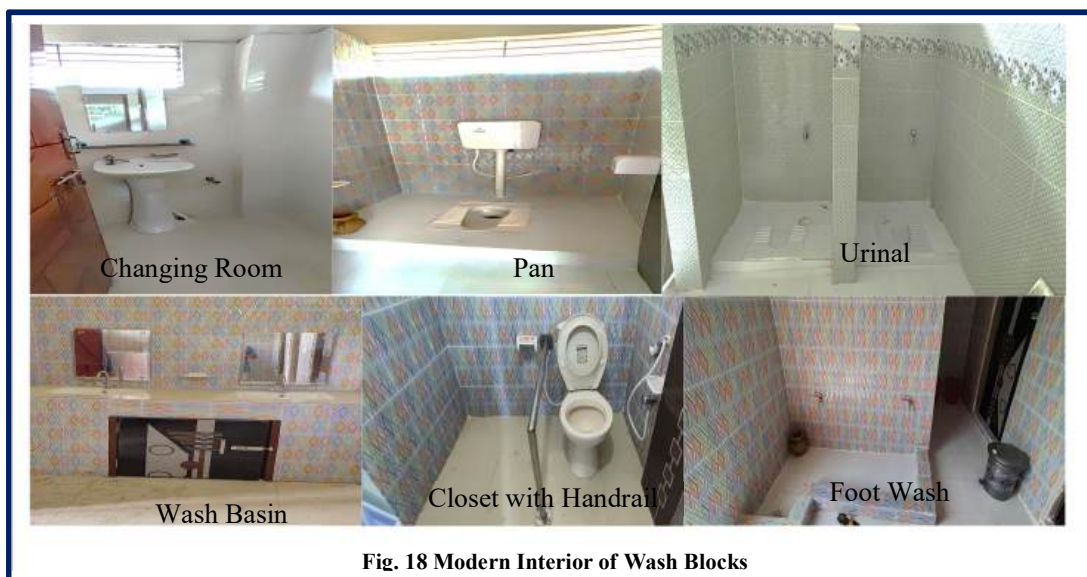
[42] Prior to the installation of water sources, hand washing of students before and after meals especially mid-day meal and after using the toilet was a matter of concern. As a result, students were more susceptible to diseases which triggered the absence of students from school. Besides these, newly constructed wash blocks with modern interior facilities will surely create enthusiasm among children for the best utilization of wash blocks. A glimpse of wash block facilities is shown in Fig 18.

[43] Working with the motto of 'clean hand, safe hand' DPHE confirmed the installation of tube wells with running water supply by the provision of submersible pumps in all the above-mentioned schools during the reporting tenure. The construction of a wash basin for hand washing (Fig.18) ensured total hand washing facilities in the school. Due to the global pandemic situation, although regular hygiene promotion activities could not be conducted yet monthly coordination meeting with DPE officials, TEO, ATEO, and Primary School Headmasters is an indication of the intensity of preparation for hygiene activities.
