**HOUSING & BUILDING RESEARCH  
JOURNAL**

Vol. 1, No. 1, 1978

1. Experimentation with Double Curvature Shell Roof as Low Cost Roofing Element BY—KAZI ATA-UL HAQUE .....	1
2. Study of Efflorescence in Brick and Mortar BY—A.U. AHMED, A.K.M. KHORSHED ALAM AND B. MONIR .....	13
3. Possibility of Mechanisation in the Building Industry in Bangladesh BY—LUTFUR RAHMAN .....	17
4. Chemical Properties of Building Materials BY—A.K.M. KHORSHED ALAM AND A.U. AHMED .....	23
5. Ferrocement Grain Silo BY—A.Q.M. SHAHIDULLAH, MIRZA MAHBUBUL HAQUE, MD. HASANUZZAMAN KHAN AND KAZI ATA-UL HAQUE .....	31
6. Possibility of Introducing Precast Elements for Low-Cost Housing BY—MIRZA MAHBUBUL HAQUE AND KAZI ATA-UL HAQUE .....	39
7. Investigation into the Problems of Brick Manufacturing in the Southern Part of Bangladesh BY—A.U. AHMED, MAJUMDER A.K.M.A. HANNAN AND M.A. SATTAR .....	44

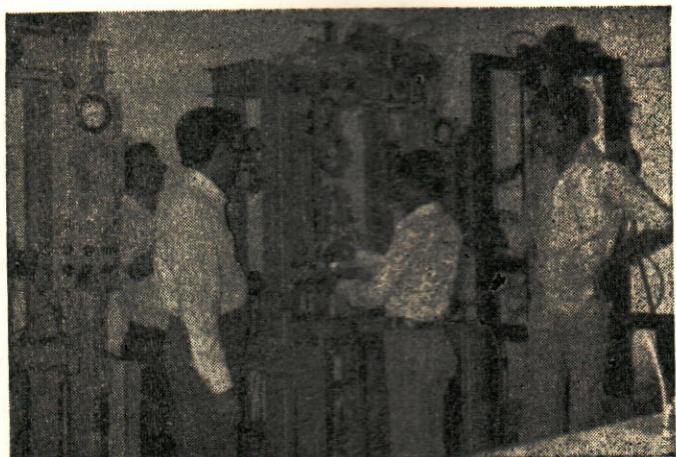
Fig. 2. Soil tests being performed with tri-axial machine
