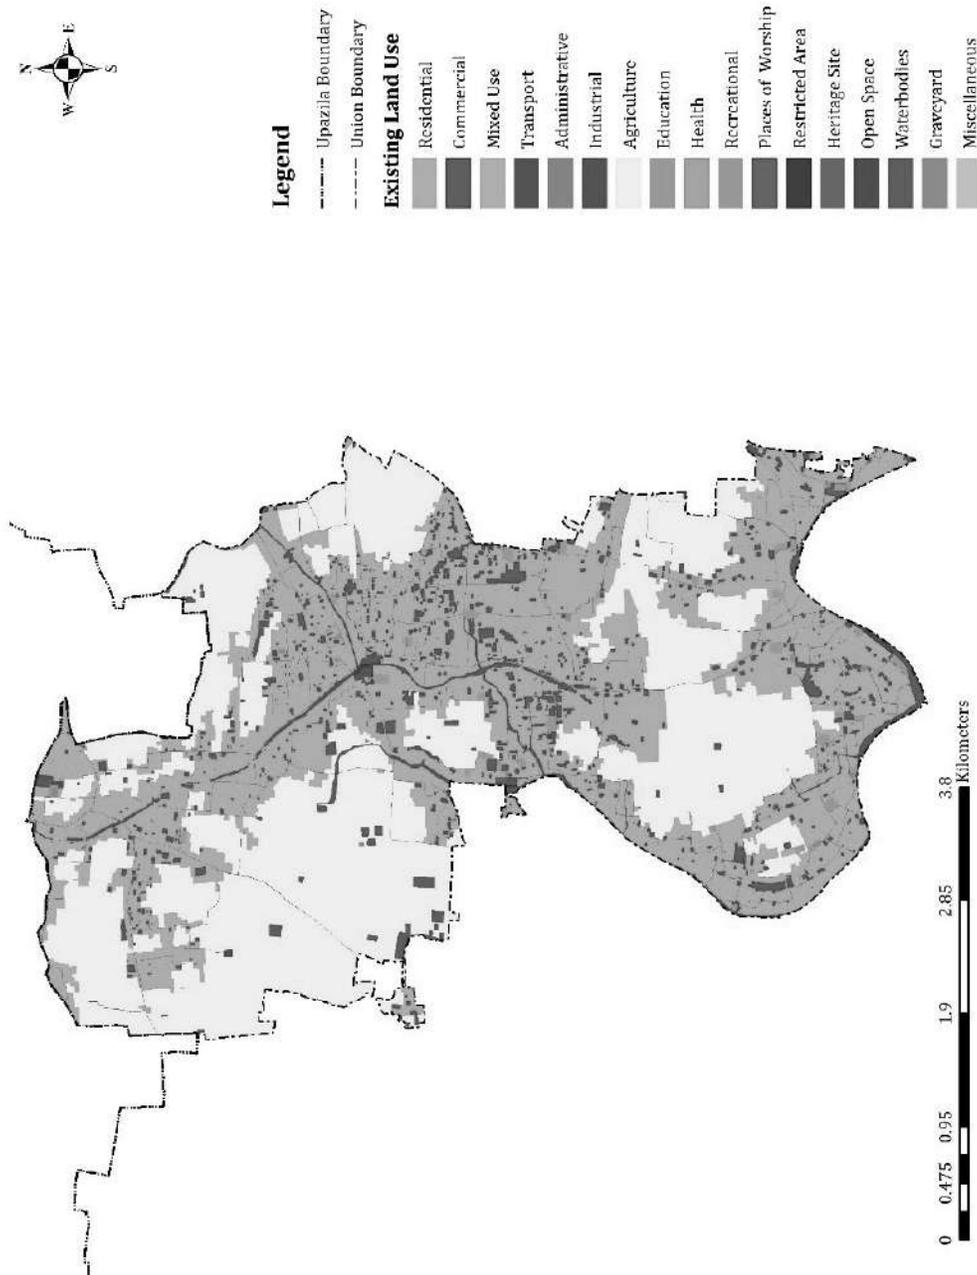
Figure 6-13: Existing Land Use Pattern of Nayansree Union

Nearly 45.55% of Nayansree Union's area is dedicated to agriculture, which forms the bedrock of its economy and livelihoods. Residential areas, primarily rural homesteads, are the second most prominent land use, occupying a significant portion and reflecting the established community presence. Road contributes to 1.18% of the total Nayansree Union Land. Besides, Waterbody contributes about 6.54% of the total land area of Nayansree Union, including Pond, Khal, and Rivers.

Agriculture: Nayansree Union's land use profile reveals a distinct agricultural character, with nearly 45.55% of its total area dedicated to agricultural land use. This underscores the significance of agriculture as the primary economic driver and livelihood source for the community. This area includes single—and double-cropping land and various types of livestock farms.

Residential: Residential areas, primarily rural homesteads, occupy the second largest land share, nearly 44.33%, suggesting a well-established community presence. Residential area is established majorly around the bank of the Ichamoti river and Bokchor road connectivity.

Waterbodies: Waterbodies comprise around 6.54%, encompassing ponds, khals, and rivers, adding valuable ecological diversity to the landscape. Ichamoti River flows by the south and southwest sides of the Nayansree union.

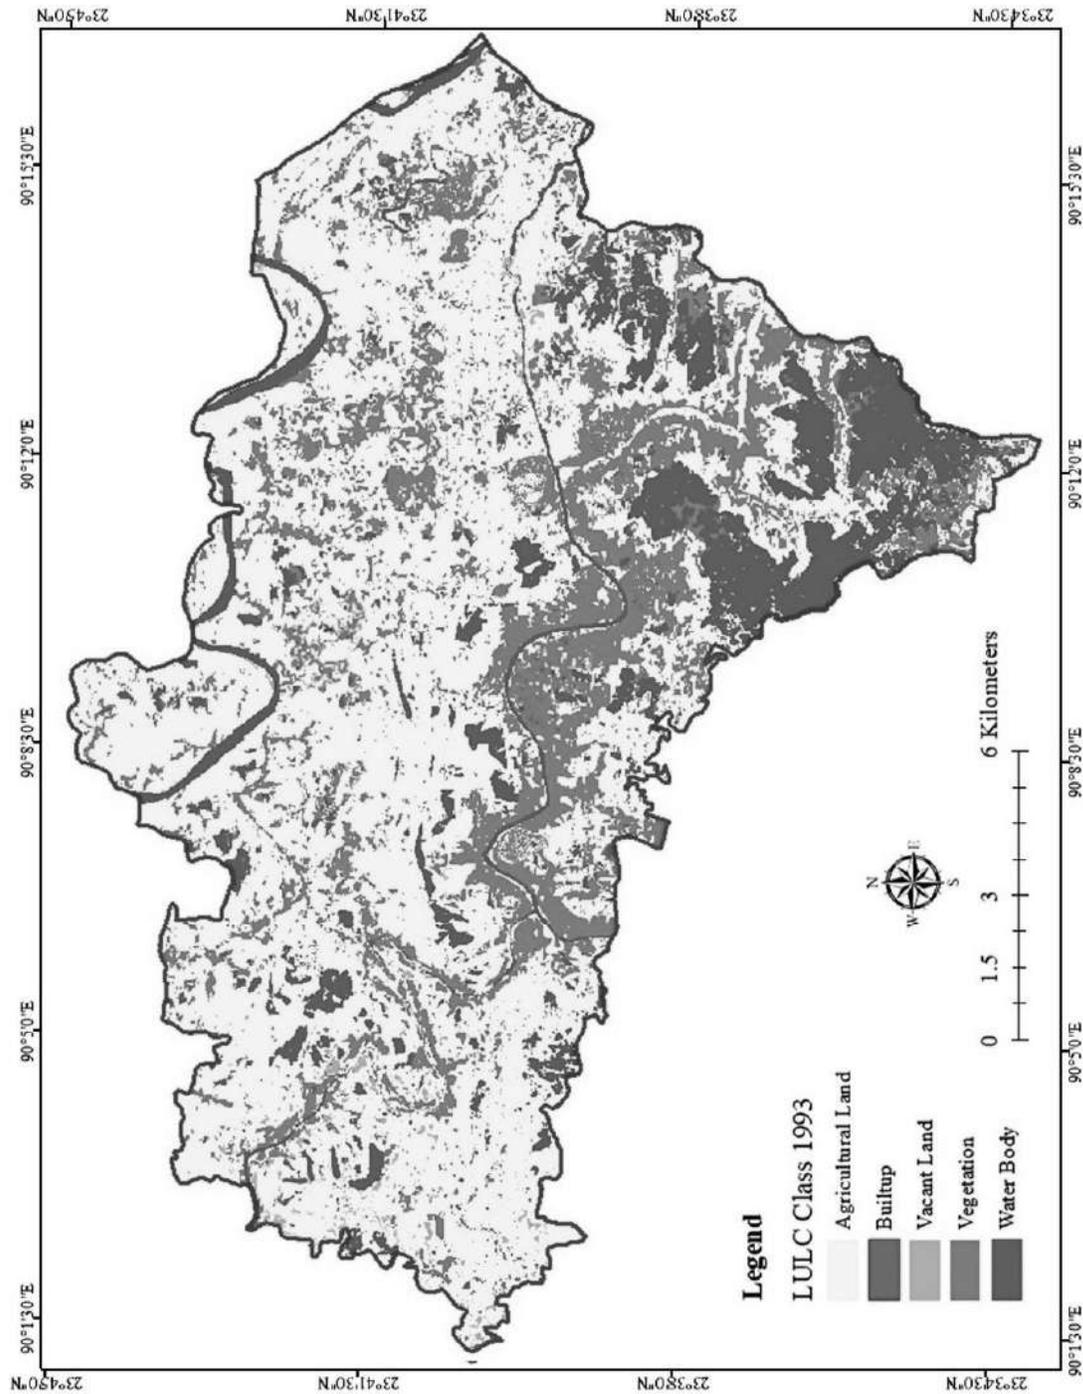
Figure 6-24: Land Cover of 1993

In 1993, the land use distribution in the specified area reflected a diverse array of human and natural activities. With a total area of 246.25 square kilometers, the landscape showcased a variety of land utilization patterns, each contributing uniquely to the region's character and functionality. The dominant land use category in 1993 was agricultural land, comprising 176.46 square kilometers, which accounted for a substantial 71.66% of the total area. This vast expanse of land was dedicated to farming activities, including crop cultivation, livestock rearing, and other agricultural practices vital for sustaining the local economy and food production. Contrasting with the expansive agricultural zones, built-up areas occupied a relatively small portion of the landscape, encompassing 1.38 square kilometers or merely 0.56% of the total area. These developed regions were characterized by urban infrastructure, including buildings, roads, and other human-made structures, indicative of urbanization and settlement expansion. Similarly modest in extent were vacant lands, totaling 1.07 square kilometers, constituting a mere 0.44% of the entire area. These undeveloped spaces, though limited, likely served as potential sites for future development or remained in their natural state, contributing to biodiversity and ecosystem health within the region. Vegetation, encompassing 53.03 square kilometers or 21.53% of the landscape, represented a vital component of the area's ecological fabric. This category included lush forests, verdant grasslands, and other natural habitats, providing essential ecosystem services, such as carbon sequestration, soil retention, and wildlife habitat. Lastly, water bodies

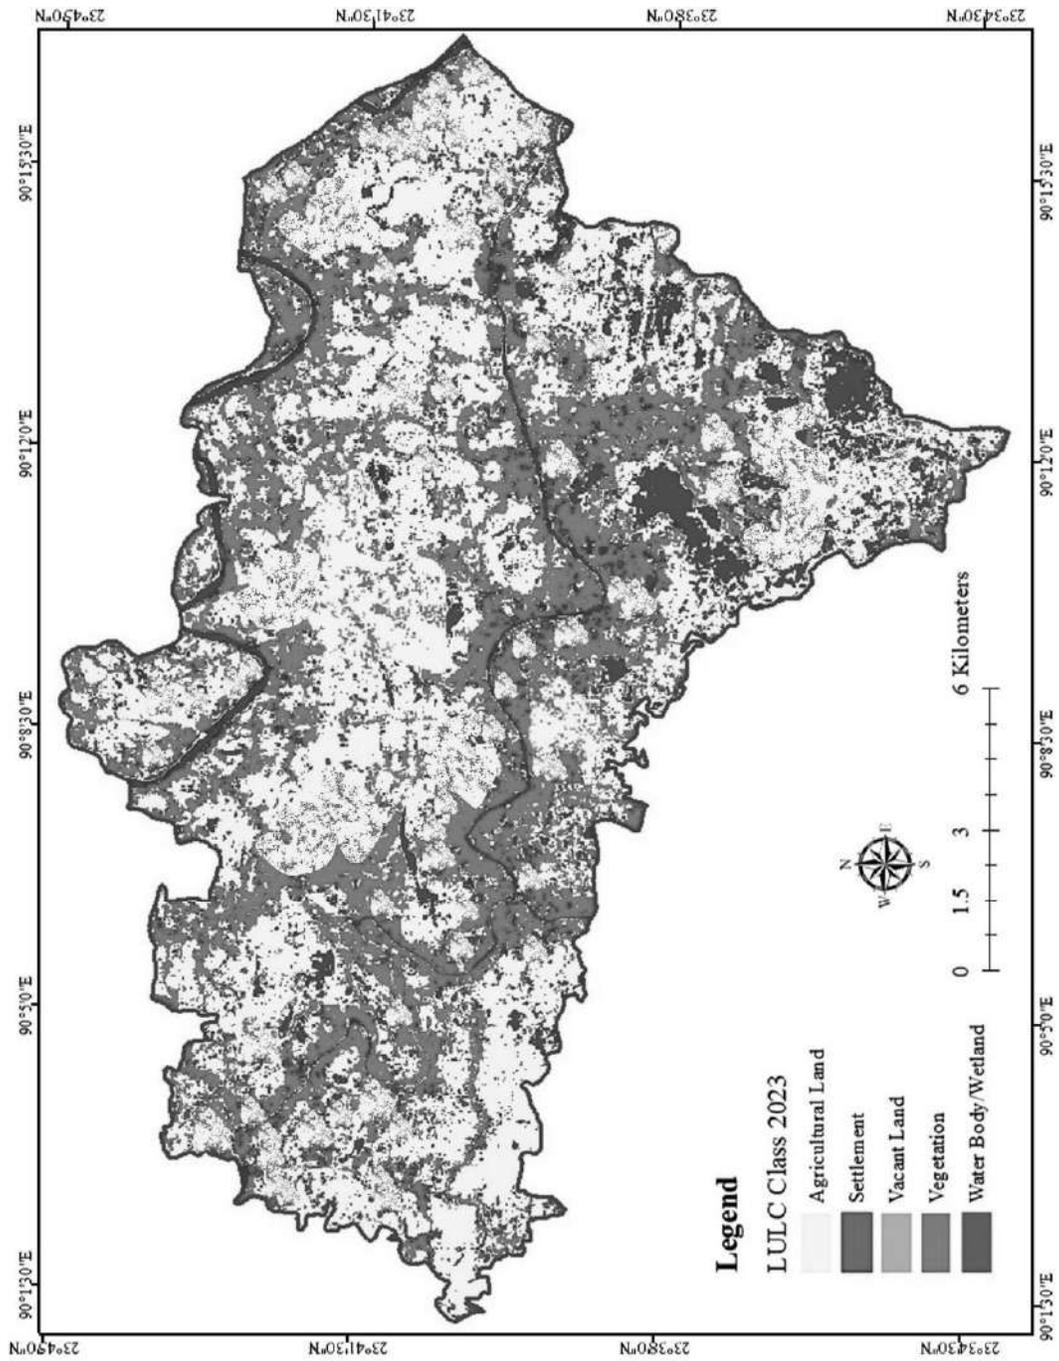
Figure 6-26: Land Cover of 2023

Year	1993		2003		2013		2023	
	Area Sqkm	Percentage						
Agricultural Land	176.46	71.66	175.86	71.42	175.73	71.36	172.73	70.14
Built-up	1.38	0.56	2.74	1.11	3.91	1.59	9.55	3.88
Vacant Land	1.07	0.44	1.71	0.70	1.53	0.62	1.05	0.43
Vegetation	53.03	21.53	52.43	21.29	52.33	21.25	50.61	20.55
Water Body	14.31	5.81	13.51	5.49	12.76	5.18	12.31	5.00
Total	246.25	100.00	246.25	100.00	246.25	100.00	246.25	100.00

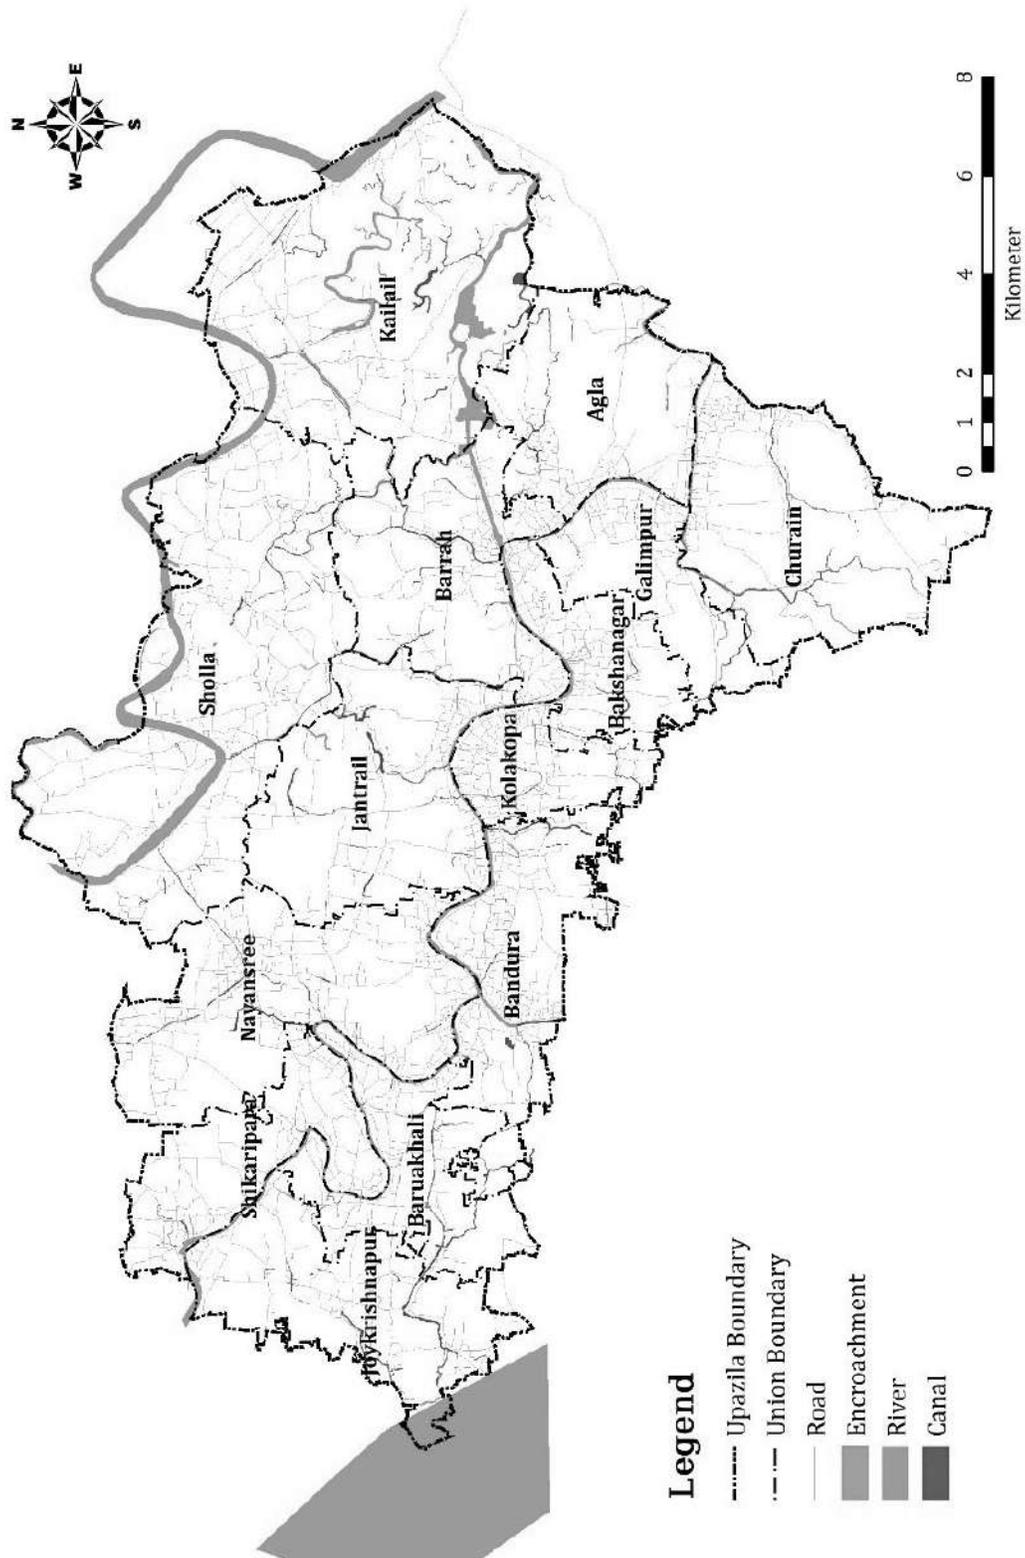
Figure 7-1: Location of Encroachment

The encroachment of water body has been identified from digitized Mouza maps (Past condition) and the orthophoto acquired from drone image (Present condition). This area of the rivers and canals have been lost due to several reasons like siltation, loss of flow, accretion at river and canal banks, illegal occupiers and others. Delineated location of encroachment is shown in Figure 7-1.

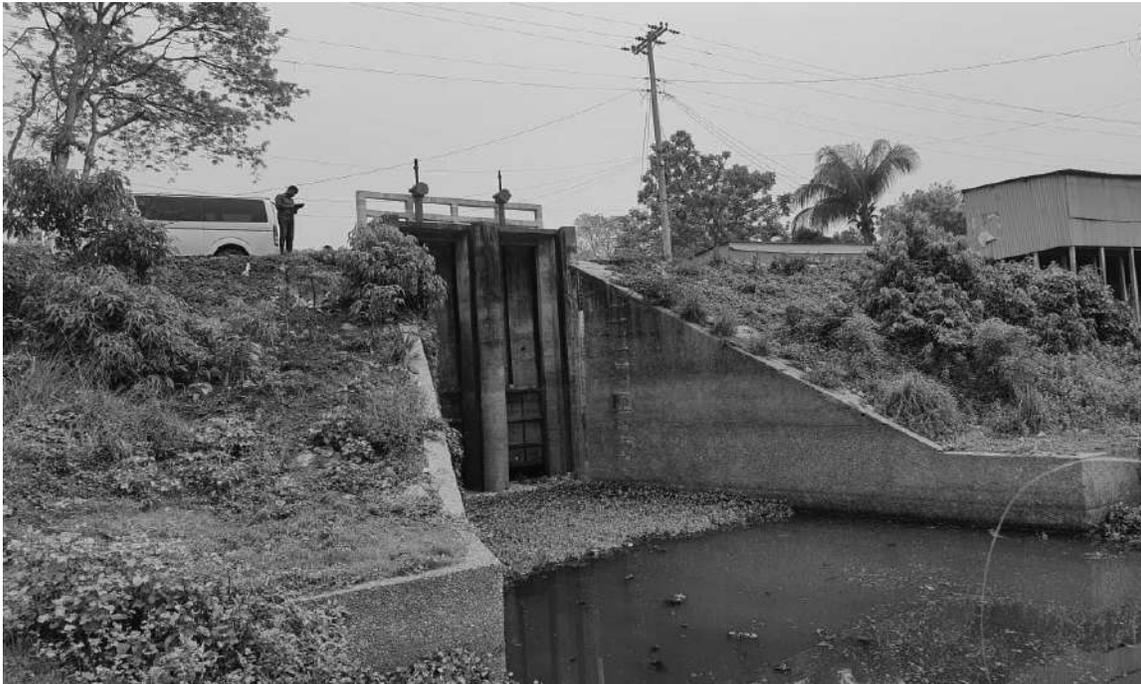
Figure 7-2: Sluice gate at Titpaldiya, Joykrishnapur

Location and condition of water control structures have been identified during physical feature survey. Four sluice gate locations are shown in **Error! Reference source not found.** Sluice gate at Titpaldiya, Joykrishnapur on the Beribadh to Joypara Road (Figure 7-2) was found operational but poor in timely management of flow through the gate. Local people said farmers living within the embankment do not get water timely through the sluice gate. The Beribadh to Joypara Road is the embankment which was built to protect the area from flood caused by the increased water level in the Padma River. This road cum embankment is blocking the flow of many canals and the Ichamati River which is shown in Figure 7-2. Area within the embankment does not get water for agricultural use in dry season. As the Ichamati River is blocked, it is not navigable between the Padma River and the Ichamati River.

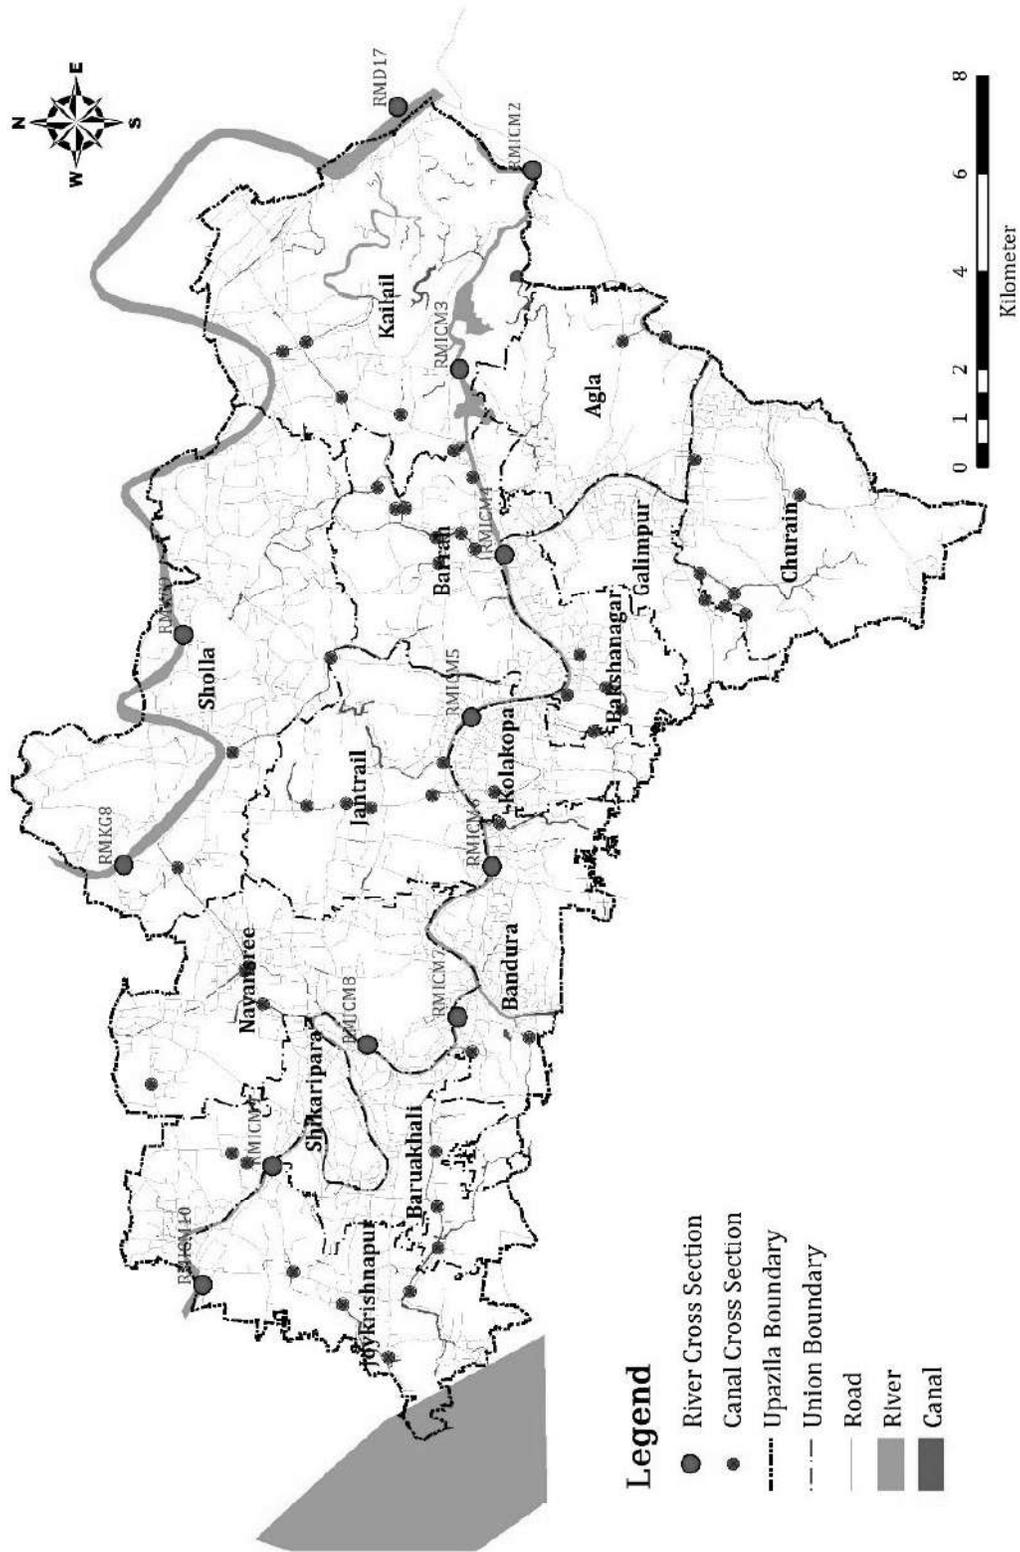
Figure 7-4: Cross section location of rivers and canals

There are almost 50 canals that pass-through Nawabganj through fourteen unions. The survey team collected cross sectional data between 500m intervals. Locations of the river cross sections are shown in Figure 7-4. Detailed information regarding the length of canals, their links with the river, condition, cross sections etc. are included in this report at ANNEXURE 7-2.

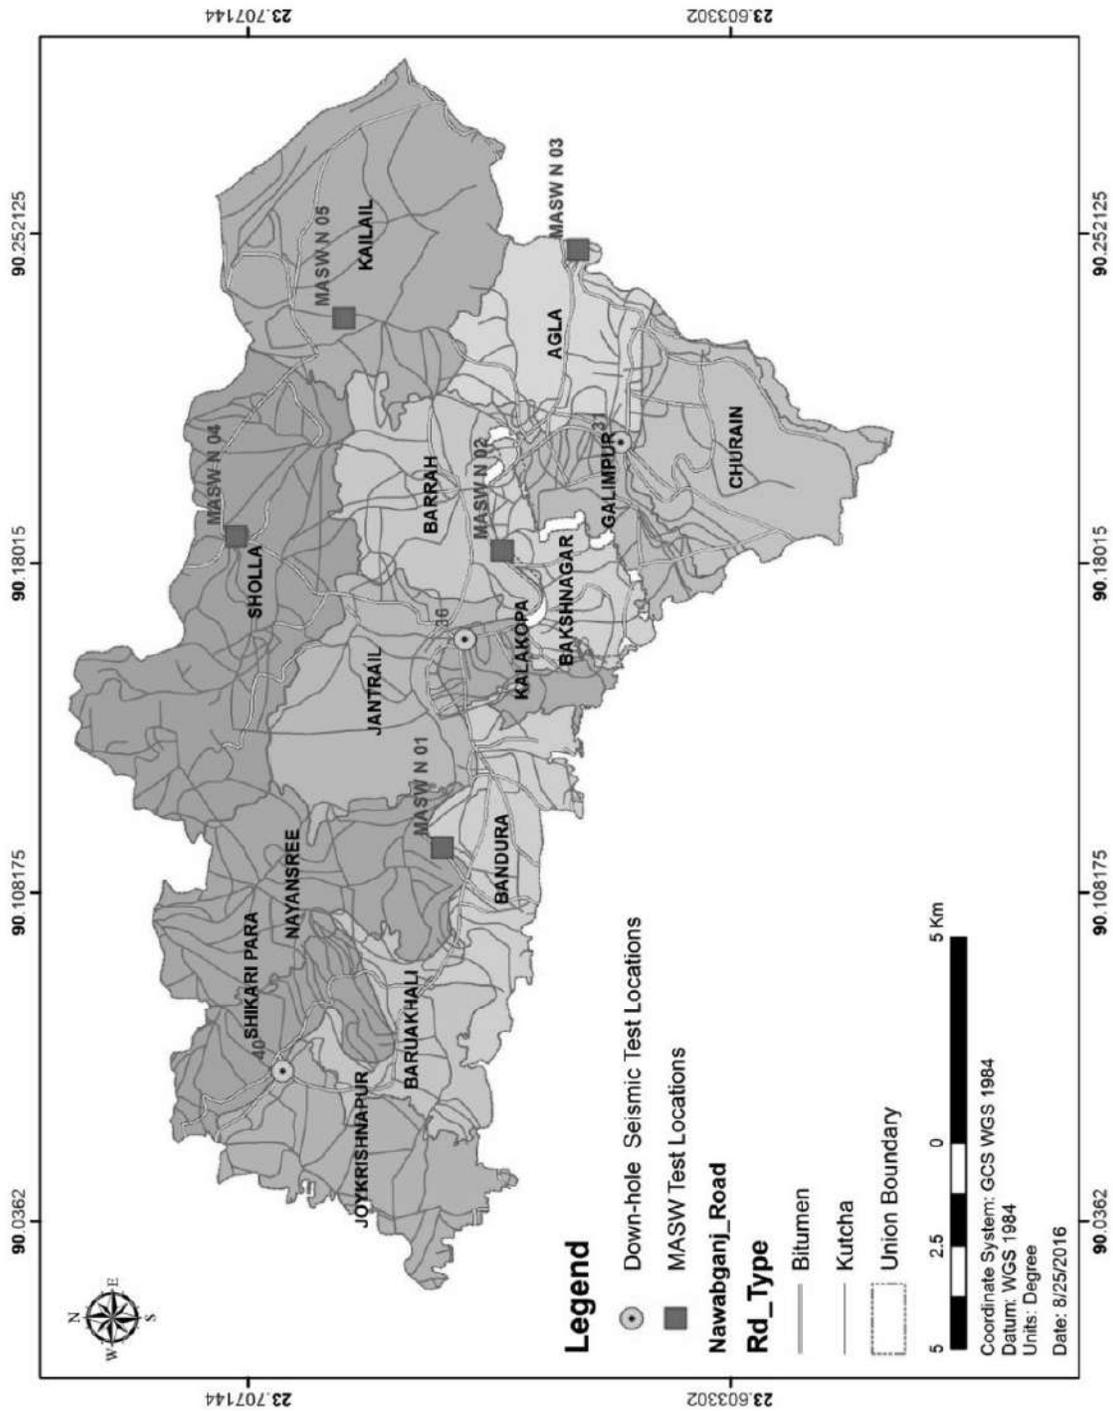
Figure 8-2: Locations Map of the Geophysical tests at Nawabganj Upazila

The main objectives of these investigation to estimate local site effects against earthquakes and the task has been segregated by three-fold: 1) To determine shear wave velocity profile at various sites, 2) To classify soil conditions according to seismic design specifications and 3) To analyze soil amplifications in the area. Field measurements of shear wave velocities were conducted in Nawabganj Upazila and described below.

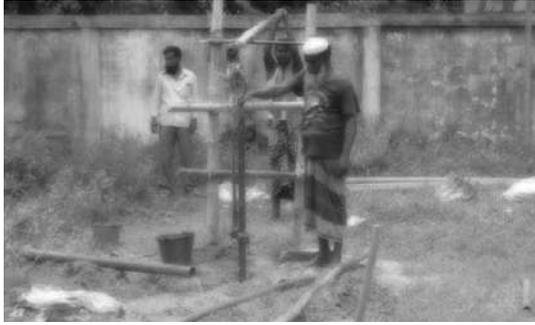
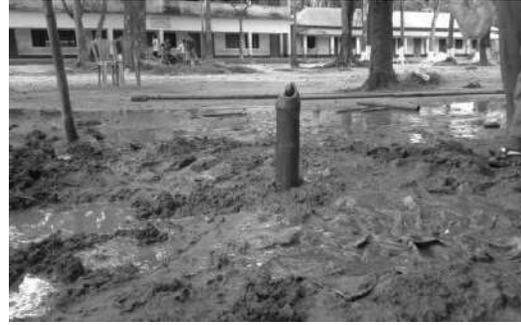
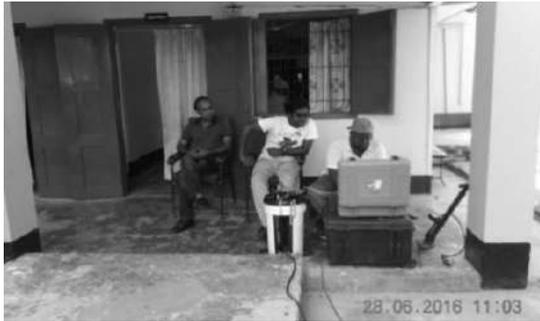
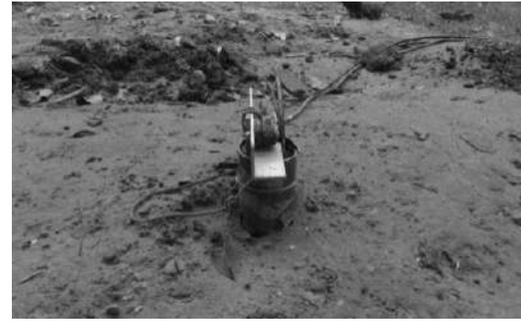
Figure 8-3: PS logging Data Acquisitions at Nawabganj Upazila (Plate 2)

Preparing PVC Casing for PS Logging Test

Test hole

Data Acquisition Unit

Geophone Installation into the Borehole

As a fundamental parameter, shear wave velocity is required to define the dynamic properties of soils. If the soil velocity is less than 180m/s, it can be said as loose or soft soil. Estimation of shear wave velocity (V_s) / average shear wave velocity (AVS) and mapping is a way to characterize varying site conditions, and it can also be used to model earthquake-related ground shaking. Estimation of AVS aims to generate a map of estimated shear wave velocities for the upper 30m of the subsurface. Further this map can be used for seismic site response analysis i.e., to determine peak ground acceleration (PGA) and spectral acceleration (SA) values of both bedrock and ground surface. In this context, Downhole seismic test data acquisition has been completed at Nawabganj Upazila in three different locations on date 28th June 2016.

The average shear wave velocity (AVS) of each PS logging test is tabulated in Table 3. Work plan of the test depth was 30m, however, in some locations did not reach the geophone to the 30 m in depth due to adverse conditions of PVC.

According to down hole seismic test results, the average shear wave velocities up to depth 30 are 146 m/s to 160 m/s. if considering 30-meter depth position, the average shear wave velocity of all borehole locations are showing soft or loose soil condition as foundation soil on the other hand if considering below 20 meters to 30-meter depth position, the average velocity of shear wave is showing moderate soil condition. But actual soil condition (soil type, engineering properties and seismic behavior of soil) will be known when all the field data (SPT and soil laboratory test result, down hole seismic test result and MASW test result) has been integrated in a module to produces different type of maps including micro-zonation map of the project area.

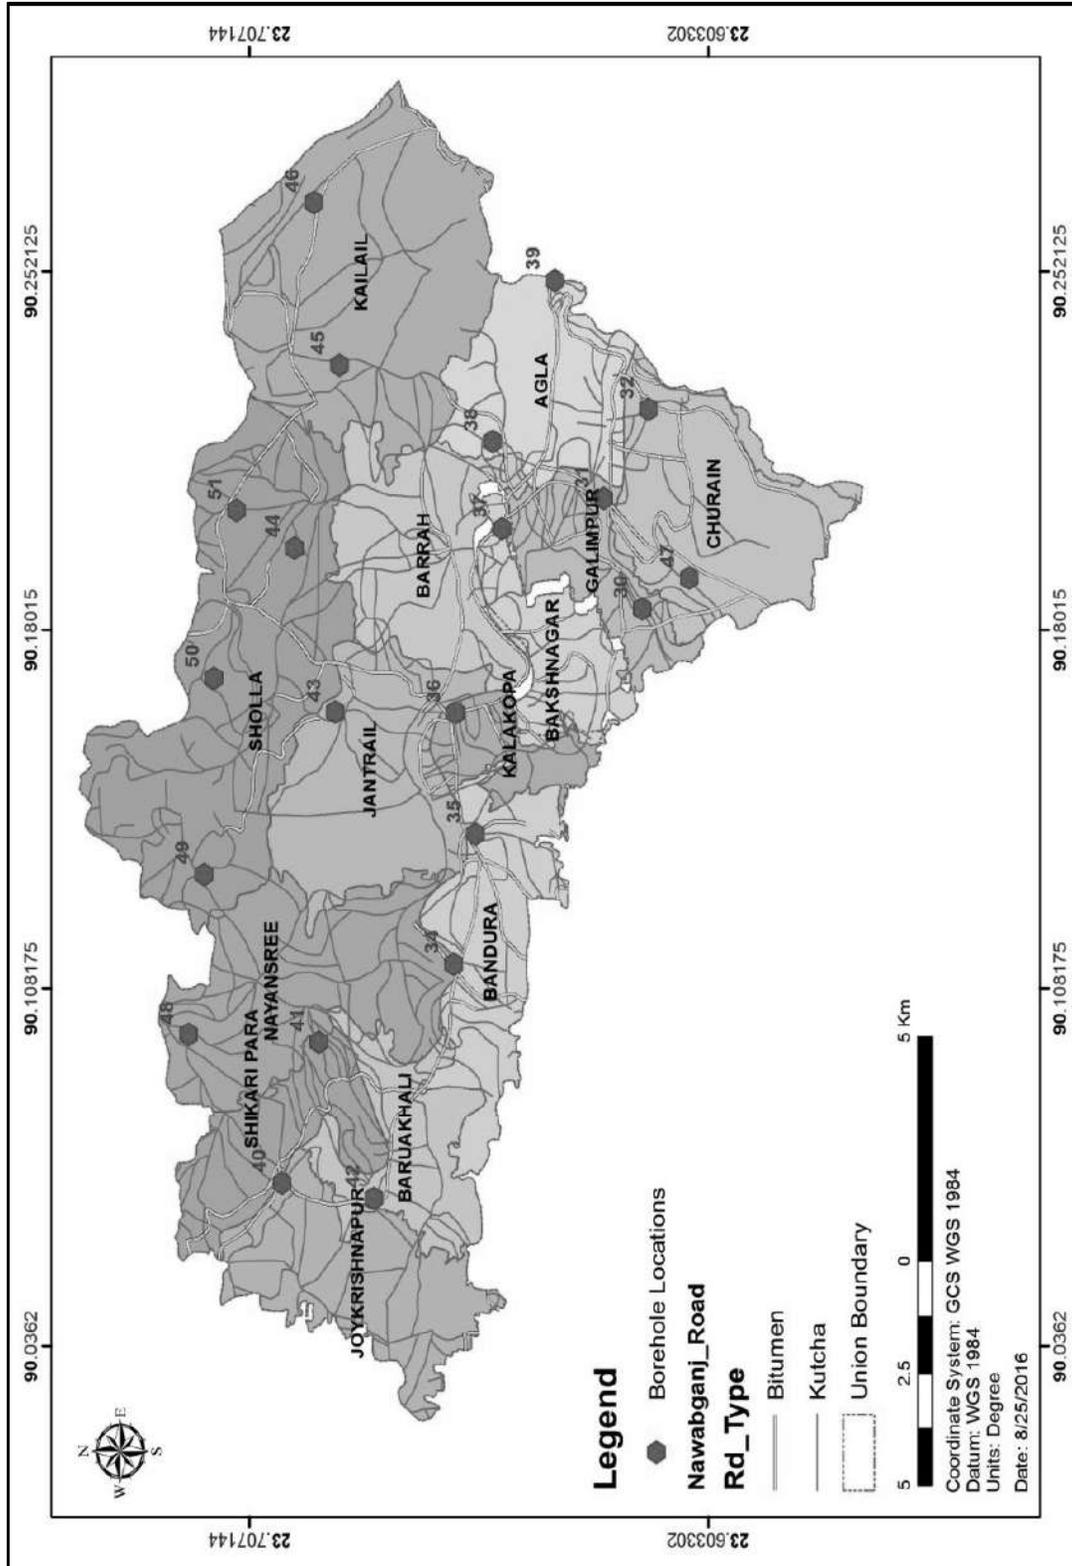
Figure 8-5: Locations Map of the Standard Penetration tests (SPT) at Nawabganj Upazila

To ensure safety of human beings and materials, geotechnical investigations have become an essential component of every construction, it includes a detailed investigation of soil strength, composition, water content, and other important soil characteristics. Investigation borings with standard penetration test were conducted to know vertical geological conditions. The borings with SPT were carried out at 21 points at Nawabganj Upazila.

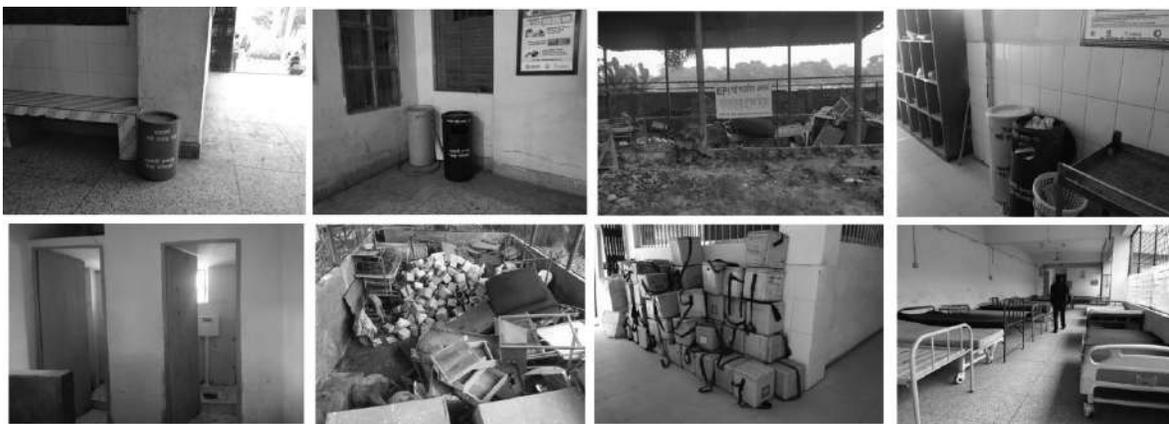
Figure 9-21: Medical Waste Management Scenario of Nawabganj Upazila Health Complex

A study was conducted to assess medical waste segregation in Nawabganj by utilizing a questionnaire survey in different healthcare facilities. The investigation found that, on average, 62% of hospitals, clinics, and diagnostic centers failed to provide information related to medical waste segregation, while the rest were able to provide this information. Among them, an average of 17% of hospitals declared that they do not segregate medical waste according to color code; instead, they store all kinds of waste in a common bin, mixing it with general waste. Only 21% of medical service providers store medical waste according to the color code stipulated by the environmental management framework of the Ministry of Health and Family Welfare. The survey covered the Upazila Health Complex of Nawabganj Upazila. The condition of this public hospital is represented in Figure 9- 20. The Upazila Complex has several color-coded bins to store waste in a classified manner, but the bins are not cleaned or maintained properly. The number of bins present in this hospital is not sufficient to serve the huge number of patients within its complex.

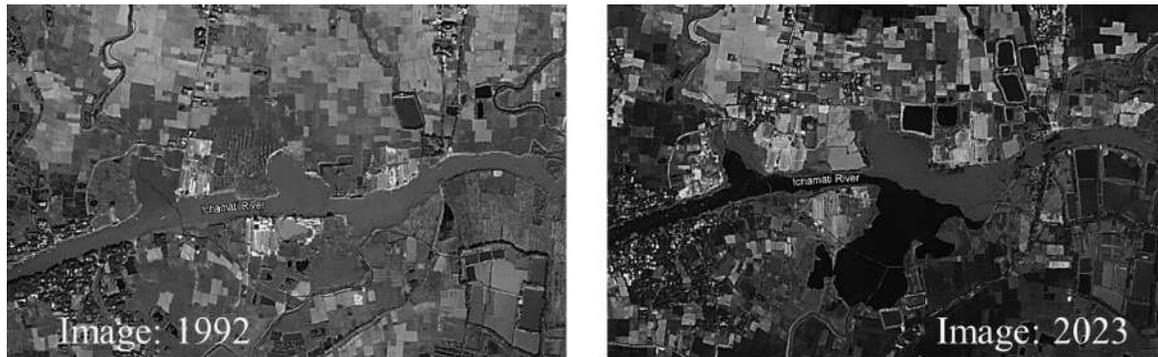
Figure 9-47: Ichamati River Erosion from 1992 to 2023

Nawabganj Upazila, positioned within Dhaka District, is adjacent to the rivers Padma, Kaliganga, and Ichamati, the latter winding through the upazila itself. Due to climate change, there is a noticeable transformation in the morphology of the riverbanks within this upazila. Figure 9- 47 illustrate the river erosion scenarios of the Padma and Ichamati Rivers, respectively, in the study area.

The analysis of river morphological changes was conducted using remote sensing technologies, utilizing change detection tools in ENVI 5.3, which is specialized for analyzing remotely sensed data. To identify the morphological changes in the riverbank, Landsat 5 TM and Landsat 8 OLI imagery were used for the years 1992 and 2023, respectively.
