Project: Contract No.: PD/ALDLP/ADB-EIB/2015: Construction of Dual Gauge Double Line and Conversion of Existing Railway into Dual Gauge between Akhaura-Laksam
Subject: Submission of Semi-annual Environmental Monitoring Report as per "Appendix A-Terms of Reference, Part 4, G(vii)" & "L. Reporting Requirement L.3.1"

**CONSULTING SERVICES CONTRACT FOR CONSTRUCTION SUPERVISION OF
AKHAURA-LAKSAM DOUBLE TRACK PROJECT**

ENVIRONMENTAL MONITORING REPORT

Semi-annual Report: January-June 2017

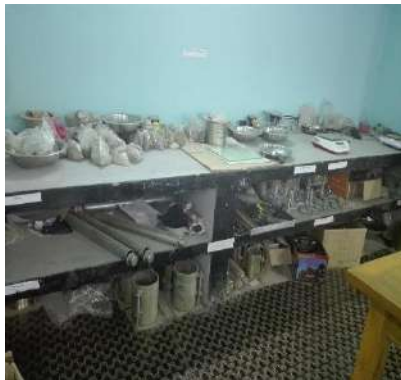
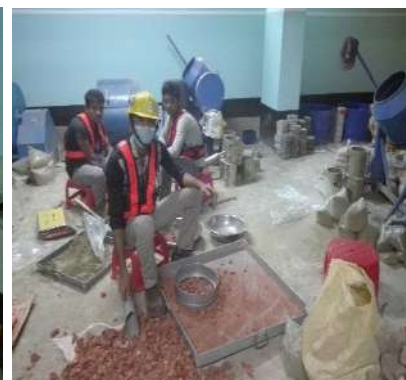
Contractors have set up a laboratory on the ground floor and first floor at Labiba tower, Comilla. The first floor laboratory is well spacious and well equipped. It is still under development. The ground floor laboratory is also well equipped and functioning well.

Though both the laboratories are well equipped, and has been set up nicely, care should be taken in context of environment. Unused lubricants, oil, petroleum products and waste management system is not observed.

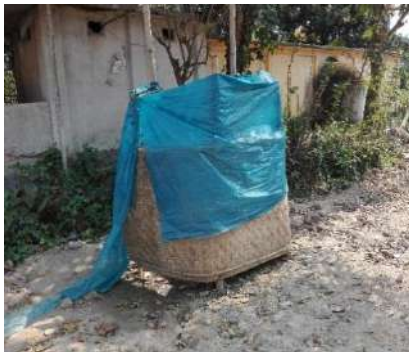
- 1) Dust is being produced from workshop ground preparation and material stake ground.
- 2) The kitchen is situated very near to the labour shed and possibility of fire accident.
- 3) The kitchen has no roof and it is under open sky.
- 4) The cook is suffering from heat stress and sweating much.
- 5) The Toilet condition is not good. The toilet is unhygienic and has no roof. Frequently flies are moving there.
- 6) Drinking water facility is present near station.
- 7) Water is being spread over dust by water spraying car along site.
- 8) Workers are using PPE(Personal Protection Equipment)

The Kitchen roof should be covered with shed. The Toilet should also be roofed. Water spreading should be increased.

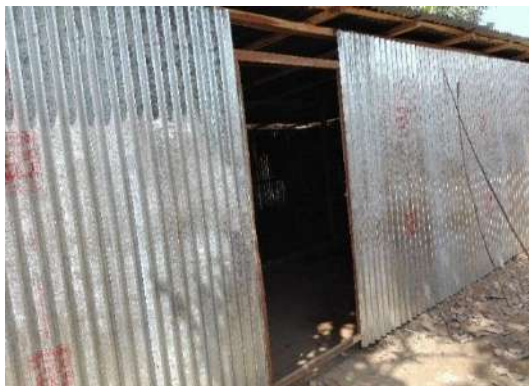
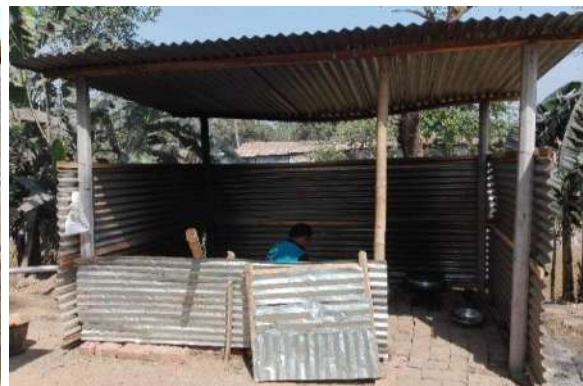
Senior Environment Specialist observed the workers camp site. The sleeping/resting place for the workers is good. There a sanitary latrine for the workers. The condition of the toilet is good. Toilet is situated beside the living place. It has covered roof. There is a good kitchen at the camp site. The kitchen is in open place and has shed. No kitchen waste dump is observed. They use tube well water for drinking purpose.

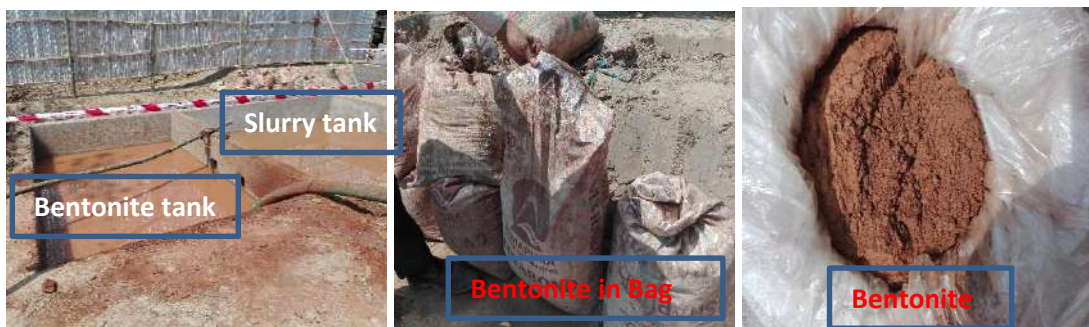
Test piling boring at bridge No. 262 was going on. During boring the contractor was using bentonite as boring fluid. They were pouring bentonite in one tank and slurry in another tank. Both the tanks are situated near the depression of water course.

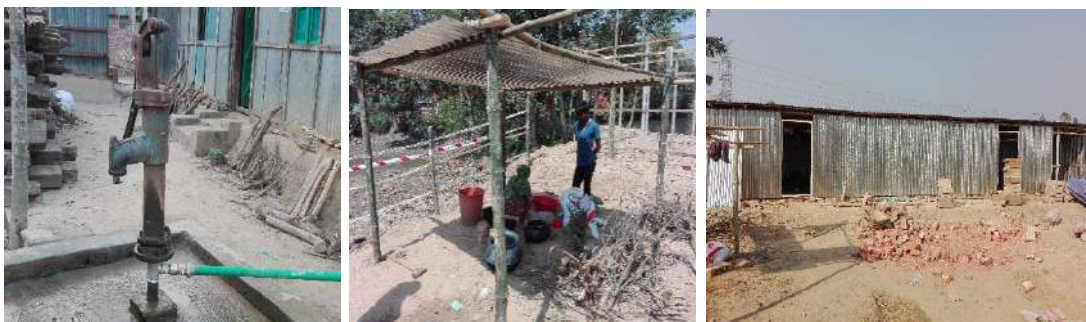
Workers camp site was found at the site. The sleeping /resting camp is built with bamboo and corrugated tin. Toilet is not so good and close to water depression. Bad smell was coming from the toilet. Possibility of health hazard. There is no kitchen rubbish dumping place and the kitchen area is dirty and unhygienic. Food may be contaminated by kitchen waste. One kitchen has roof another has no roof. No fence of kitchen was observed.

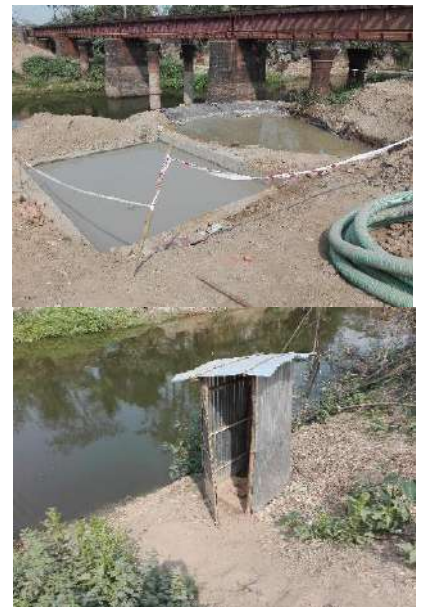
Workers camp site was observed. Though the sleeping/resting place is good, the toilet facility is not good. Toilet is situated inside the river bank. It can contaminate river water. There is no good kitchen at the camp site. The kitchen is in open place and no shed is found. No kitchen rubbish dump is observed.

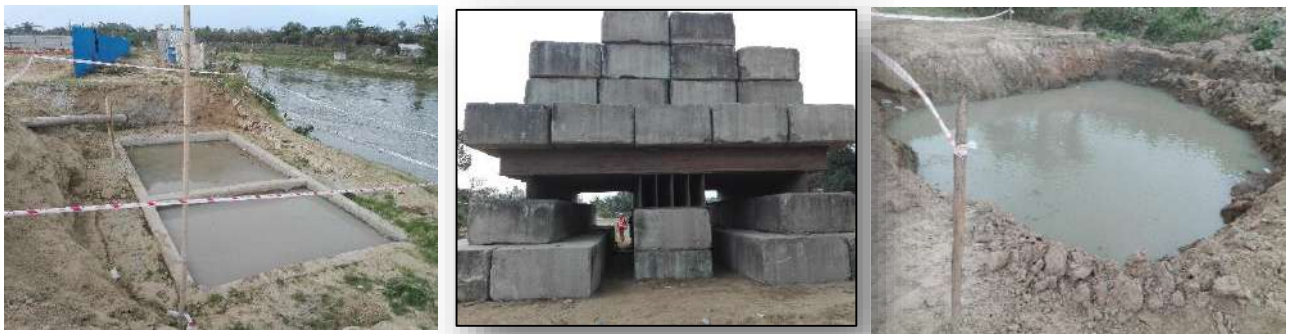
Dumping of Excavated material: Excavated material like bentonite slurry should be removed from the site without any delay. One dumping site is observed and situated near about 100 m away from the water course. Excavated material is still in the mud tank at both sides near the piling sites. Bentonite tank and slurry tank is situated at the very close to the river. There is a chance of mixing these material into river water.

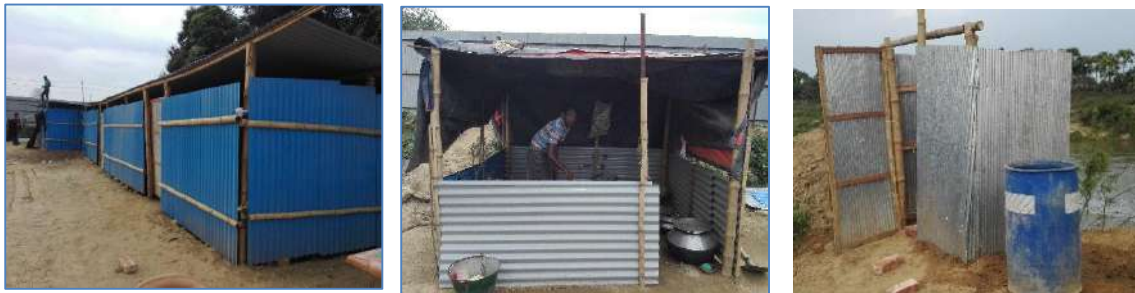
Workers camp site was observed. Workers house is being prepared well. Roofless toilet is built inside the river bank. It can contaminate river water. There is good kitchen at the camp site. The kitchen is not dirty and shed is under roof. No kitchen rubbish is observed near kitchen.

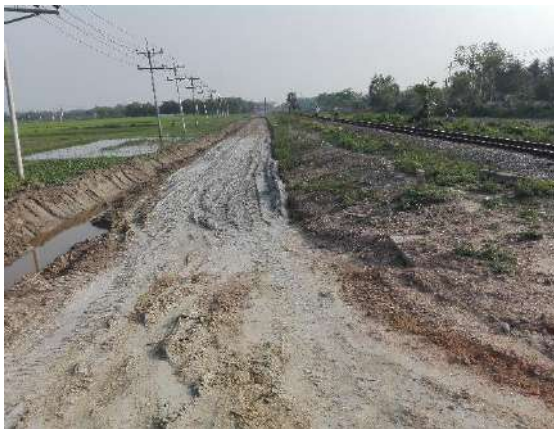
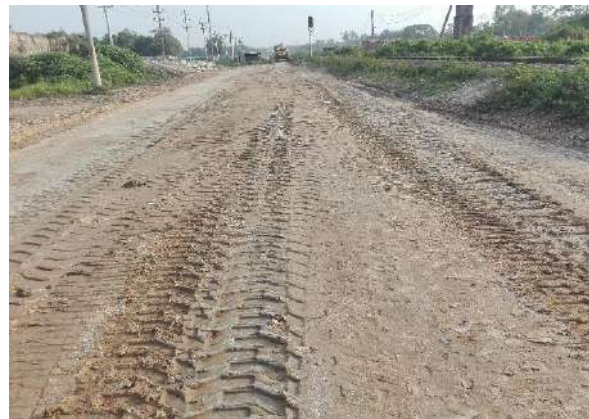
1st layer earth work for embankment (one part) and preparation for 2nd layer for the embankment

- Air Pollution: Dust is less found and so dust pollution is very few. For this reason Air pollution is not observed.
- Pollution from oil and oily products: All oil and oily products shall be stored in a designated storage location where any spillage can be safely maintained without contamination of the surrounded area. But in most cases contractor is not following the specification.
- Water Pollution: No such materials are found that create water pollution. Machineries and equipment maintain and repair at designated area. So water pollution is not found.
- Noise pollution: No machinery was seen to run and so no noise pollution is felt.

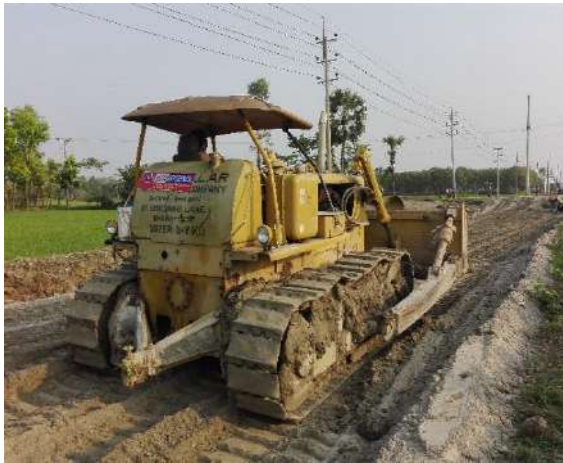
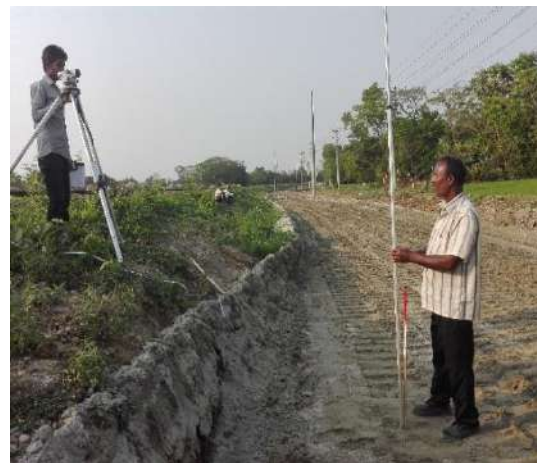
Grading and Field Dry Density Test (FDDT) by sand replacement method.

- Air Pollution: Natural rain has suppressed the dust but as some work is being run, some dust pollution has been observed though contractor's worker is suppressing dust through spraying water. So dust pollution is very minimum. On the other hand no air polluting agent was observed.

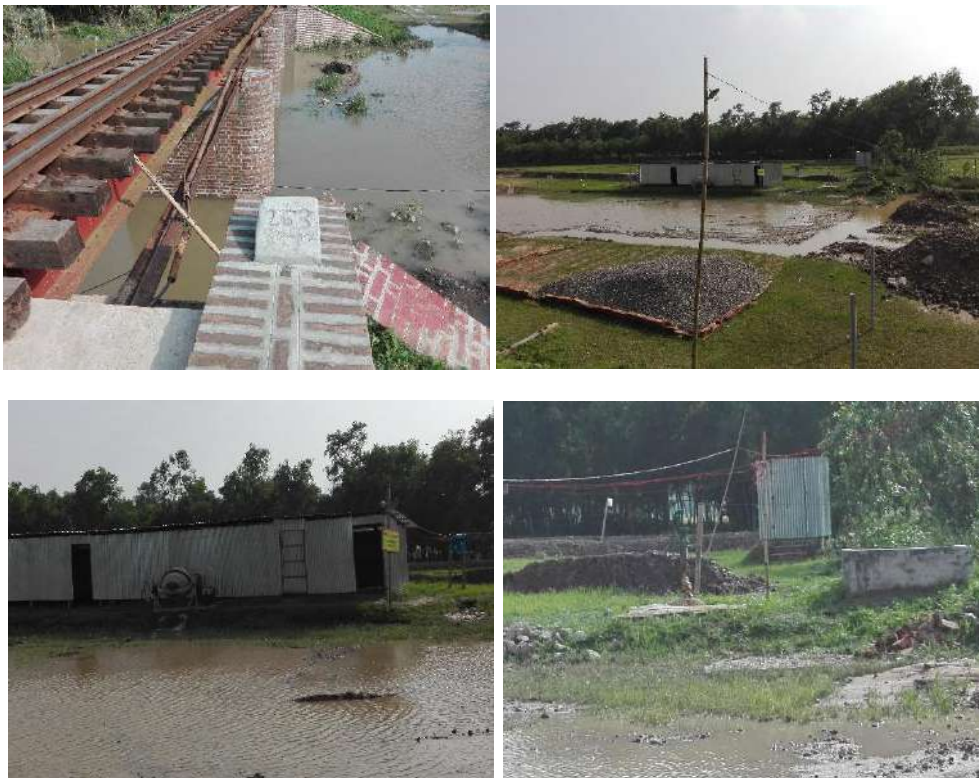
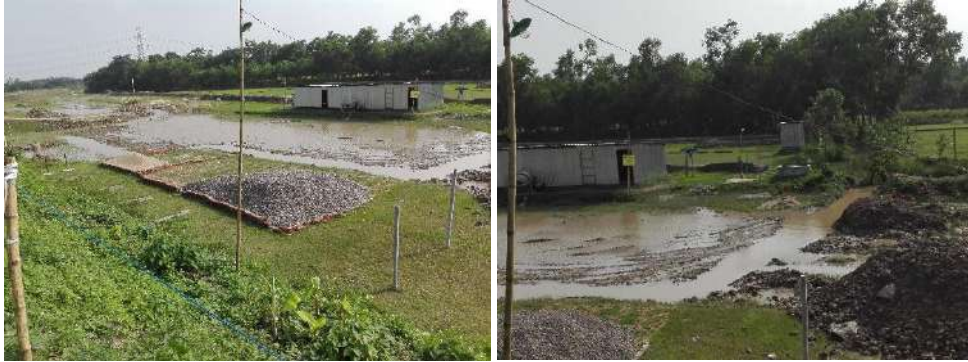
Pile cap, bentonite tank and slurry tank are under water. Water pollution has been happened by excavated material. No air pollution and noise pollution have been observed. No kitchen rubbish dumping area is seen.

The bentonite slurry tank should be clean and the material should be dumped in a designated dumping area.

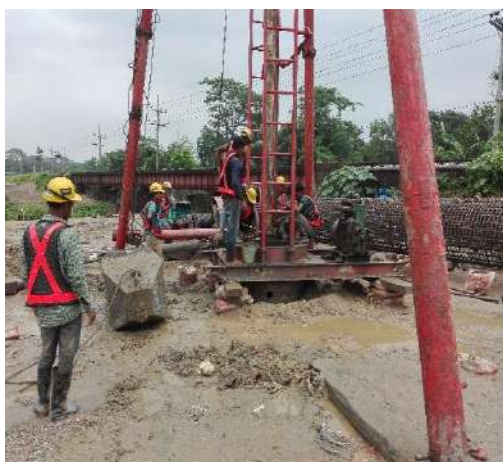
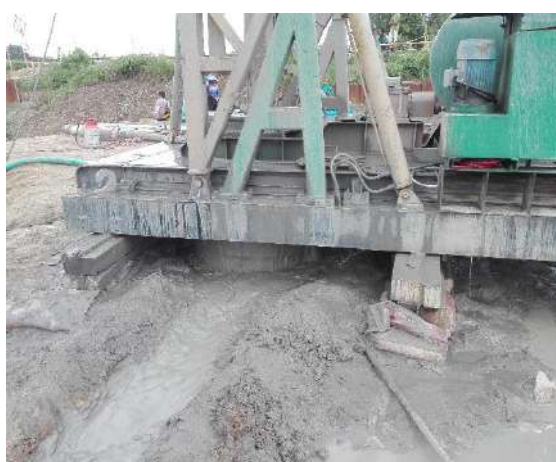
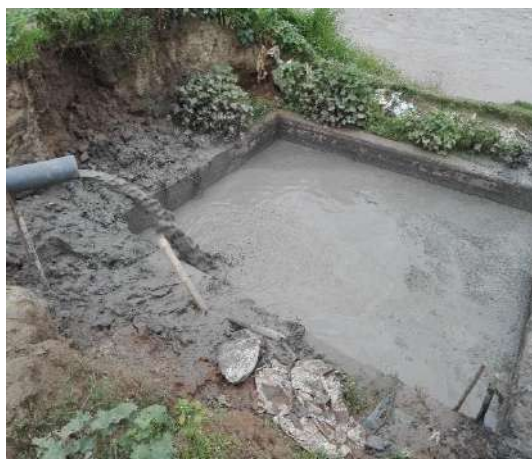
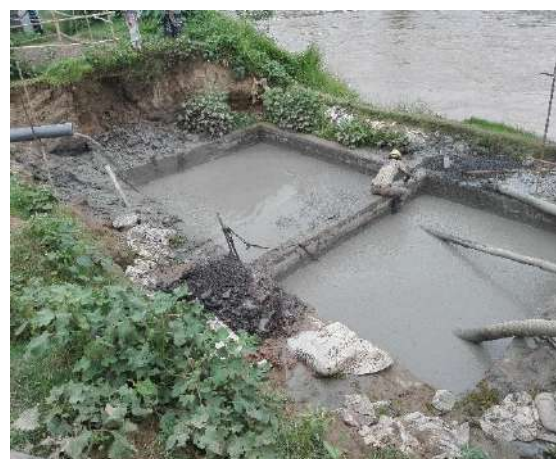
There is no electricity in this area. So, during boring they are using generator for energy and producing noise. The noise exposure time is more than 8 hours which is hazard to health. But as it is very temporary, so no chance to damage any person in hear follicle. The boring machine is mechanized rotary machine made in China.

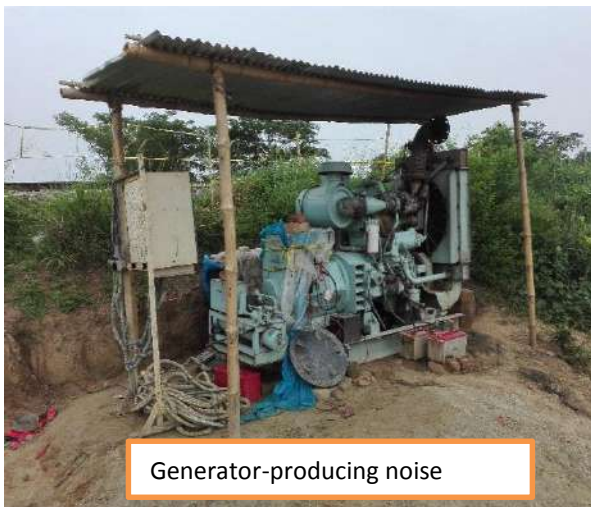
Due to rainy day no dust pollution was observed at the site. There is no electricity in this site. So, during boring they are using generator for energy and creating noise. If the noise exposure time is more than 8 hours it will be hazard to health. But as it is very temporary, so no chance to damage any person in hear follicle. One generator was producing noise and it was annoying but there was little chance to create hearing problem. On the other hand one worker was cutting tiles with a device which was producing high noise may be more than 110 dB. He was not using ear muffle or ear plug to protect the ear from such high noise.

Generator-producing noise

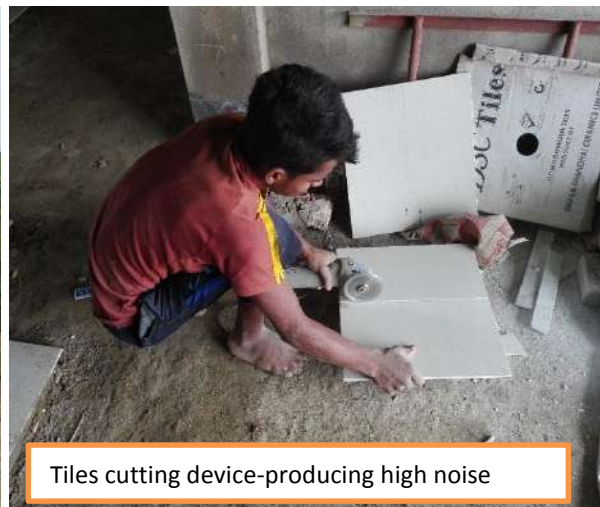
Tiles cutting device-producing high noise

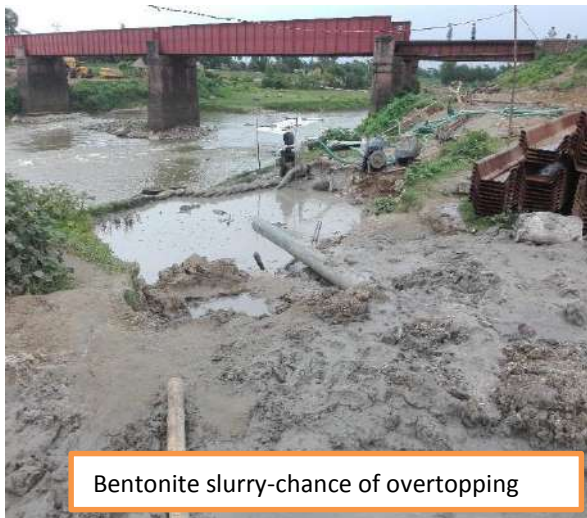
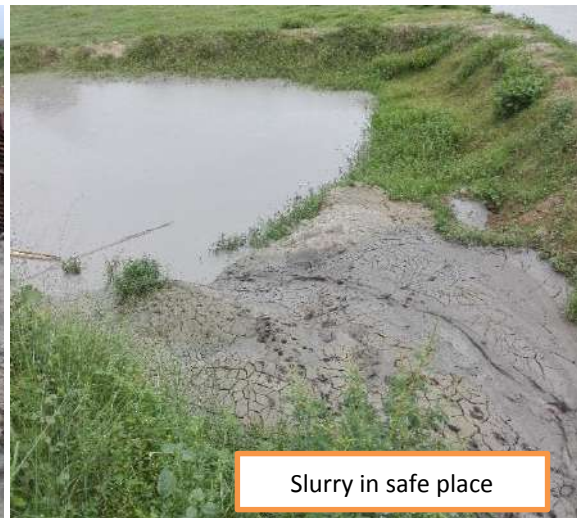
Bentonite slurry tank is observed in a protective manner. At present still no chance to pollute water. But if it rains heavily overtopping of slurry into river water is a chance. Slurry during casting is dumping in a designated place at Gumti site where there is no chance to mix into river water.

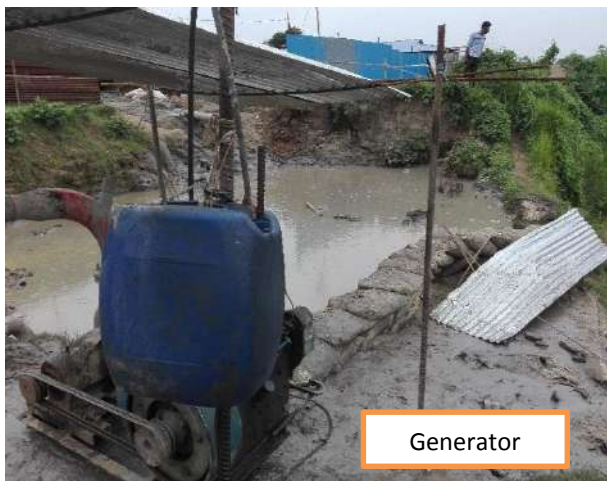
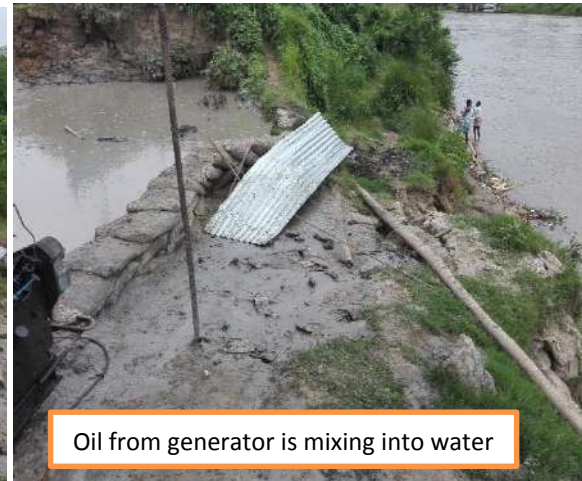
Oil, petroleum or lubricants are not being handled carefully as some of them are mixing into nearby water.

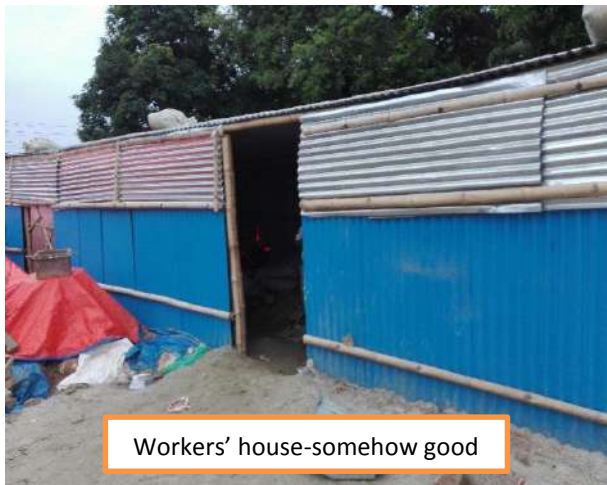
Health hygiene and sanitation condition is as same as was previous. Latrine has not been shifted from the river bank to other places nor destroyed. That is why bad smell was coming from the latrine. It is very unhygienic to health for the workers. Senior Environment Specialist is requesting contractor to destroy the bad latrine and complete the new good one as early as possible. Though workers house and kitchen is somehow good, no kitchen rubbish dumping place was found at the site

Workers' house-somehow good

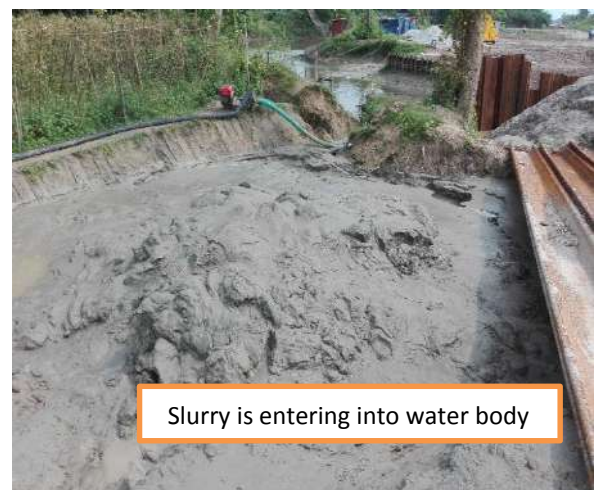
Bentonite slurry tanks

Slurry is entering into water body

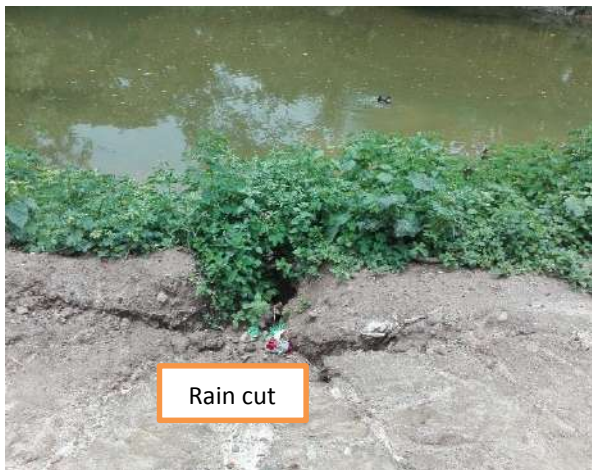
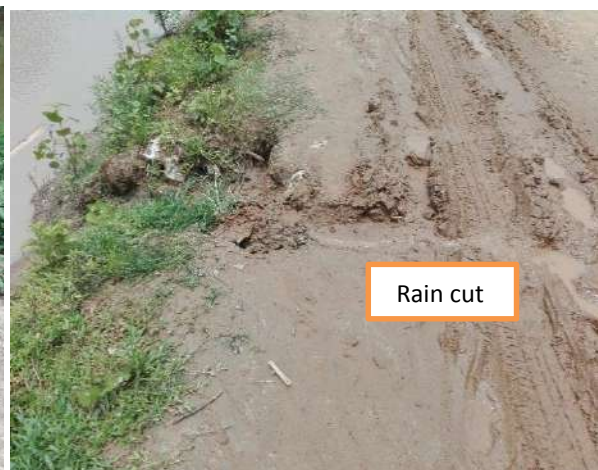
Embankment bed is damaged by the heavy rain fall. Rain cut created due to rain fall and not protected. This created turbidity into the nearby pond and it is harmful for fish in the pond.
