### DOHWA-KRNA-OCG-BARSYL-DDC Joint Venture for Construction Supervision of Akhaura-Laksam Double Track Project

Project: Contract No.: PD/ALDLP/ADB-EIB/2015: Construction of Dual Gauge Double

Draft Revised Semi-Annual (January - June 2022) Environment Monitoring Subject:

Report Second revision

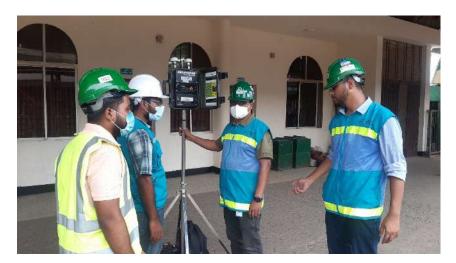
Plate 1. Ambient air quality monitoring at Akhaura Station. Picture taken on 17 April 2022.

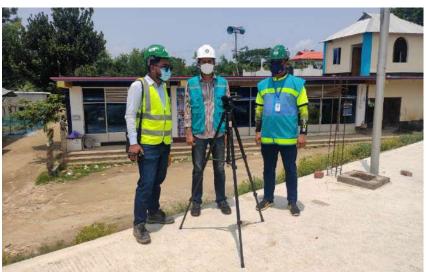
Plate 2. Ambient noise level monitoring at Pitambar, Burichang. Picture taken on 18 May 2022.

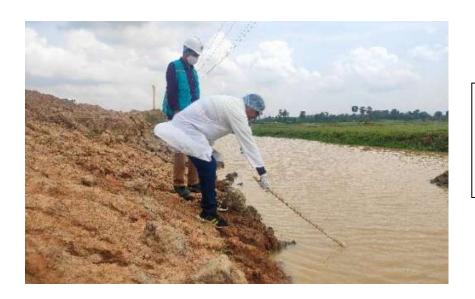
Plate 3. Surface water sample taken from Shaindara River. Picture taken on 18 May 2022.

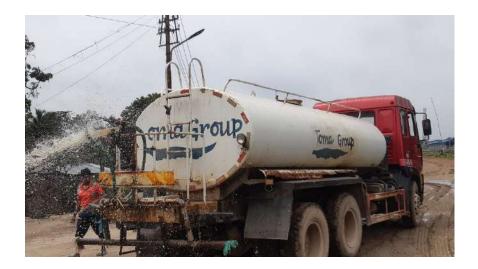
Plate 4. Photograph of watering of unpaved grounds of the Akhaura station yard. Picture taken on 4 June 2022.

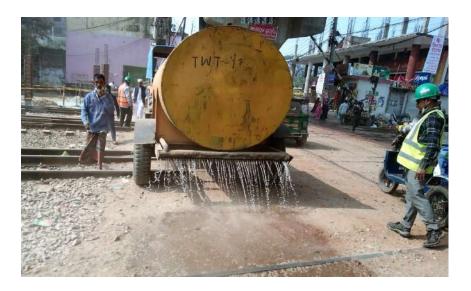
Plate 5. Photograph of watering of unpaved road crossing at Comilla Station yard. Picture taken on 3 February 2022.

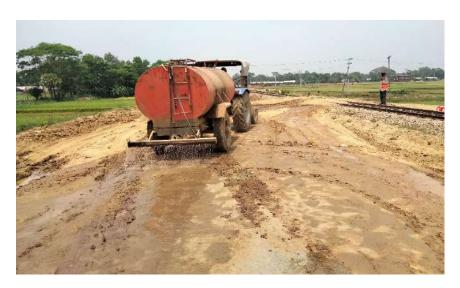
Plate 6. Photograph of watering of unpaved track embankment near the Gumti bridge area.. Picture taken on 27 April 2022.

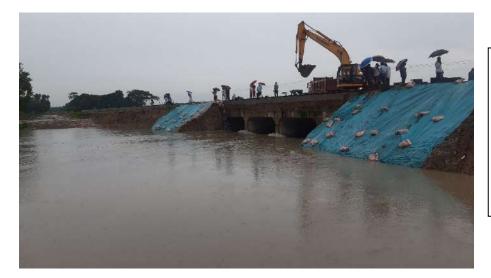
Plate 7. Photograph of clearing waterway. Temporary cover for newly established embankment to avoid soil erosion. Sodding will be done later. Picture taken on 18 June 2022.

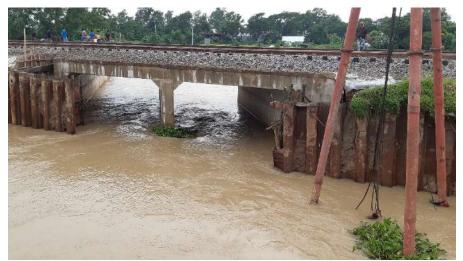
Plate 8. Newly constructed 2 cell box culvert cleared of debris to allow free flow of flood waters. Picture taken on 19 June 2022...

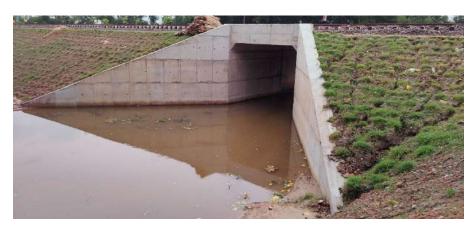
Plate 9. Photograph of newly constructed box culvert with sodded approach to help prevent soil erosion that may block the waterway. Picture taken on 25 June 2022.

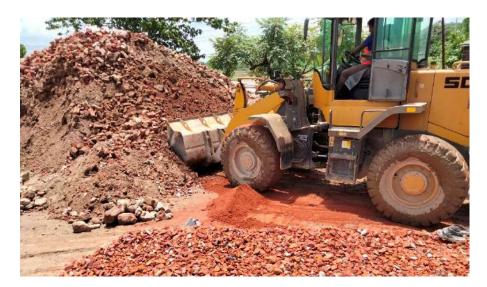
Plate 10. Photograph of front loader operator stacking unsuitable materials at the CTM MAX construction yard. Picture taken on 26 June 2022.

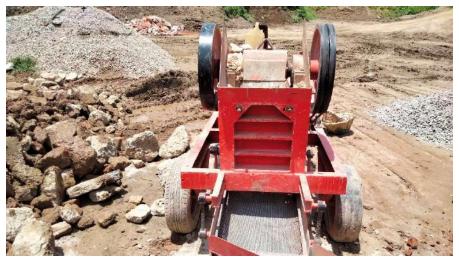
Plate 11. Photograph of a small rock crusher reducing broken concrete and other solid waste into smaller and uniform sized materials for use as concrete aggregates. Picture taken on 29 June 2022.

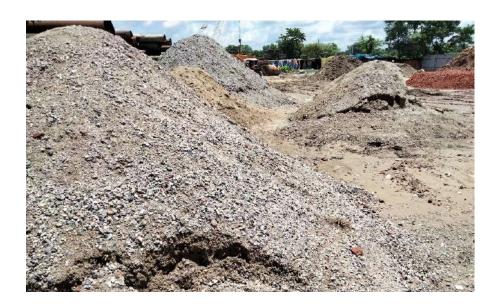
Plate 12. Photograph of crushed broken concrete from construction site, that had been stockpiled for use in repairing nearby damaged rural roads. Picture taken on 26 June 2022.

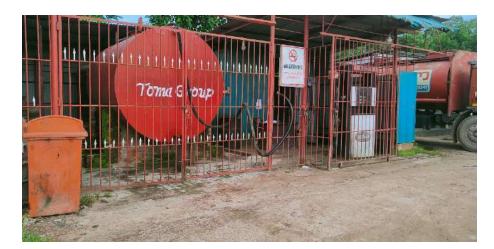
Plate 13. Photograph of the fuel filling station at the Quasba Construction yard. Picture taken on 25 June 2022.

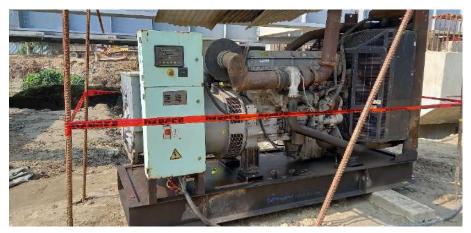
Plate 14. Photograph of the Quasba Office electric power generator with fuel tank and tin roofing. Picture taken on 9 February 2022.

- However, the Quasba used oil is stored in sealed steel drums exposed or a concrete waterproof sump with concrete walls, a single door and galvanized iron roofing. The steel drums are placed on concrete slab floor adjacent to the concrete oil sump. There were instances observed that spillages occur in the uncovered steel drum storage area maybe due to mishandling of the drums. The contractor claims they promptly clean-up the spillage, however traces of oil can still be seen on the concrete floor. Extra effort is needed to clean-up the waste oil from the floor, as well as install at least a galvanized sheet roofing for the used oil drums that are awaiting disposal. There are also other open drums filled with water beside the oil drums possibly used for fire fighting. These should be covered to prevent mosquitoes from breeding in them. Proper informative/warning markings also need to be painted on the oil storage drums and oil sump to inform the public of fire hazards, and fire fighting drums should also be well marked and painted in red or similar colors to distinguish them from the rest of the waste oil drums.

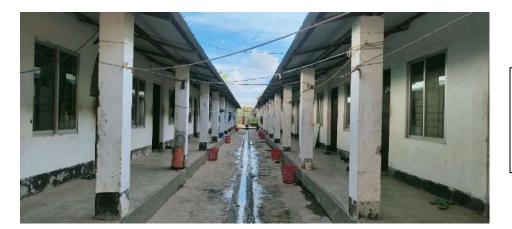
Plate 19. Maintenance of cleanliness at the worker's camps. Picture taken on 26 June 2022.

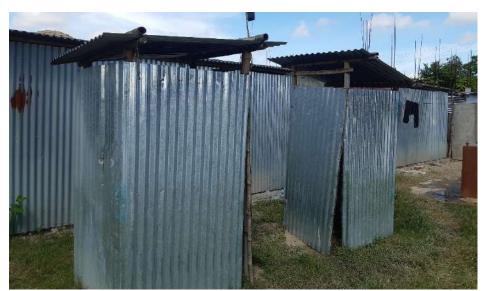
Plate 20. Hygienic Toilets installed at the Akhaura Food Godown construction site. Picture taken on 25 June 2022.

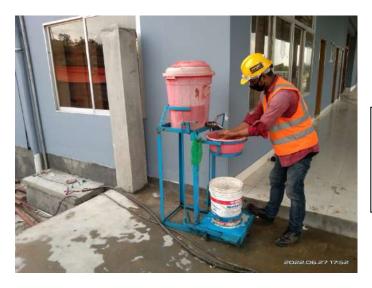
Plate 21. Hand washing station installed at the construction site.
Picture taken on 27
June 2022.

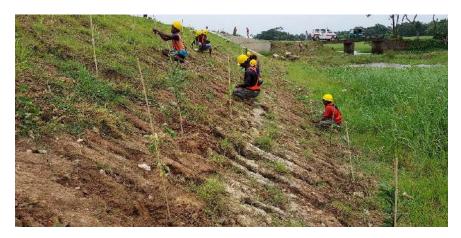
Plate 22. Out planting of new trees saplings at chainage km169+900. Photograph taken on 16 June 2022.

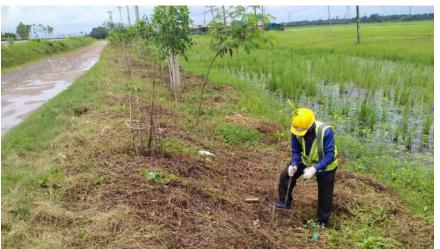
Plate 23. Ring weeding and installation of bamboo sticks to support the newly planted tree sapling in chainage km148+800. Photograph taken on 26 June 2022.

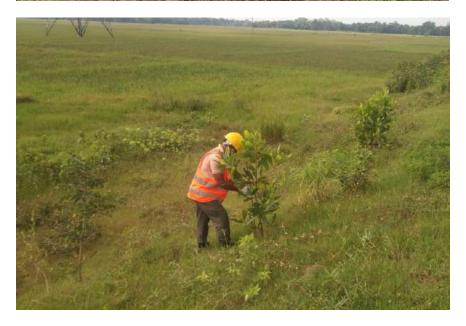
Plate 24. 2021 Tree plantation at chainage km157+100 that are undergoing maintenance work. Photograph taken on 26 June 2022

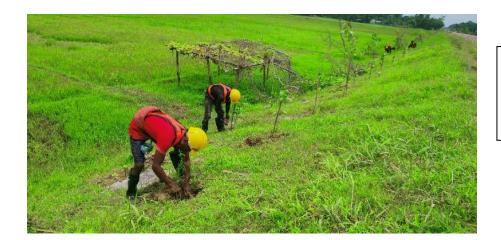
Plate 25. New plantation establishment at km183+700.Photog raph taken on 25 June 2022.

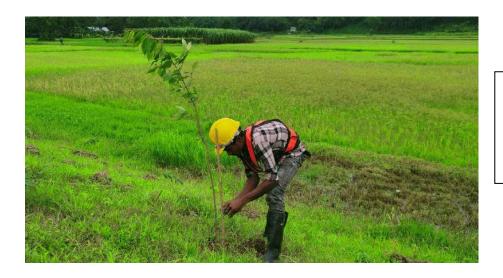
Plate 26. Worker installing a bamboo stick as support to the newly planted tree sapling. Photograph taken on 25 June 2022.

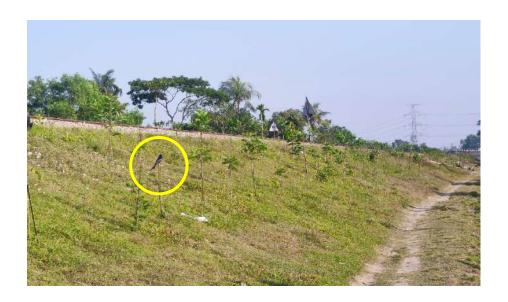
Plate 27. Surviving trees from the 2021 planting season near bridge #263. A black bird is already perching on one tree (yellow circle). Photograph taken on 26 June 2022.
