DOHWA-KRNA-OCG-BARSYL-DDC Joint Venture for
Construction Supervision of Akhaura-Laksam Double Track Project

Project: Contract No.: BR/PD/ALDLP/ADB-EIB/2015: Construction of Dual Gauge Double Line and Conversion of Existing Railway into Dual Gauge between Akhaura-Laksam

Subject: Submission of Revised Semi-annual EMR Jul-Dec. 2019

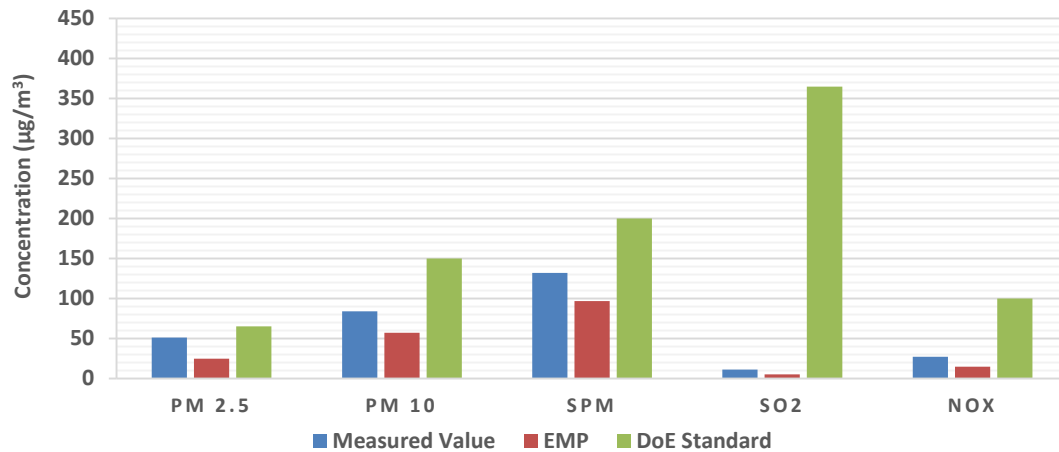
Figure 21. Ambient Air Quality at Cumilla Railway Station in October 2019

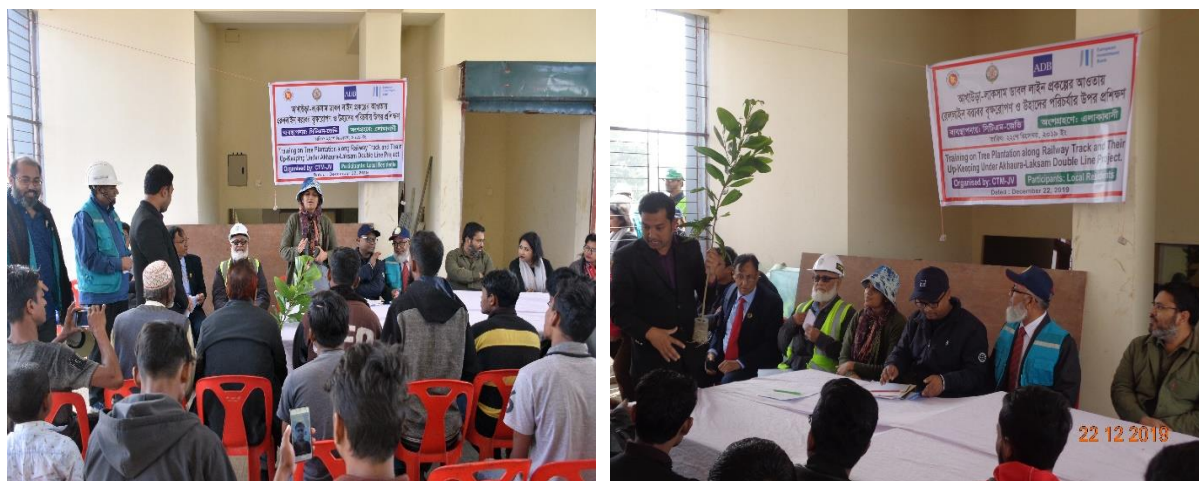
A training program on tree plantation had been performed on 22 December 2019 at Lalmai Railway Station. Local people participated in this program. The training program was organized by CTM JV. ADB BRM and Bangladesh Railway Officials along with ALDLP Project Director visited during training session. CSC's Acting Team Leader was also present during visit. CSC Environmental Specialists assisted the training program. More training program will be performed next time involving female persons. Below is the training photograph.

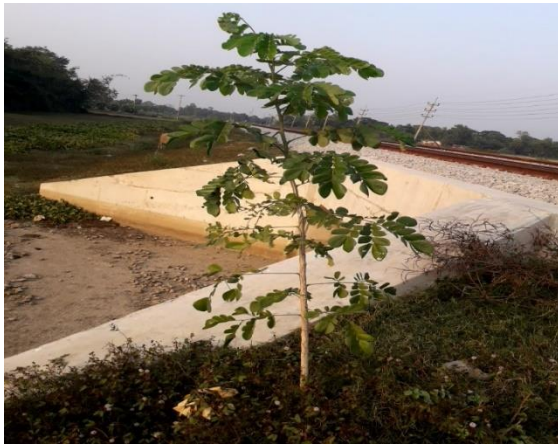
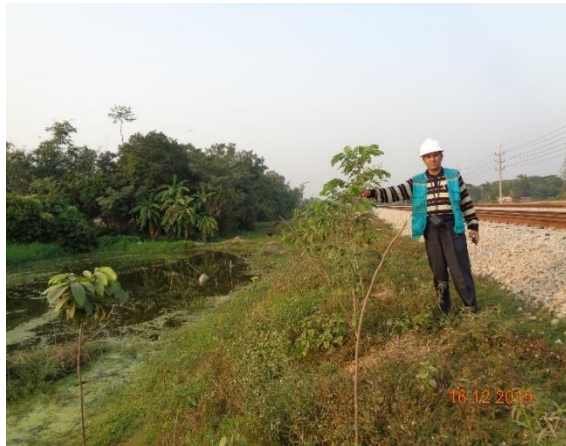
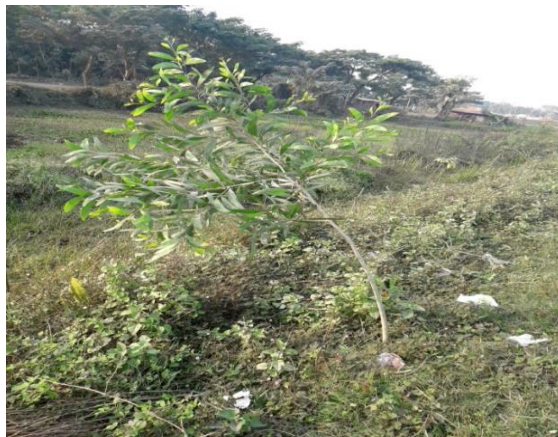
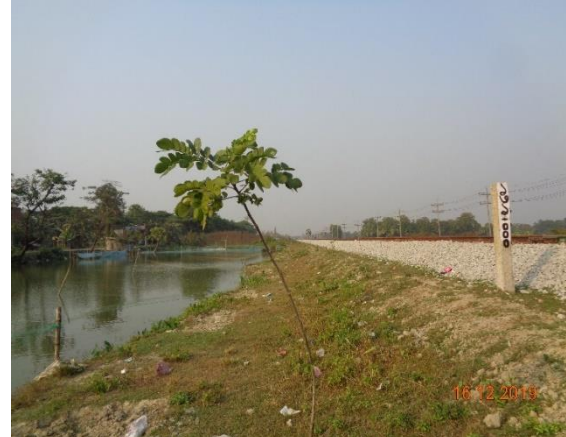
Reasons of tree die-

- i. Improper plantation practices i.e. untrained and/or unskilled workmanship
- ii. Lack of care i.e. no watering, no protection for cattle grazing, insufficient manpower
- iii. Involvement of local communities was absent in the program
- iv. Lack of protection i.e. surround fencing, supports to grow vertically
- v. Eaten by cattle and goats
- vi. Stakes from plant are stolen by poor people for fuel

Recommendations –

- i. Deploy skilled manpower for the plantation job
- ii. Procure suitable, healthy, strong and steady saplings
- iii. Maintain the tree spacing (2m) and ratio of Timber : Fruit : Medicine : Fuel (5:3:1:1)
- iv. Comply with proper plantation guidelines for saplings of different species
- v. Prepare each point of the plantation area well
- vi. Ensure proper care after plantation
- vii. Water and manure timely
- viii. Ensure protection by fencing
- ix. Plant long tree at the bottom row of embankment and bush tree at upper row.

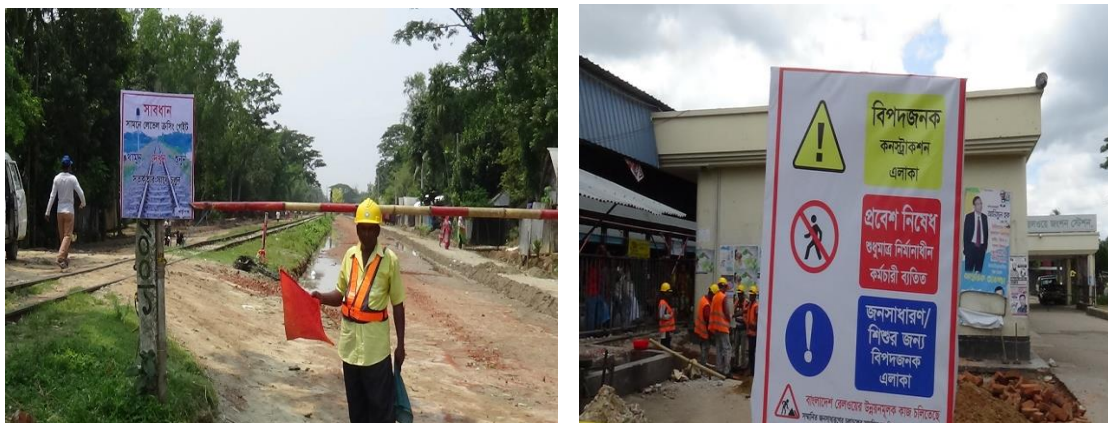
- **Safety Sign at Temporary Level Crossing**

As instructed earlier, Safety signboard with slogan and pictures should be made bigger to create visual impacts. And Signboards should be posted in appropriate places of the level crossings. But most of the board are without pictures. Language of the board also should be in Bangla for clear understanding of the local people.

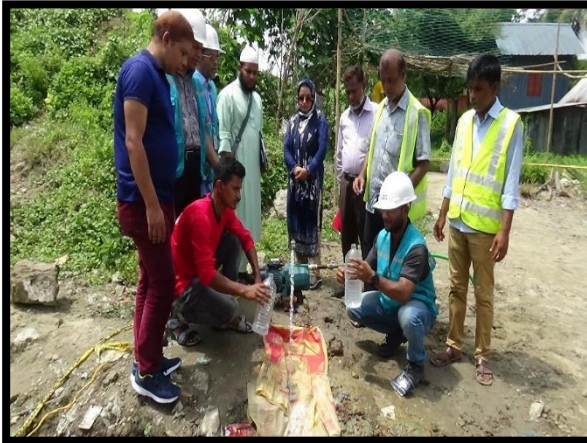
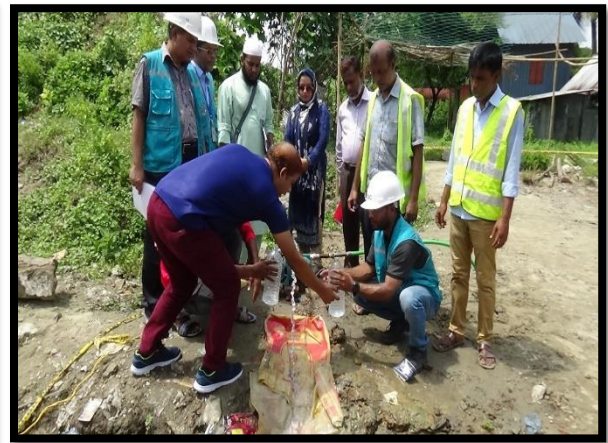
Water sample was collected from test boring of overhead tank of Akhaura Station for testing in BUET lab on 17/09/2019. The depth of this boring was 688 feet. At the time of sample collection Additional Chief Engineer Md. Abdus Salam and Deputy Director (ways and work) Ms. Tania Mostafa from Bangladesh Railway was present along with CSC's Environmental Specialists. From CSC's environment team Senior Environment Specialist Dr. Md. Kabil Hossain and Junior Environment Specialist Md. Redoan Rakib Mugdho were present. All the arrangements were done by Station Building Department of TOMA part (Contractor).

Due to getting non-potable water again a meeting was held at Akhaura CSC's site office with BR, CTM and CSC on 18/12/2019 and decided further testing after washing the pump continuously for 10-15 days. Then new sample of water will be collected again for testing at BUET. It was also decided that if the result fail again, the test boring should be continue up to 1000 feet till getting the potable water.

Photographs: Collection of water sample of test boring of deep tube well for lab test at Akhaura

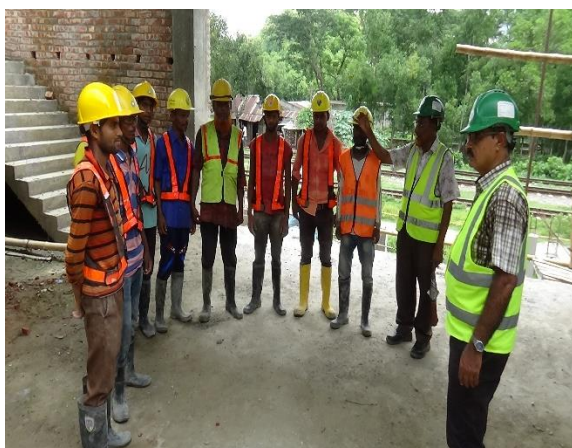
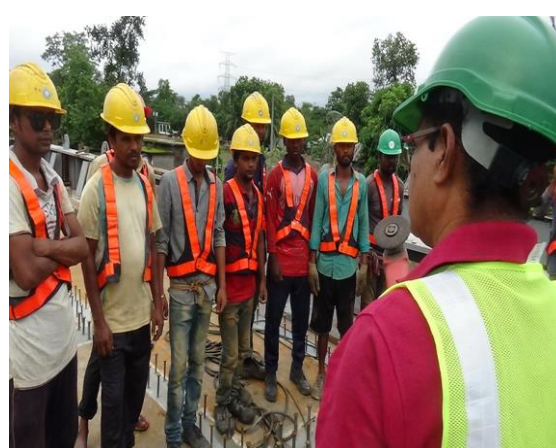
13.18 Safety promotional event

Based on the HSE principle CTM organize safety promotional event and carry out other promotional activities. They are giving various HSE training and visual presentation for their employee by this event. The safety promotional events content elements such as –Awareness Training, Fire Fighting Training, Emergency Procedure Training, First Aid Training and Safety related heart touching video presentations. They have also installed many type of safety promotional poster in their workplace.

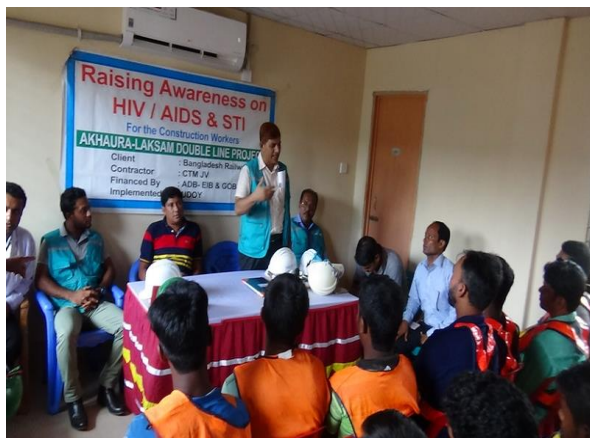
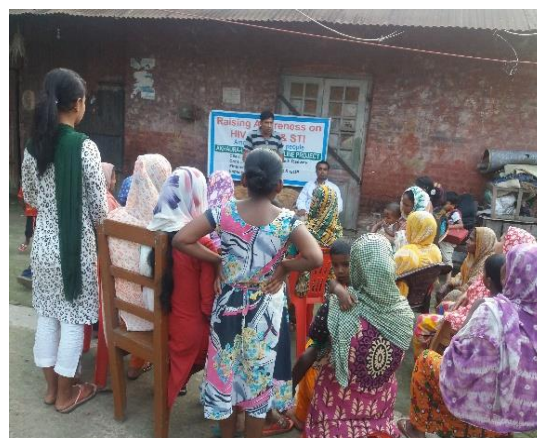
Orientation Session on HIV/AIDS and STI awareness

Activities for	Date & Time	Venue	Resource persons	Participants		
				Male	Female	Total
Workers	22/12/2019	Mandabagh Railway Station	06	19	x	25
Community people	22/12/2019	Near Mandabagh Rail Station	05	14	x	19

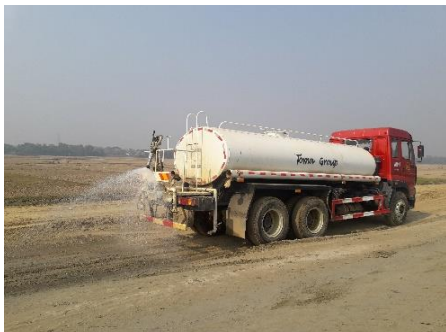
ITEMS	OBSERVATIONS	ENGINEER'S RECOMMENDATION	PHOTOGRAPH	REFERENCE
Parameters: Air Quality and Dust Control				
Dust Suppression	Water car spraying water to suppress dust	<p>Good Practice but limited movement. Frequency of movement should be increased.</p> <ol style="list-style-type: none"> Spray water 4 times a day to avoid blowing dust at all the at the places construction of embankment, stations and placement of ballast. Also limit the vehicle speed to ≤ 35 Km/h.

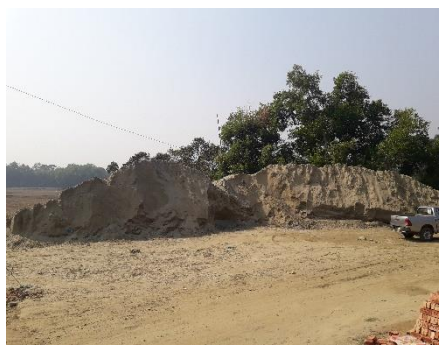
<p>[H 6.2 (b) (P-6)] [EMP 2.2 (P-97)] [EMP 2.3.1 (P-97)] [EMP 2.5.2 (P-99)] [EIA VI B (1) 187 (P-50)]</p>
Bare Stockpiled Materials	Open Stockpile , which causes air pollution	<ol style="list-style-type: none"> Cover stockpiled sand. Spray water 4 times a day to avoid blowing dust at all the places construction of embankment, stations and placement of ballast. Also limit the vehicle speed to ≤ 35 Km/h.

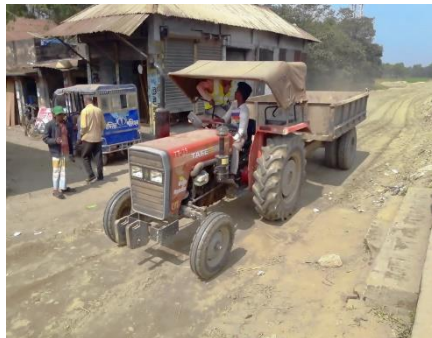
ITEMS	OBSERVATIONS	ENGINEER'S RECOMMENDATION	PHOTOGRAPH	REFERENCE
Dry Embankment Surface	Dry Embankment surface creates dust and air pollution.	<ol style="list-style-type: none"> Spray water 4 times a day to avoid blowing dust at all the at the places construction of embankment, stations and placement of ballast. Also limit the vehicle speed to ≤ 35 Km/h.

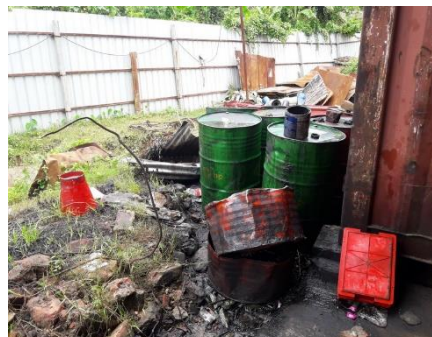
[H 6.2 (b) (P-6)] [EMP 2.2 (P-97)] [EMP 2.3.1 (P-97)] [EMP 2.5.2 (P-99)] [EIA VI B (1) 187 (P-50)]
Parameters: Control of Petroleum Products				
Storage of Surplus or Disposable Petroleum Products	Oil filled drums kept open with no spillage protection measures	<ol style="list-style-type: none"> Specify the designated area with impermeable substance not near water body or stream provided with roof at the top and fence surrounding. Provide tray during fuelling activities to limit unwanted spillage where needed. Maintain at least 500m distance from any housing area during any refuelling activities.

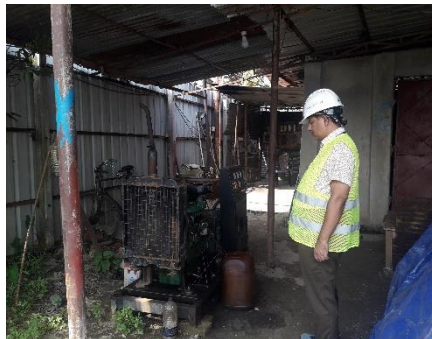
ITEMS	OBSERVATIONS	ENGINEER'S RECOMMENDATION	PHOTOGRAPH	REFERENCE
Operating Defective Vehicle, Machine, Equipment or Plant at Work Site	Defective machine with no oil spillage measures taken running at camp area	I. Provide problem free machines for any kinds of operation II. Maintain and run in a good place with casting or plane sheet or drum sheet at the bottom of the machine to avoid spillage, and pollution III. Provide tray during fuelling activities to limit unwanted spillage where needed.

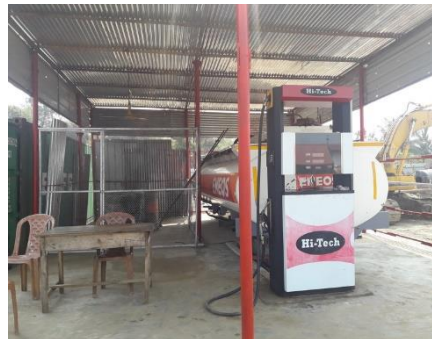
[H 6.6 (a) (P-8)] [H 6.6 (b) (P-8)] [H 6.6 (c) (P-8)] [EIA VI B (8) 216 (P-58)]
Storage of Petroleum Products	Oil pump storage area with concrete casting below to avoid oil spillage	Good Practice

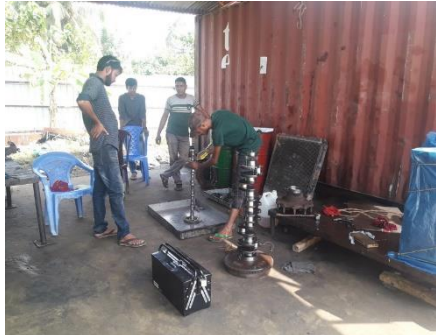
ITEMS	OBSERVATIONS	ENGINEER'S RECOMMENDATION	PHOTOGRAPH	REFERENCE
Servicing of Defective Vehicle, Machine, Equipment or Plant at Workshop	Using Dip pans during servicing activities at workshop	Good Practice

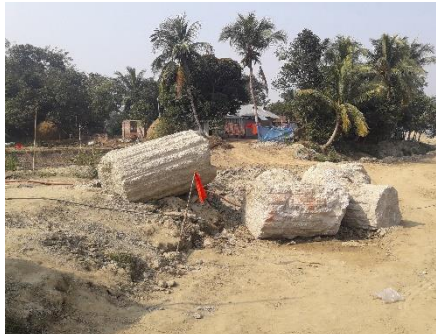
[H 6.6 (a) (P-8)] [H 6.6 (b) (P-8)] [H 6.6 (c) (P-8)] [EIA VI B (8) 216 (P-58)]
Parameters: Disposal of construction Debris and others Materials				
Man Made Construction Debris	Broken CIP heads found beside the new embankment for long time.	<ol style="list-style-type: none"> Debris should not be left lying on the ground surface or buried in any agricultural land. Recycle, reuse, relocate or remove the wastes to designated dumping yards. Break the huge or big into small parts and remove. Implement waste disposal system.

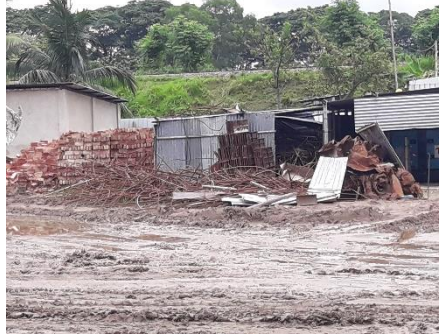
ITEMS	OBSERVATIONS	ENGINEER'S RECOMMENDATION	PHOTOGRAPH	REFERENCE
Construction Waste materials	Haphazard condition. Different construction wastes kept in a scatter manner	<ol style="list-style-type: none"> Wastes like litter or food scraps should not be dumped or burnt anywhere and left lying on the ground surface or buried in any agricultural land. Recycle, reuse, relocate or remove the wastes to designated dumping yards. Provide bins to segregate the waste. Implement waste disposal system. Weekly inspection is must

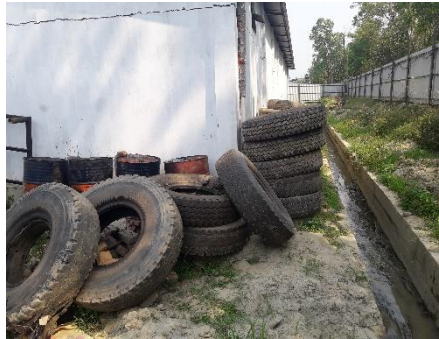
[EMP 2.4.2 (P-98)] [EMP 2.10.1 (P-100)] [EIA VI B (8) 215 (P-58)] [EIA VI B (8) 217 (P-58)]
Man Made Construction Debris	Left over tires and empty drums kept in a scatter manner and can cause diseases and others environmental problems.	<ol style="list-style-type: none"> Debris should not be left lying on the ground surface or buried in any agricultural land. Recycle, reuse, relocate or remove the wastes to designated dumping yards. Break the huge or big into small parts and remove. Implement waste disposal system.

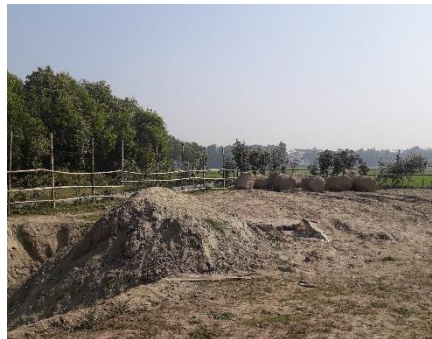
ITEMS	OBSERVATIONS	ENGINEER'S RECOMMENDATION	PHOTOGRAPH	REFERENCE
Dumping Area	An area is selected for dumping solid wastes and also others. But not yet asked for any approval from engineers.	Urgent request for sending a formal letter for engineer's approval.

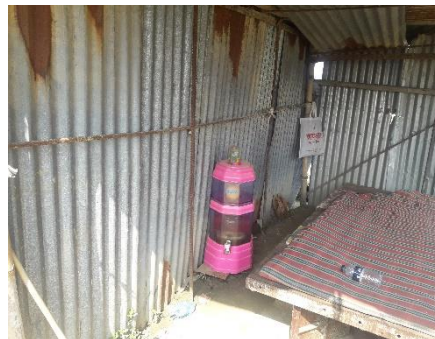
Parameters: Occupational Health and Safety				
Potable Drinking Water	Safe drinking water facilities available	Good practice but should increase this services I. Clean and disinfect the facility regularly. II. Implement waste disposal system. III. Weekly inspection is must.

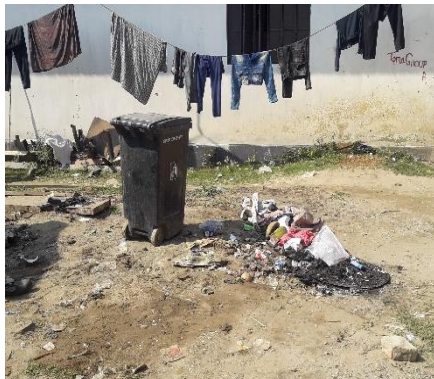
ITEMS	OBSERVATIONS	ENGINEER'S RECOMMENDATION	PHOTOGRAPH	REFERENCE
House Keeping	Waste bin provided for collection of wastes but users are littering	<p>Good practice but users should be groomed and trained.</p> <ol style="list-style-type: none"> Wastes like litter or food scraps should not be dumped or burnt anywhere and left lying on the ground surface or buried in any agricultural land. Recycle, reuse, relocate or remove the wastes to designated dumping yards. Provide bins to segregate the waste. Implement waste disposal system. Weekly inspection is must

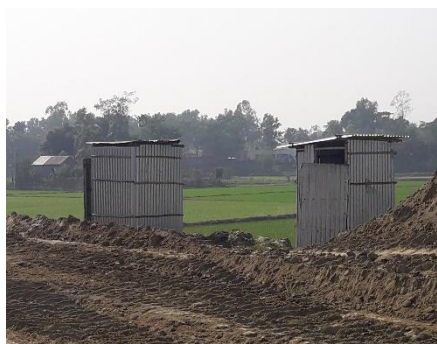
<p>[EMP 2.4.2 (P-98)] [EMP 2.10.1 (P-100)] [EIA VI B (8) 215 (P-58)] [EIA VI B (8) 217 (P-58)]</p>
Sanitary Toilet Facility	Hygienic toilet provided	Good Practice and should be carried on

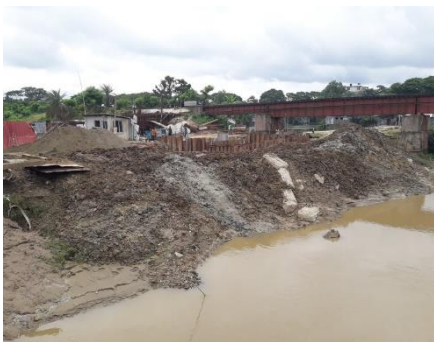
ITEMS	OBSERVATIONS	ENGINEER'S RECOMMENDATION	PHOTOGRAPH	REFERENCE
Parameters: Protection of top soil and Erosion, Water Course impacts in Wetlands/Canals/Rivers				
Erosion, Sedimentation and Contamination of Superficial or Organic Surplus Adjacent to Natural Drainage	Erosion protection measures not taken	I. Erosion and sedimentation control measures should be taken during cross-drainage work. II. Ensure the continuous stream flow during any construction works.

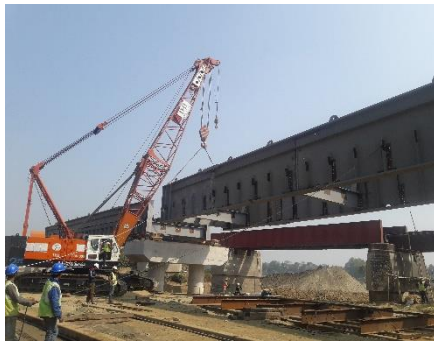
[H 6.3 (c) (P-7)] [H 6.3 (d) (P-7)] [H 6.3 (e) (P-7)] [H 6.3 (f) (P-7)] [H 6.3 (g) (P-7)]
Water Congestion or Loss of Navigability Due to Cross Drainage Works	Loss of navigability	I. Erosion and sedimentation control measures should be taken during cross-drainage work. II. Ensure the continuous stream flow during any construction works.

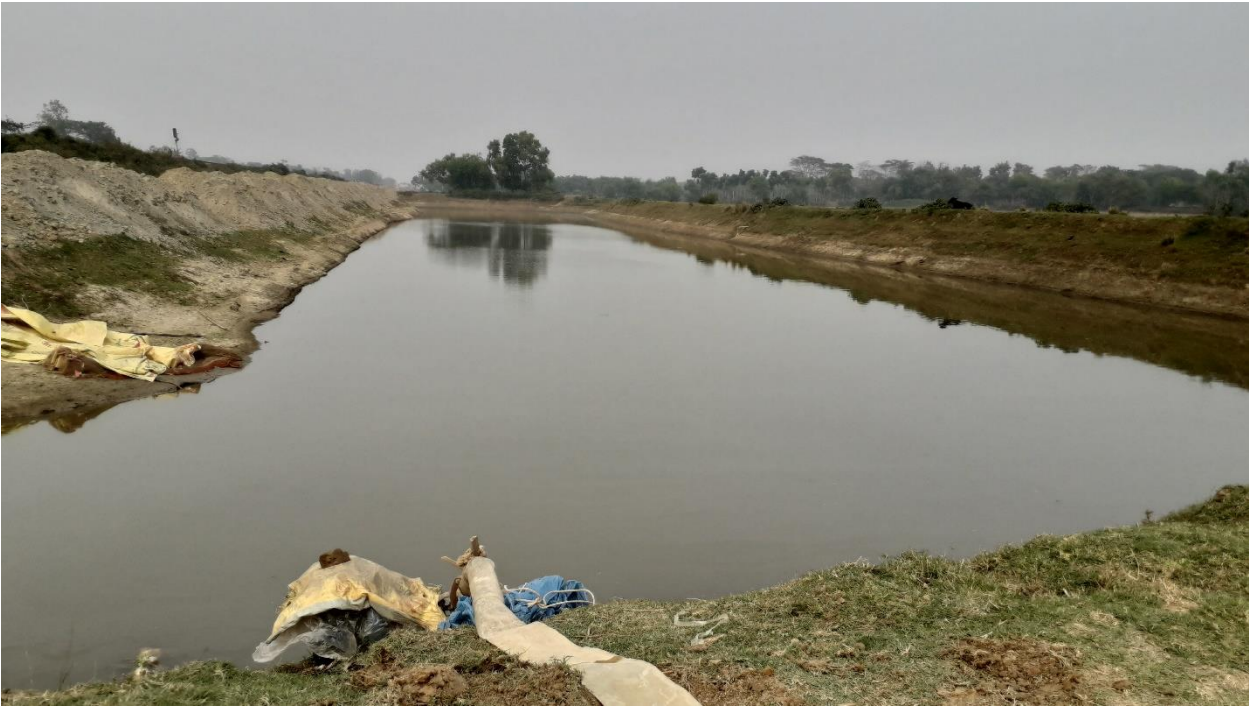
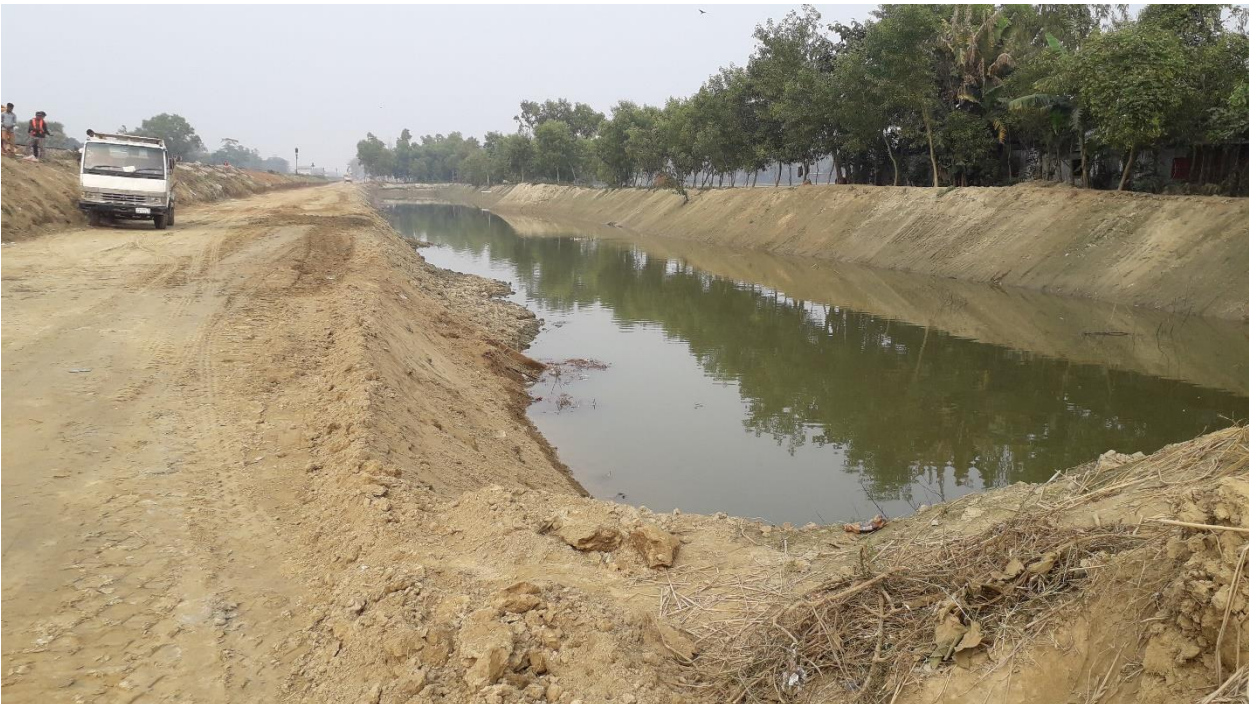
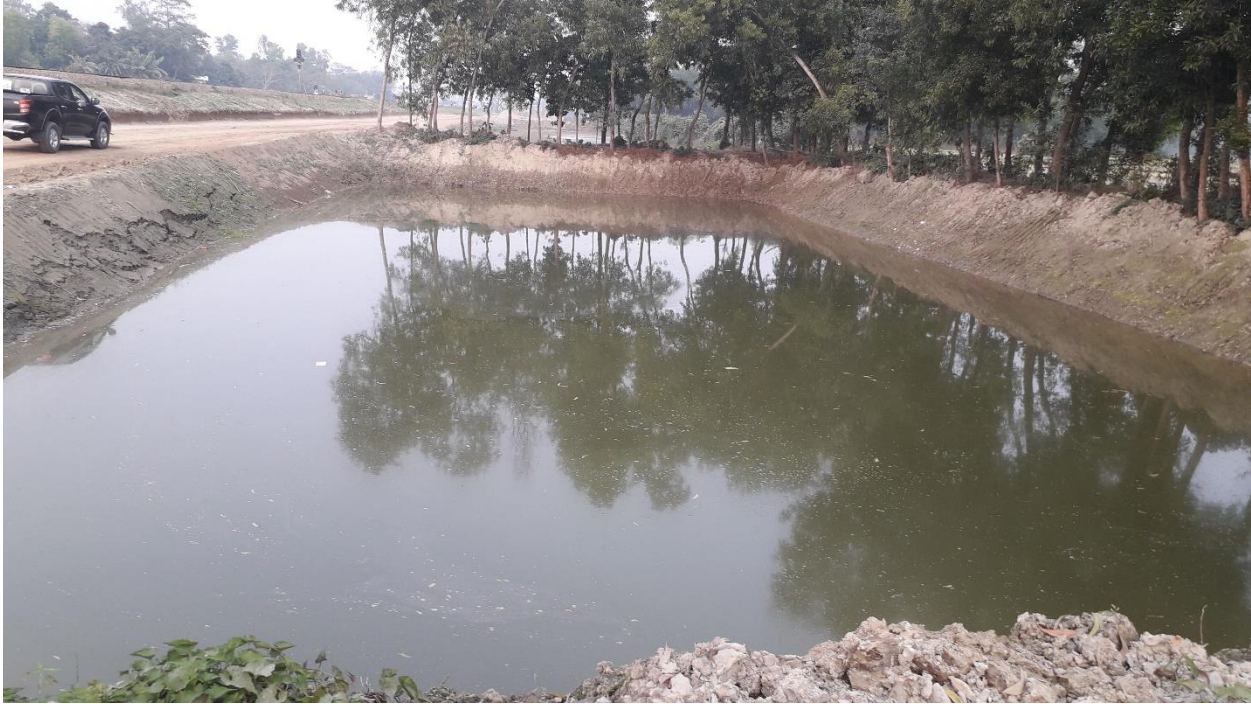
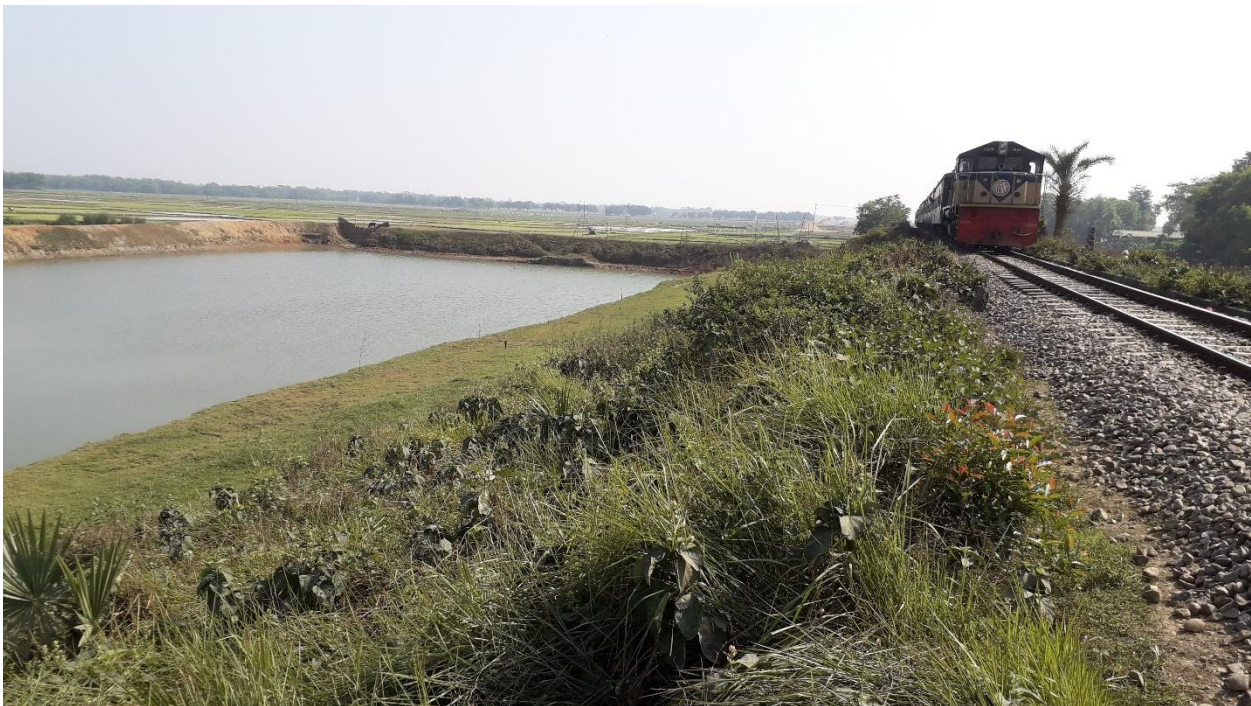
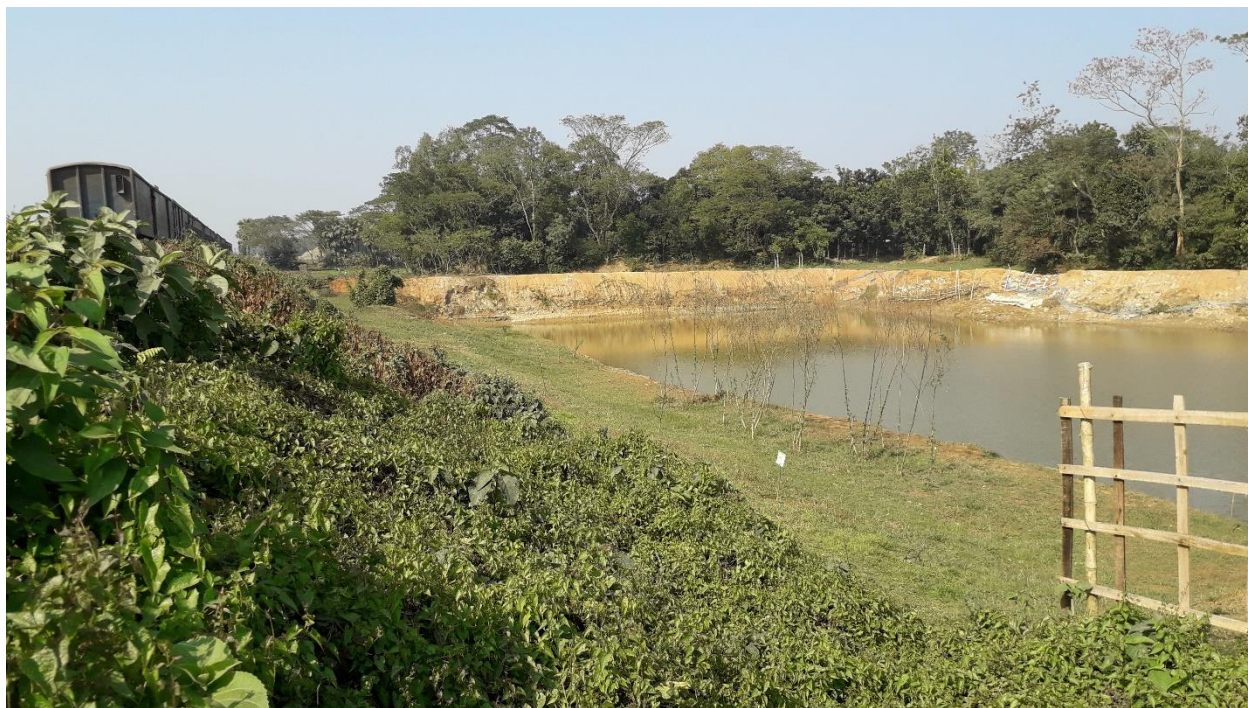
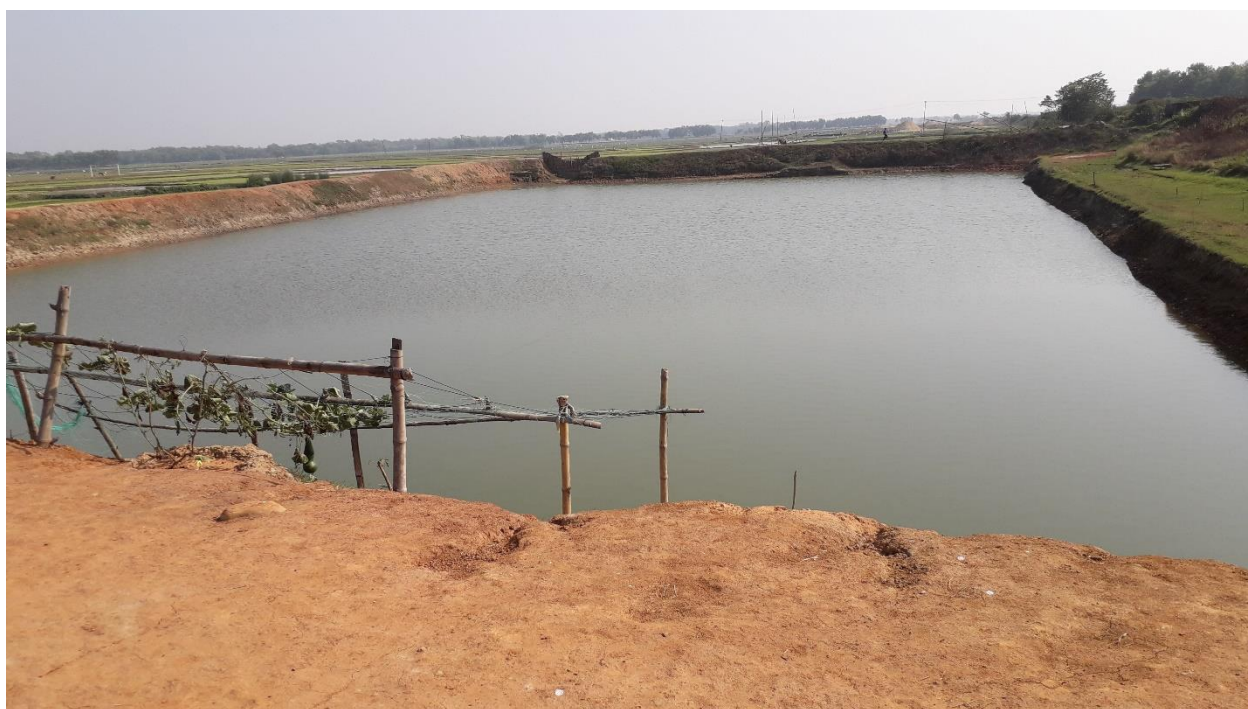
15.6 Appendix-F. Photographs of Borrow pit ponds

Photographs of Borrow pit ponds excavated during earth work of ALDLP
