DOHWA-KRNA-OCG-BARSYL-DDC Joint Venture  
for Construction Supervision of Akhaura-Laksam Double Track Project

**Project:** Contract No.: PD/ALDLP/ADB-EIB/2015: Construction of Dual Gauge Double Line and Conversion of Existing Railway into Dual Gauge between Akhaura-Laksam

**Subject:** Response to Comments of ADB on the draft Semi-Annual Environmental Monitoring Report for the period July-December 2023

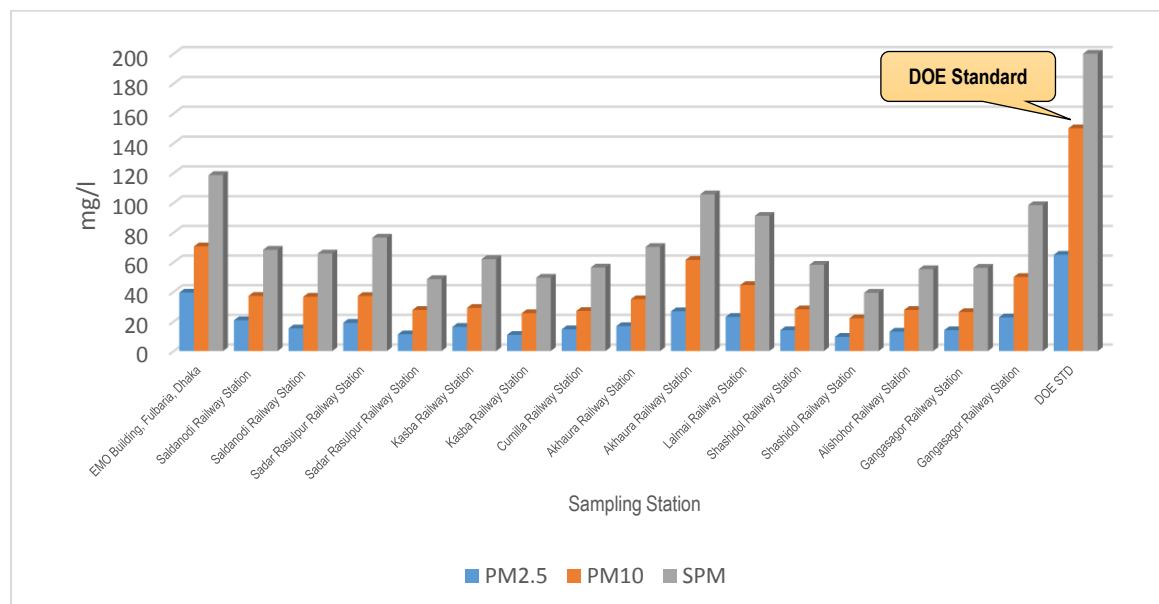
Figure 2.1. Air Quality Test Results for PM<sub>2.5</sub>, PM<sub>10</sub> and SPM

A total of 10 ambient air samples were collected from 10 Railway Stations and the EMO Building construction site. The ambient status of major air pollutants viz. Particulate Matter (SPM, PM<sub>10</sub> and PM<sub>2.5</sub>), Sulfur Dioxide (SO<sub>2</sub>), Oxides of Nitrogen (NO<sub>x</sub>), and Carbon Monoxide (CO) have been assessed by monitoring air quality. All parameters of air quality are found within the acceptable limits specified by the DoE. PM<sub>2.5</sub> values are between 9.59 to 39.46 ug/m<sup>3</sup>; PM<sub>10</sub> have results between 22.12 to 70.64 ug/m<sup>3</sup>; SPM was measured between 49.52 to 118.61 ug/m<sup>3</sup>; SO<sub>2</sub> is between 2.37 to 14.31

ug/m<sup>3</sup>; NO<sub>x</sub> figures is between 10.37 to 33.89 ug/m<sup>3</sup>; while CO levels are between 0.01 to 0.23 ppm. All of the test results are found compliant with the DOE standard for the said contaminants.

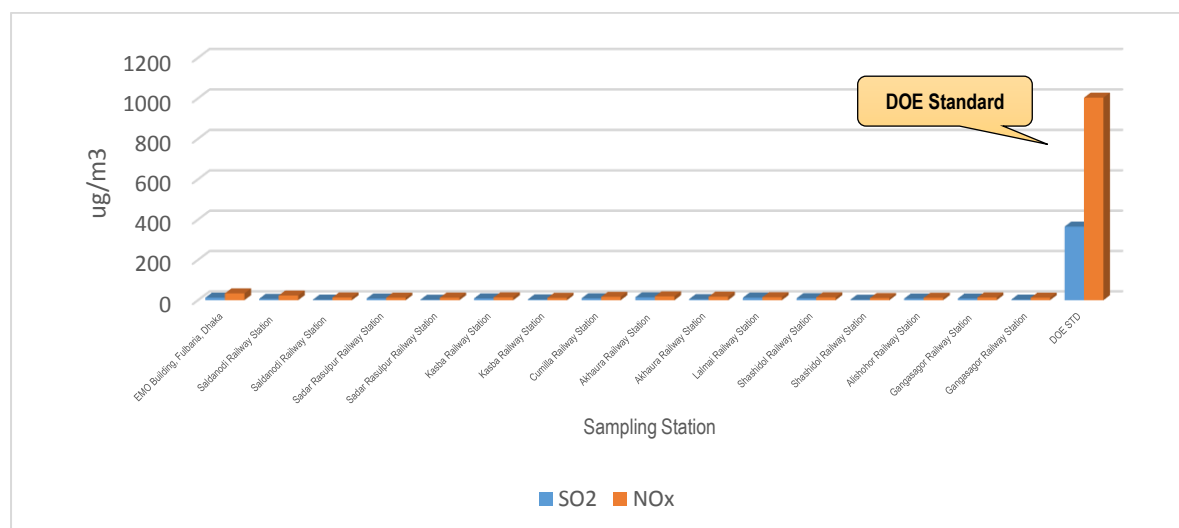
Figure 2.2. Air Quality Test Results for SO<sub>2</sub> and NO<sub>x</sub>

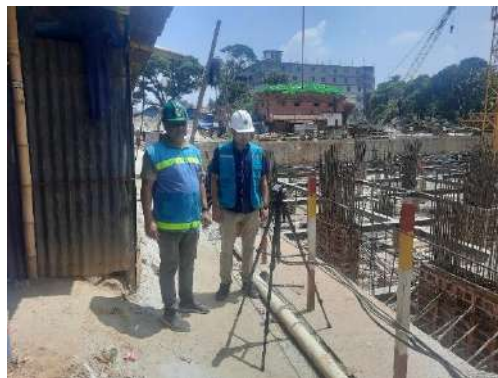
Plate 2.1 Noise level monitoring by EQMS Environmental Spl at the EMO Building Construction site. CSC Jr. Environment Spl (right) observe the monitoring process .

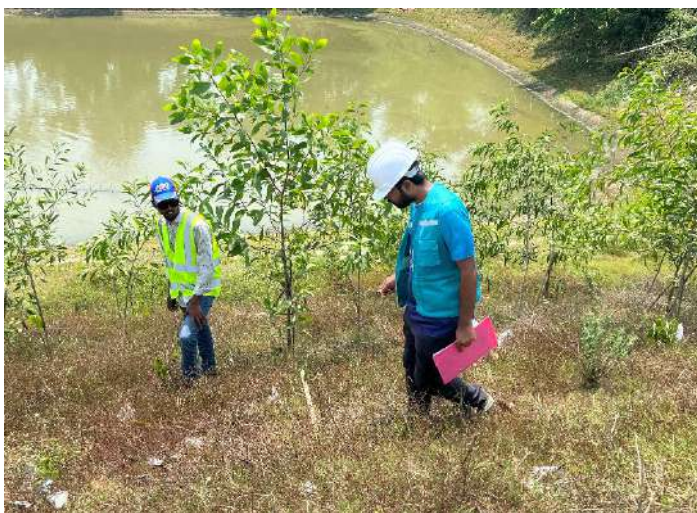
Plate 3.1. CSC Jr. Environment Specialist (right) examines an acasmoni (*Acasia auriculiformis*) and notes its quality, while a CTM JV members counts the number of surviving trees during the 100% tree inventory of the 2022 plantation.

91. Based on the results of the tree inventory conducted in Sections 1, 2 and 3 for the 2022 plantation, most (81.9%) of surviving trees comply with the prescribed standards for planted trees. These standards include: healthy (absence of signs of infestation), at least 1 m height, broad evergreen leaves and branches. It was observed that surviving timber trees perform better at 85.3% compliant, followed by fuel wood trees at 81.9%, and medicinal trees at 74.2%. On a species basis, the timber tree Mangium (*Acasia mangium*) has the highest compliance rate of 91.9% for the 1,003 surviving trees (1,003/1,091 saplings), which is followed by another fruit tree palm (*Borossus flabelliformis*) with 88.8% (700/788 saplings) and the third placer is the timber tree Akasmoni (*Acasia auriculiformis*) with 88.3% compliance (14,047/15,917 saplings). The species with the most number of surviving trees is the timber tree Akasmoni (*Acasia auriculiformis*) with 15,917 trees (88.3% compliant). This was followed by the medicinal tree Arjun (*Terminalia arjuna*) with 1,512 trees (80.7% compliant). **Table 3.7** contains the summary of tree inventory results of trees planted in 2022 that had survived in all Project Sections.

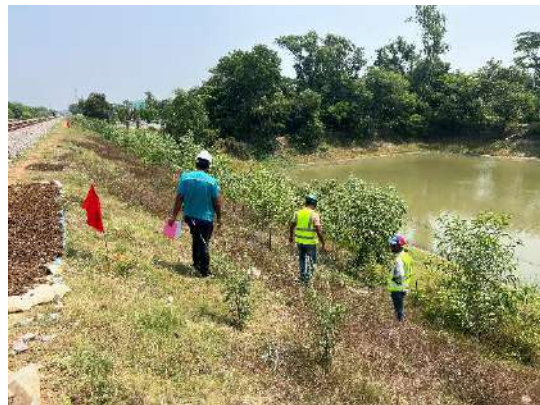
Plate 3.5. Surviving timber trees found mostly at the bottom of the embankment slope. Saplings planted near the top or middle of the embankment slope either died or has poor growth.

101. The tree planting sites are found mostly along the track embankment slopes. These sites only have a portion of the essential elements for good plant growth. These elements include: a) favorable temperatures; b) adequate sunlight; c) limited water; d) air; and e) time. The compacted soil along the track is most unsuitable for plant growth. The soil itself is mostly devoid of organic matter so that no voids/spaces in the soil matrix may be created especially when these (organic matter) eventual decomposition<sup>6</sup>, very limited plant nutrients are also present. In view of this, very minimal water nor nitrogen (air) or other nutrients is able to reach the roots of the planted trees saplings. Compacted soil also hinders the growth of plant roots that seeks to reach out for more grounds thereby improving the anchorage of plants to the soil, as well as well as seek out sources of water, nitrogen and other nutrients. Productive soils are those that are loose, to allow the movement of water, nitrogen and other nutrients to reach the plant roots that absorbs them through the process of osmosis. Nitrogen are fixed to the roots by fungi through the process called mycorrhiza. For compacted soils such as those in the track embankments, these processes are constrained.

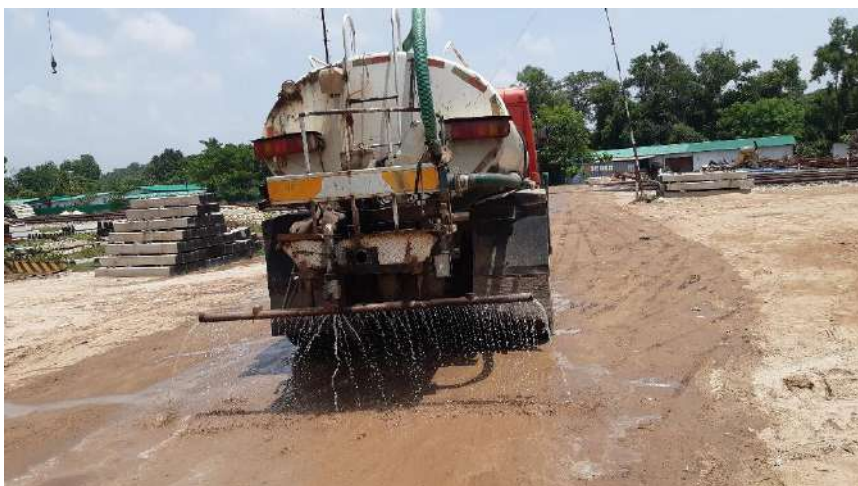
Plate 6. Photograph of watering of unpaved track embankment at the Quasba Station Yard. Picture taken on 21 August 2023.

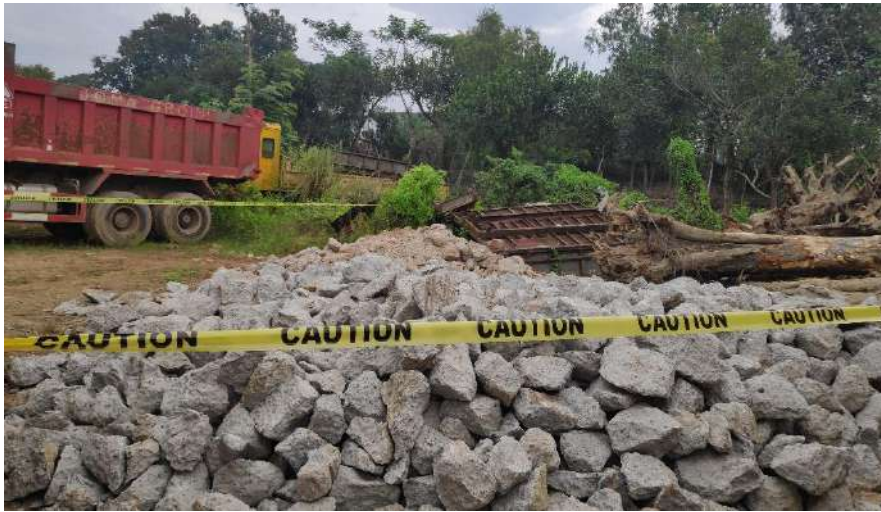
Plate 7. Photograph of excess construction materials, excavation spoils and cut trees deposited in temporary storage area prior to disposal in LGU authorized sites, on 16 November 2023

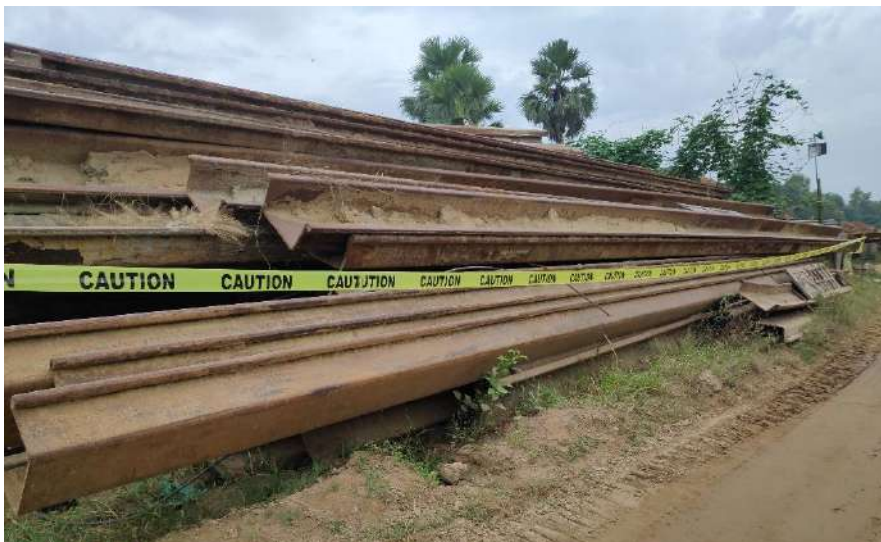
Plate 8. Photograph of old railway track that had been deposited in a temporary storage area at Quasba Station. Picture taken on 16 November 2023.

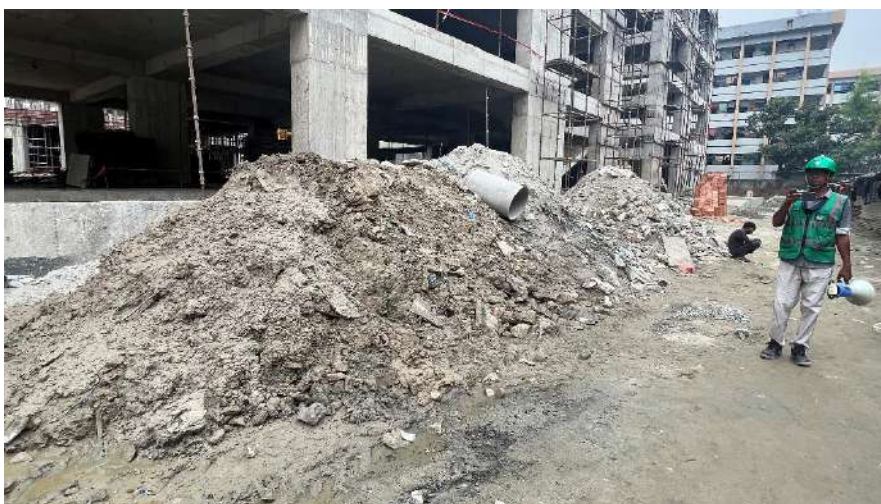
Plate 9. Excavated materials from EMO Building earthworks awaiting collection by Contractor's trucks for transport and reuse as backfill materials for their other Projects. Picture taken on 5 December 2023.

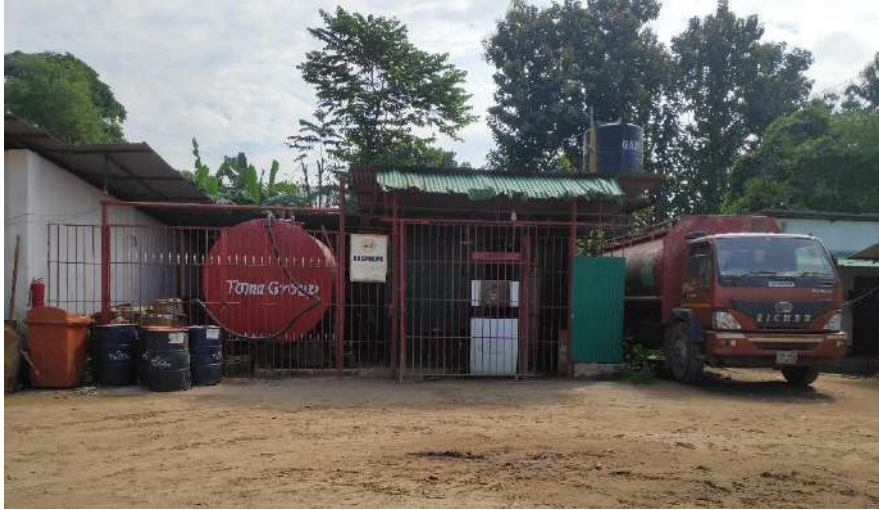
Plate 10. Photograph of the Quasba Fuel refilling station. Picture taken on 16 November 2023.

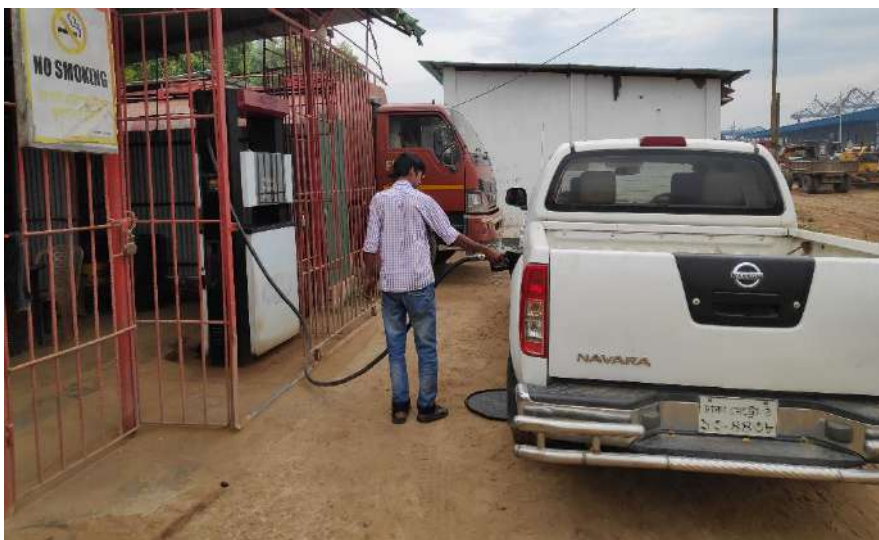
Plate 13. Photograph of the fuel filling station at the Quasba Construction yard. Picture taken on 16 November 2023.

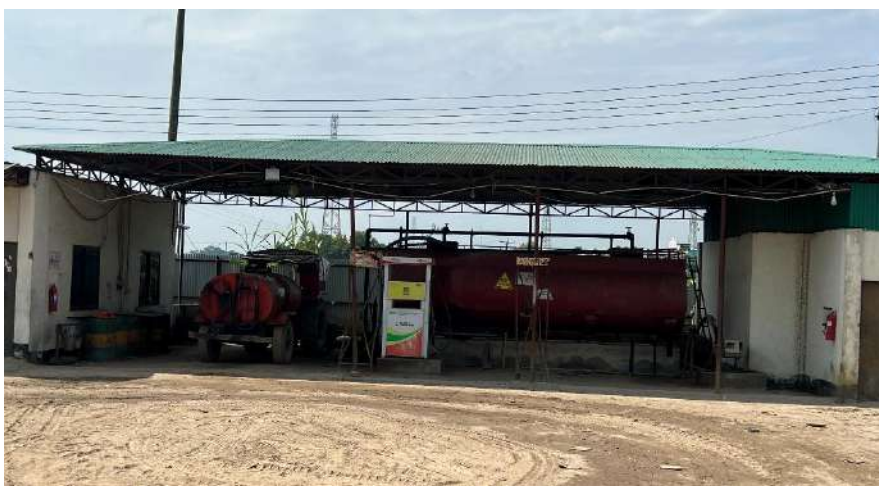
Plate 11. Photograph of the Lalmai Fuel Filling Tank at Lalmai Station. Picture taken on 22 October 2023.

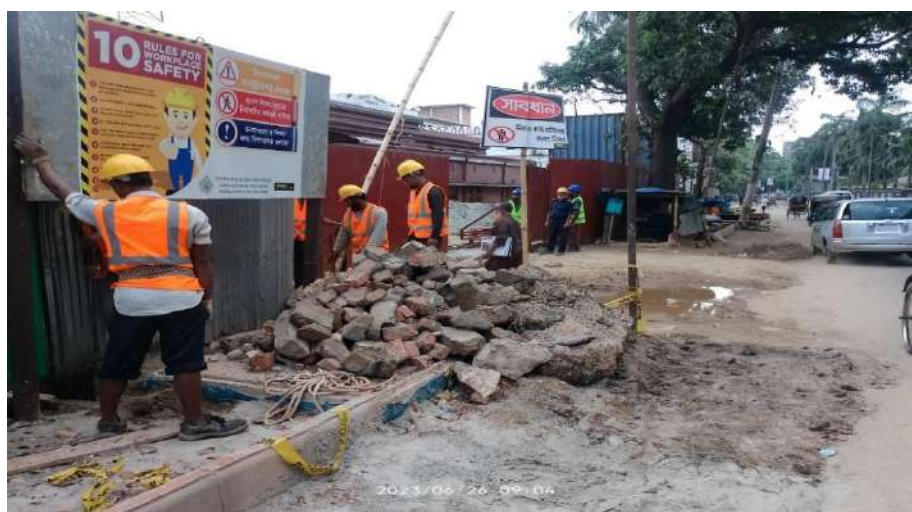
Plate 15. Safety signs installed on the front perimeter wall of the EMO Building site. Picture taken on 10 July 2023.

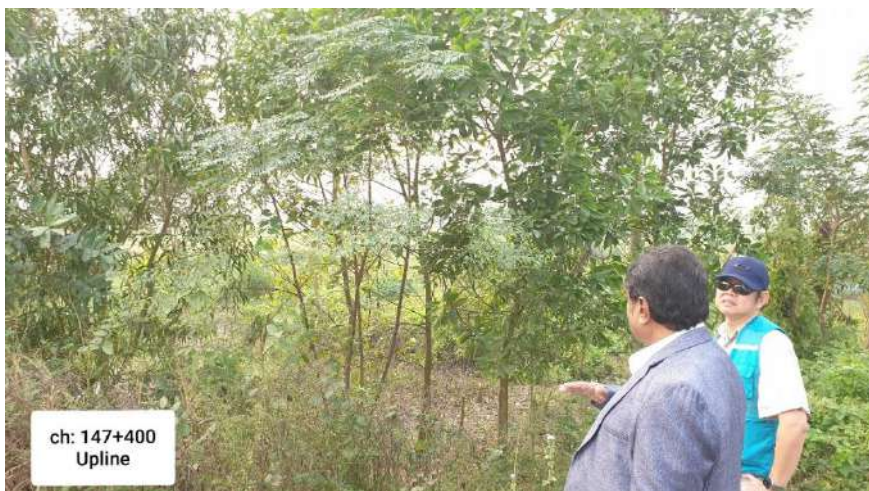
Plate 20. CSC Project Coordinator (PC) Mr. Naim Khan (left) and CSC Resident Social/Resettlement & Gender Spl A. Salvador investigate the damages caused by Cumilla Rural Electrification Association Maintenance Crew on the 2020 tree plantation. Photograph taken on 13 December 2023.

98. Another meeting was held with the Senior General Manager of the Cumilla Rural Electrification Association and his Deputy General Manager for line 2 on 13 December 2023 regarding the irresponsible cutting of Project trees by their REA line 2 Maintenance Crew. The SGM committed instructed his 4 Deputy General Manager to stop cutting ALDLP trees and instead just do trimming of tree branches and leaves that are compromising their electric power transmission lines. **Table 3.8** contains the list of meetings held, objectives, participants and agreements made. Of interest to note that local government officials mentioned that they were never consulted regarding the Project and informed of their role in its construction and operations. These local leaders had expressed their desire to assist the Project such as in the protection of the tree plantation established. **Annex 8** contains one of the highlights of the meetings with local

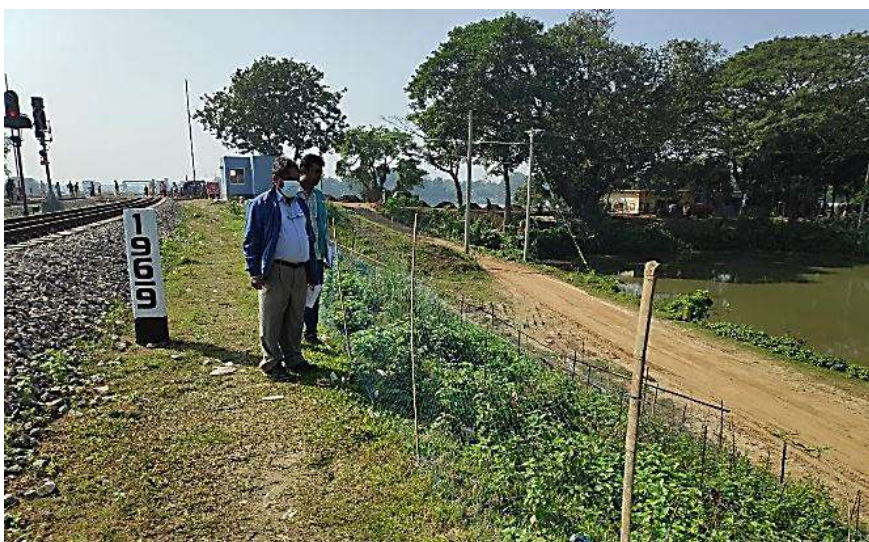
Plate 21. CSC Project Coordinator (PC) Mr. Naim Khan (left) inspects the healthy 2023 tree plantation at chainage km196+900 (upline) located in Section 3. Photograph taken on 18 December 2023

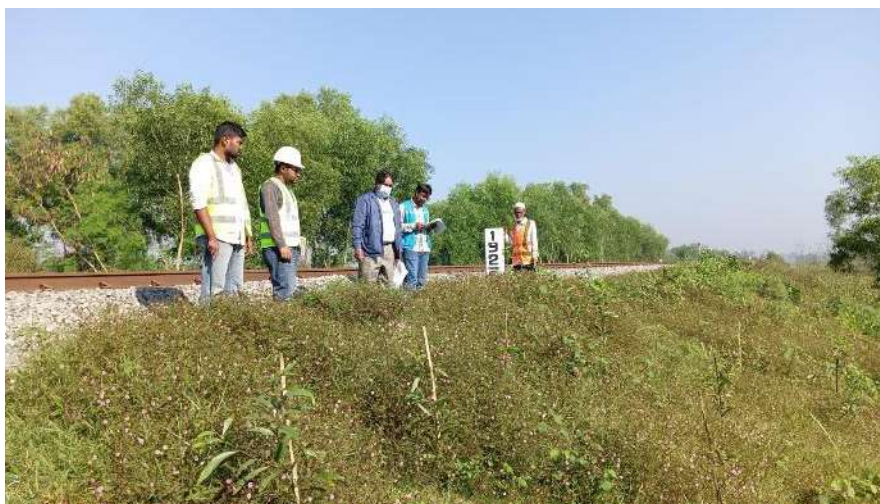
Plate 22. CSC PC inspects a segment of the tree plantation at chainage km192+400 (downline) that lacks maintenance & protection. Weeds are found almost covering the planted saplings. Photograph taken on 18 December 2023.

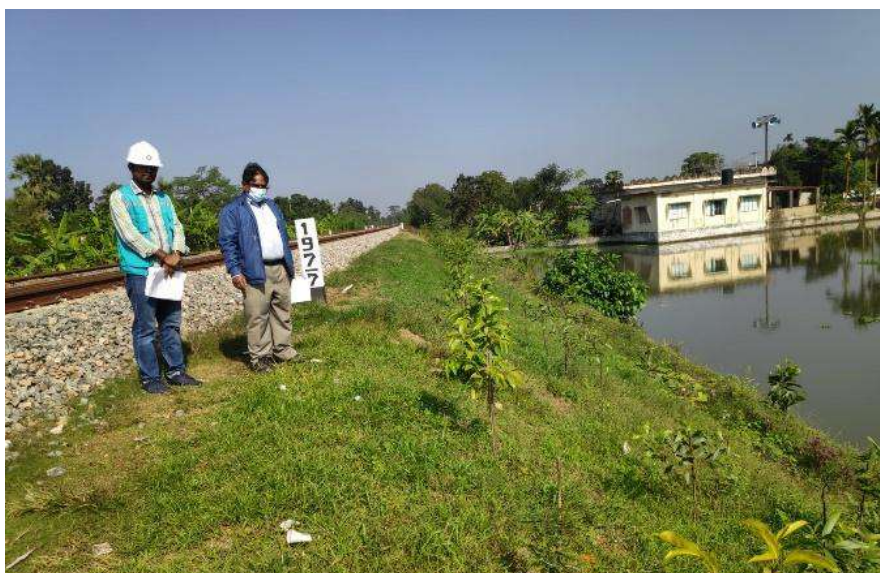
Plate 23. CSC PC Mr. Naim Khan (right) inspects a healthy tree plantation at chainage km197+700 (upline). CSC Jr. Environmental Spl. M. Hassan (left) looks on. The pond had served as a barrier against foraging animals. Photograph taken on 18 December 2023.

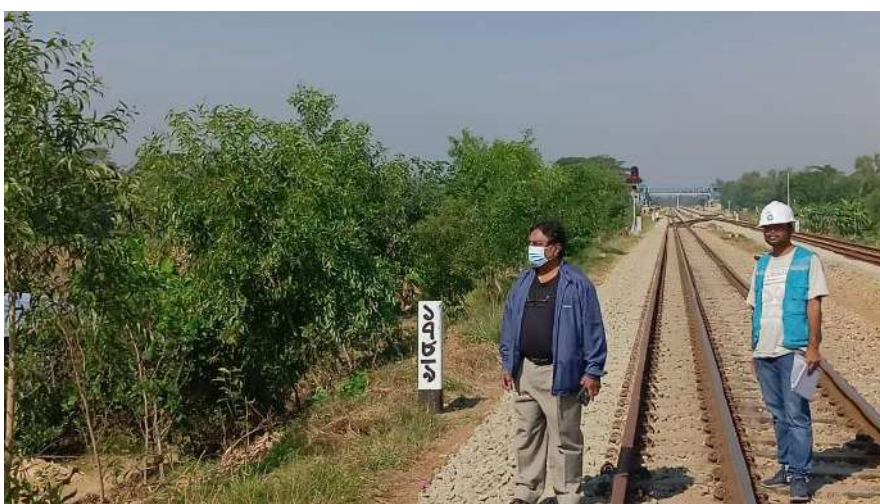
Plate 24. CSC PC Mr. Naim Khan (left) inspects a healthy 2021 plantation of *Acacia auriculiformis* at chainage km178+900 (upline). CSC Jr. Environmental Spl. M. Hassan (right) looks on. Photograph taken on 17 May 2023.

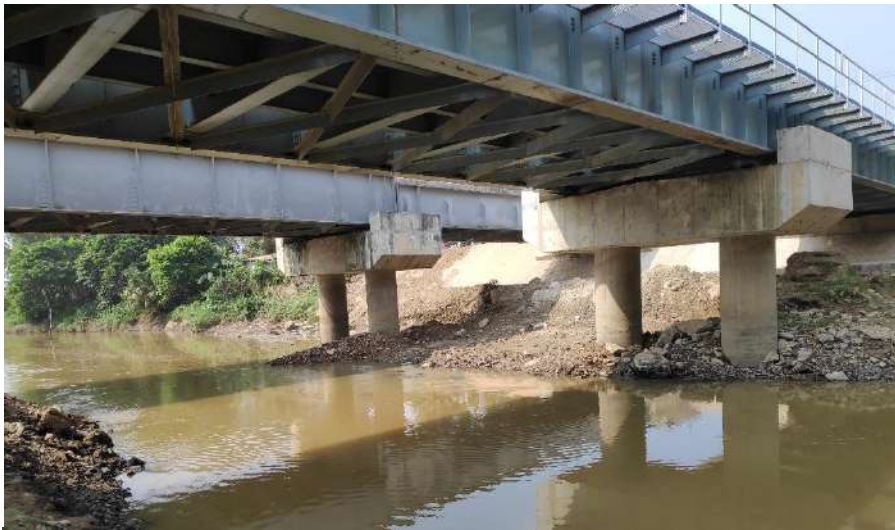
Plate 25. Waterway at Bridge 261 (Salda Nadi bridge) already cleared of debris. Photograph taken on 19 October 2023.

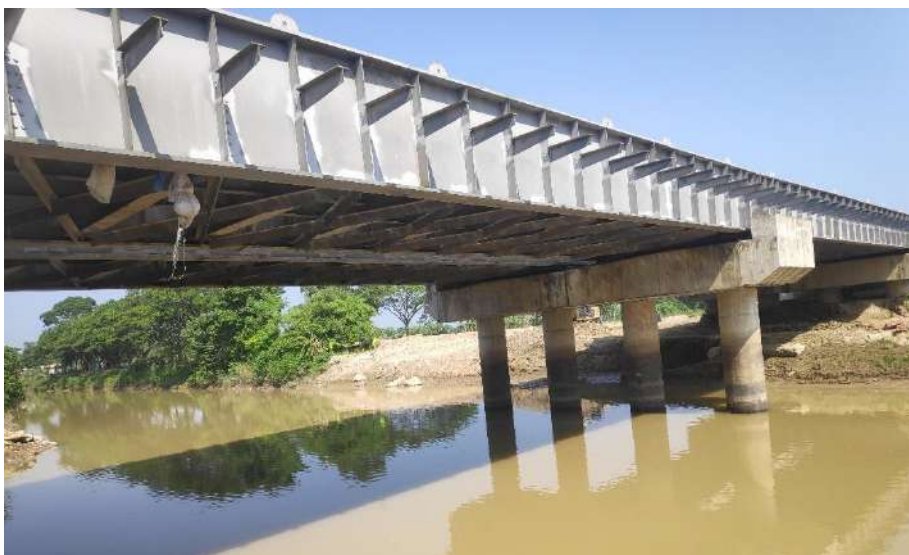
Plate 26. Waterway at Bridge 276 already cleared of debris. Photograph taken on 21 October 2023.

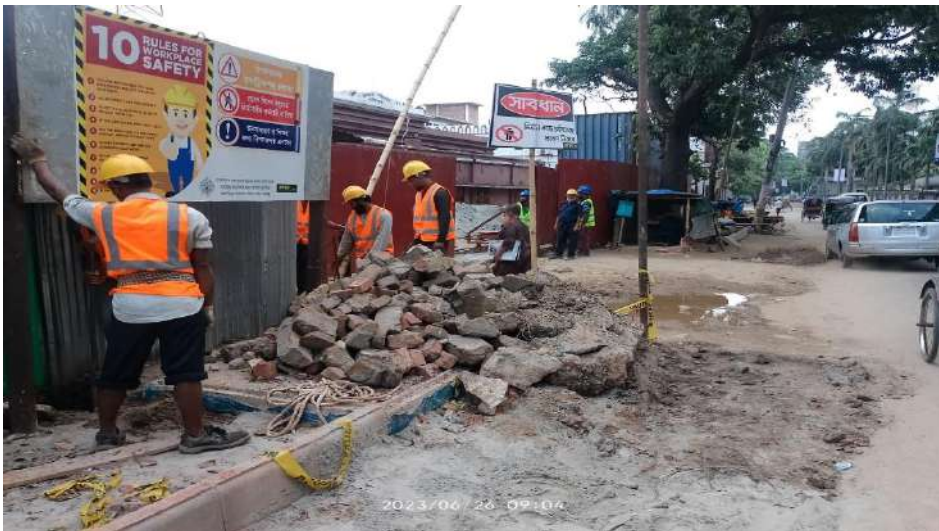
Plate 32. Safety informative signs installed at the front perimeter wall of EMO Building construction site. Debris also temporarily piled for collection by licensed contractor. Photograph taken on 26 July 2023.

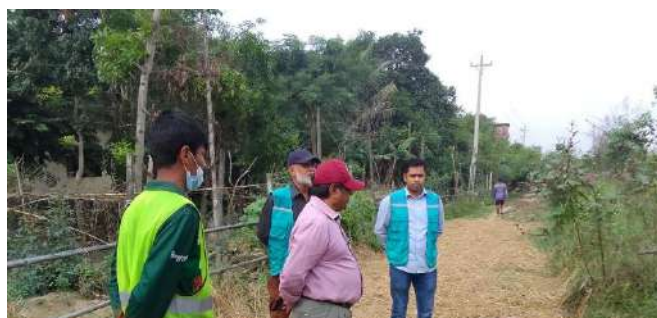
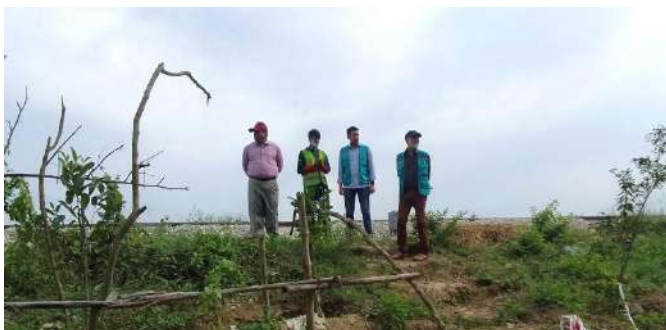
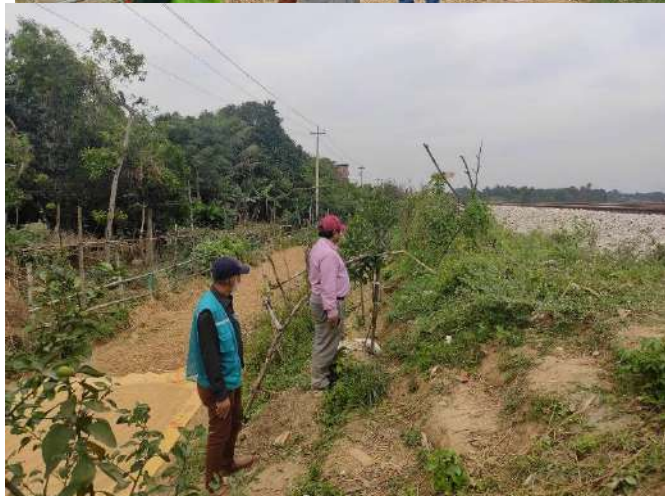
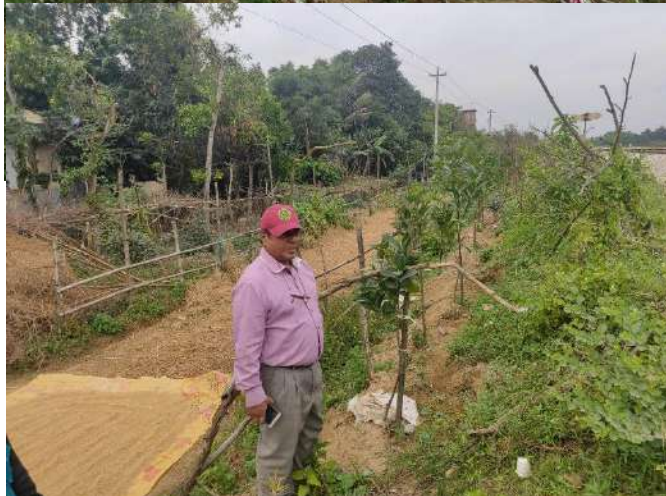
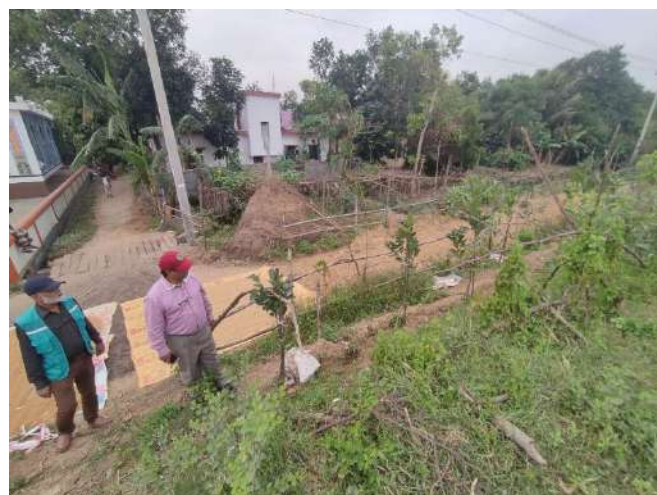
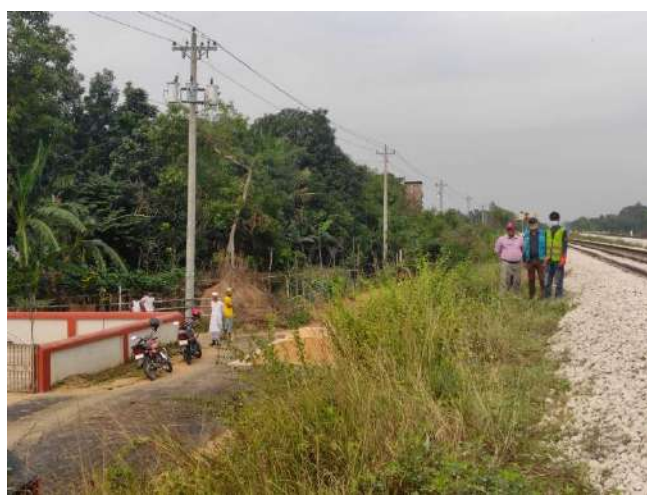
Plate 4-10: CSC & CTM team visit the tree plantation site near Bridge 246 (chainage 158+650 upline) to see affected site.
