Project: Contract No.: PD/ALDLP/ADB-EIB/2015: Construction of Dual Gauge Double Line and Conversion of Existing Railway into Dual Gauge between Akhaura-Laksam

**CONSULTING SERVICES CONTRACT
FOR CONSTRUCTION SUPERVISION OF
AKHAURA-LAKSAM DOUBLE TRACT PROJECT**

**SEMI-ANNUAL
ENVIRONMENT MONITORING REPORT
JULY - DECEMBER 2021**

BAN 3170: SASEC Railway Connectivity: Akhaura-Laksam Double Track Project

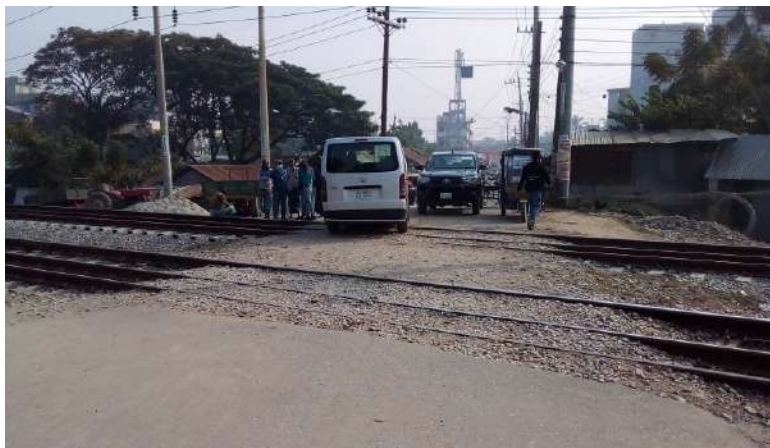
109. During the reporting period, there was only 1 environment/health & safety related community complaint that was referred to CSC by a local resident/lawyer. The case was a dangerous informal railway crossing at Mouza Doiyra, Comilla City Corporation (chainage km 149+590). The previously single lane Sonagazi road crossed by the railway track had been upgraded by the local government, which motivated local transport vehicles (i.e. CNG, rickshaw, autorickshaw, cars and buses) to drive faster than before. Due to the oblique alignment of the road, and presence of residential and commercial structures on the side of the road, it was difficult for motorist and pedestrians to see any incoming train. Already an CNG was reported to have been hit by a fast moving train on 18 December 2021 resulting in physical injuries to the driver and total damage of the vehicle. The case has also been reported on AKASH TV24.

110. Upon learning of the case on 21 December 2021, CSC Safeguards and Track Engineers visited the site, interview local people and reported the case to the Employer, CSC Acting Team Leader and the Contractor. The following day (22 December 2021), the Acting ALDLP Project Director visited the Doiyra rail crossing (among other places) along with senior BR, CSC and Contractor; to see for himself the actual site conditions. After a short deliberation on the possible courses of action; it was agreed that for the time being, warning signs are to be installed along the road prior to the intersection to warn motorists. The site was also included in the list of level crossings proposed to be upgraded under the Project; where railway gates that will be manned by gate guards, as well as the gate lodge will be constructed. The list also contained other illegal railway crossings that an ADB Project Review Mission had recommended for inclusion in the program.

Figure 6.2 .
Dangerous Doiyrā rail
crossing

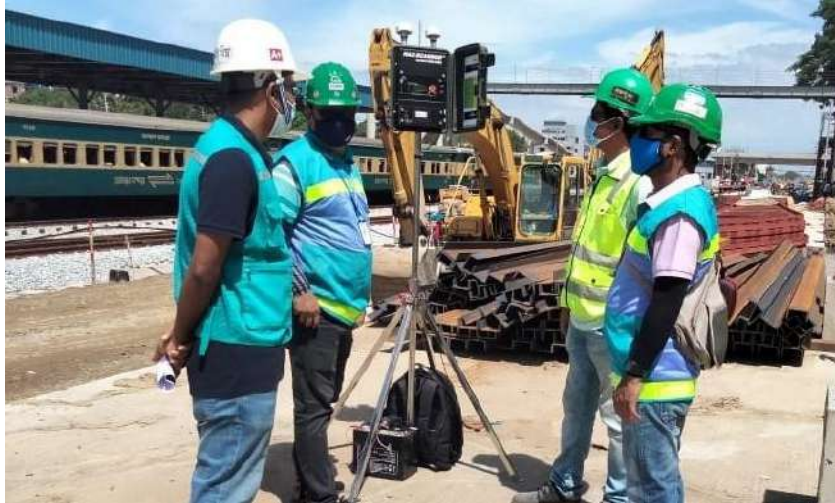
Plate 1. Ambient air quality monitoring at Comilla Station.
Picture taken on 12 September 2021.

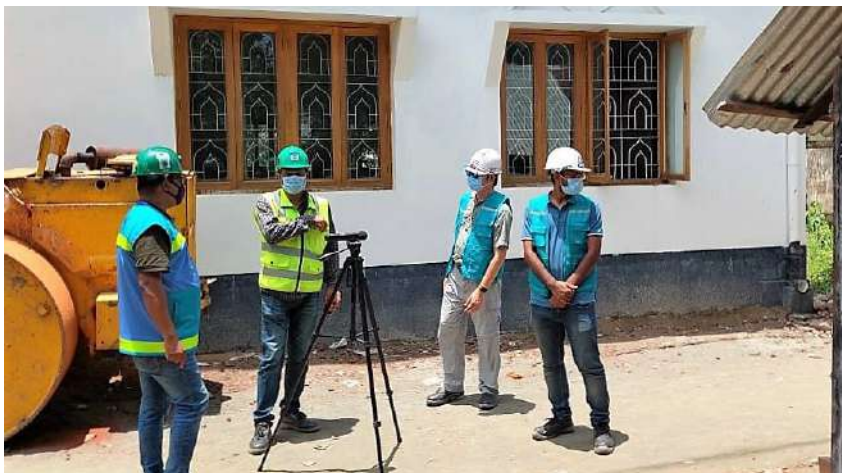
Plate 2. Ambient noise level monitoring at Rajapur station.
Picture taken on 11 July 2021.

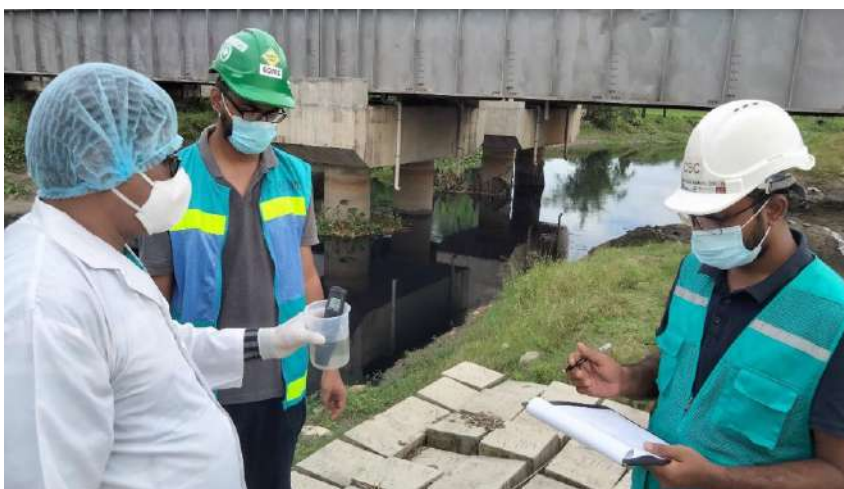
Plate 3. Surface water sample taken from Gunaiajuri station being tested for pH and TDS. Picture taken on 17 October 2021.

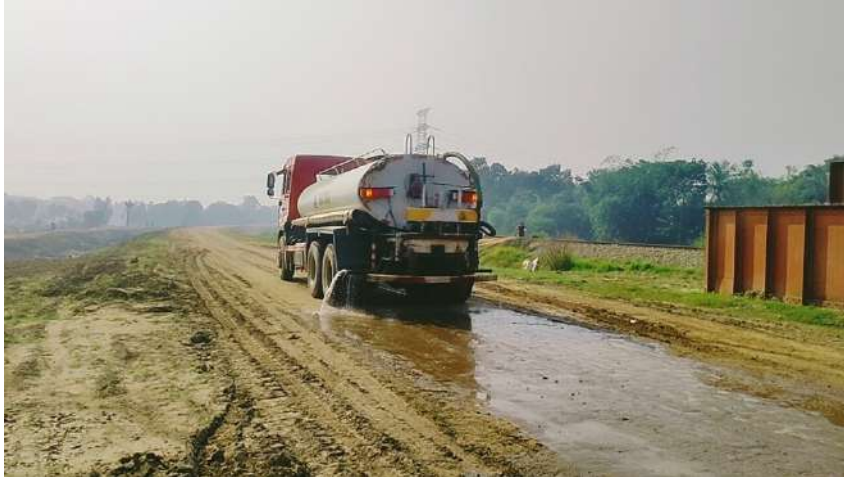
Plate 4. Photograph of watering of unpaved hauling road near Mandabag station. Picture taken on 17 November 2021.

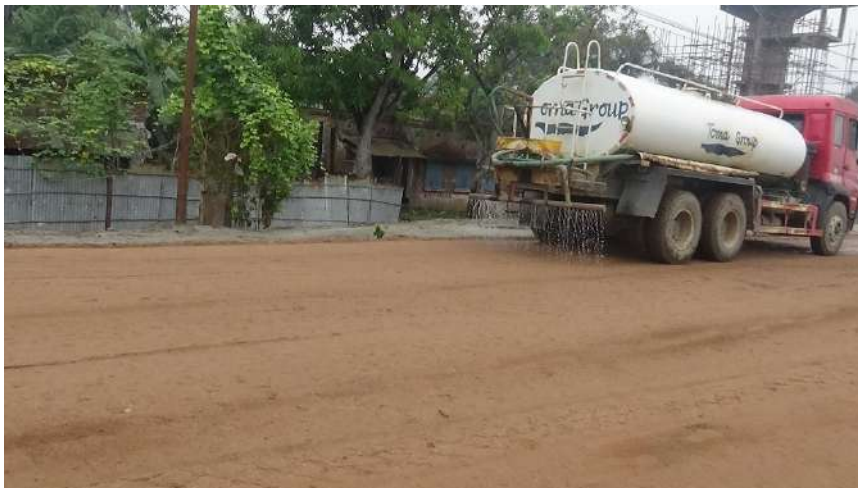
Plate 5. Photograph of watering of unpaved track embankments at Akhaura yard. Picture taken on 15 November 2021.

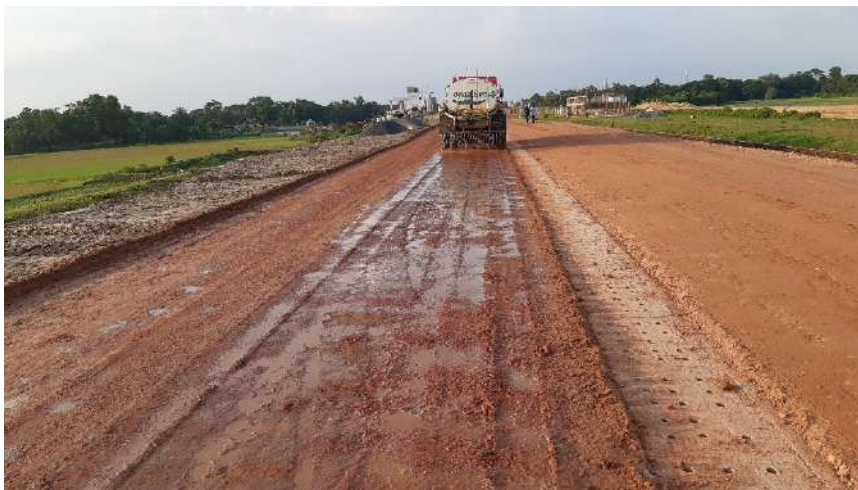
Plate 6. Photograph of watering of unpaved track embankment at the Gangasagar station yard. Picture taken on 9 September 2021.

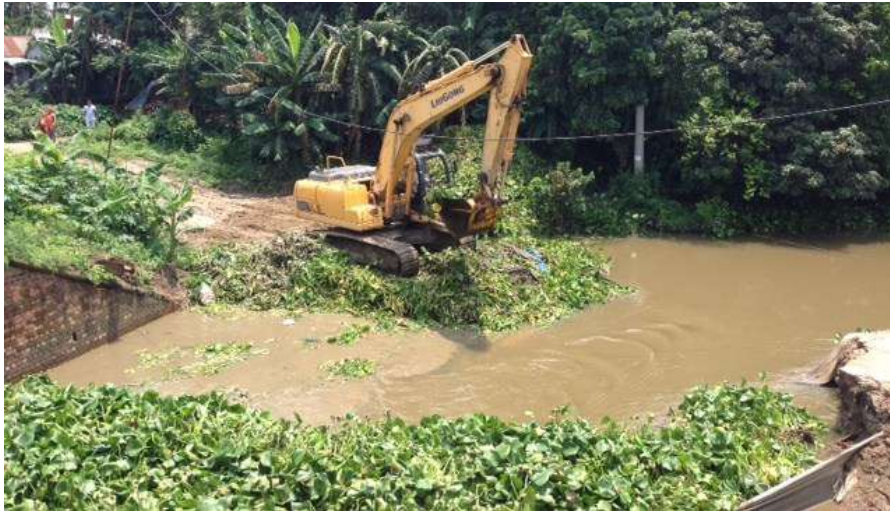
Plate 7. Photograph of clearing waterway of Bridge No. 1 at the Akhaura Station Yard. Picture taken on 8 July 2021.

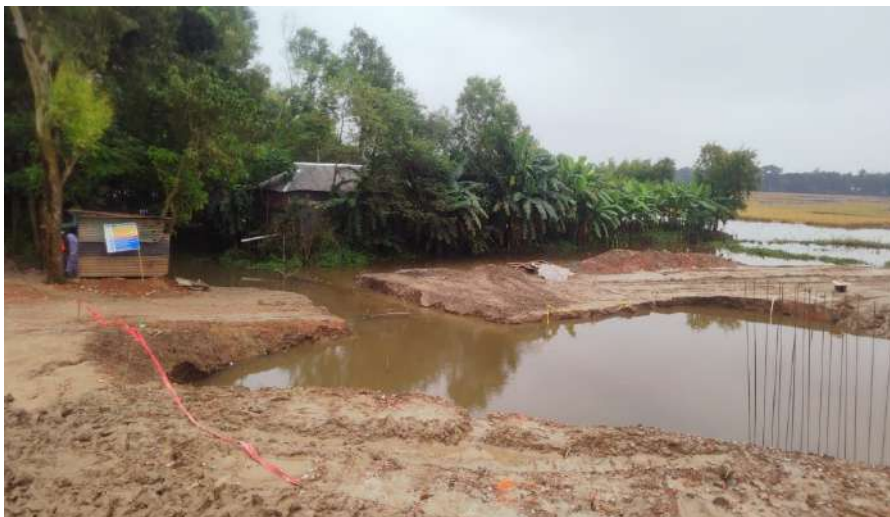
Plate 8. Photograph of clearing waterway as part of the construction of culvert No. 258. Picture taken on 22 December 2021.

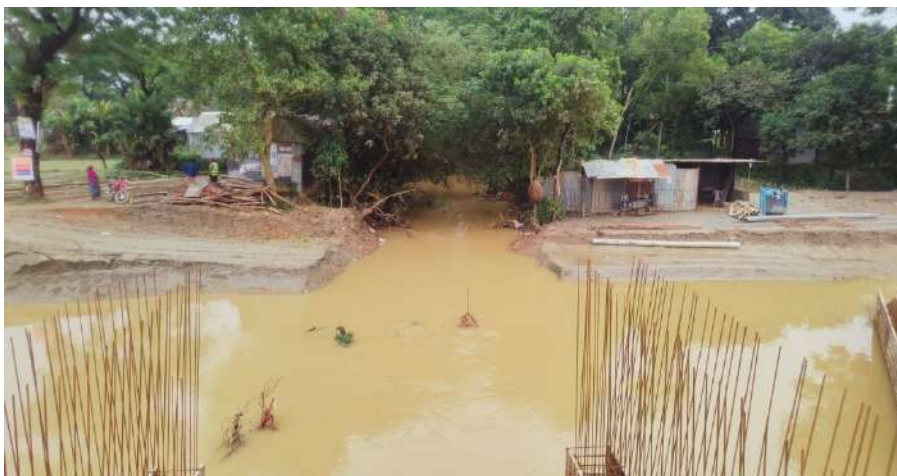
Plate 9. Photograph of clearing waterway as part of the construction of culvert No. 256. Picture taken on 8 December 2021.

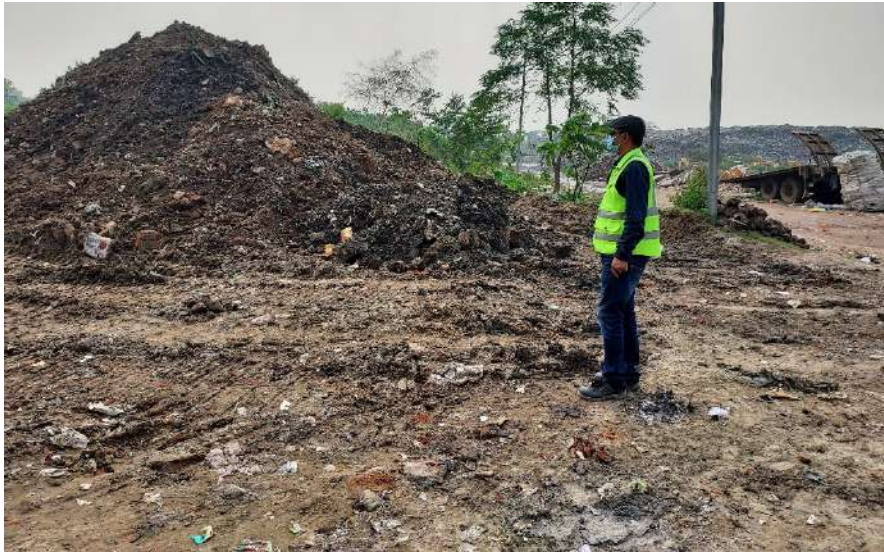
Plate 10. Photograph of unsuitable materials that were deposited at the Comilla City Corporation Dump site. Picture taken on 22 December 2021.

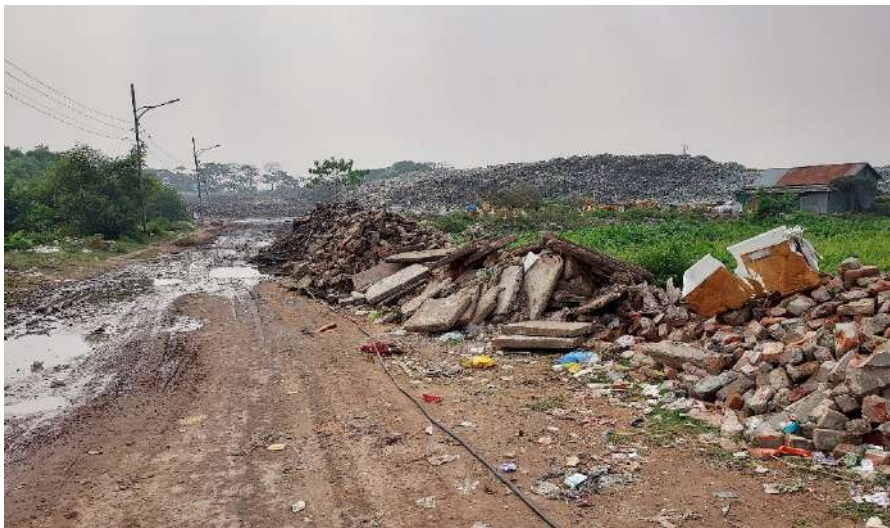
Plate 11. Photograph of construction solid waste that were deposited at the Comilla City Corporation Dump site. Picture taken on 22 December 2021.

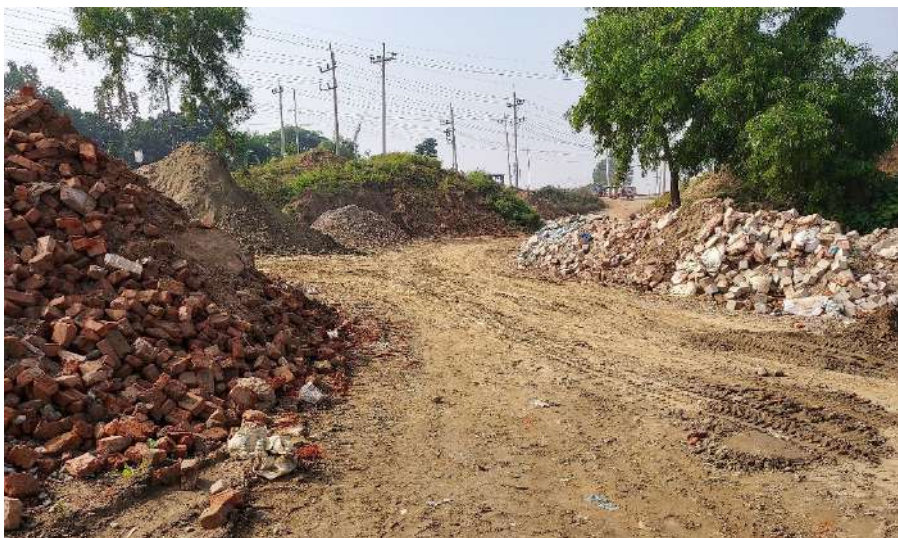
Plate 12. Photograph of solid waste from demolished structures that were temporarily placed beside the haul road, ready to be transported to the Comilla City Corporation Dump site. Picture taken on 20 December 2021.

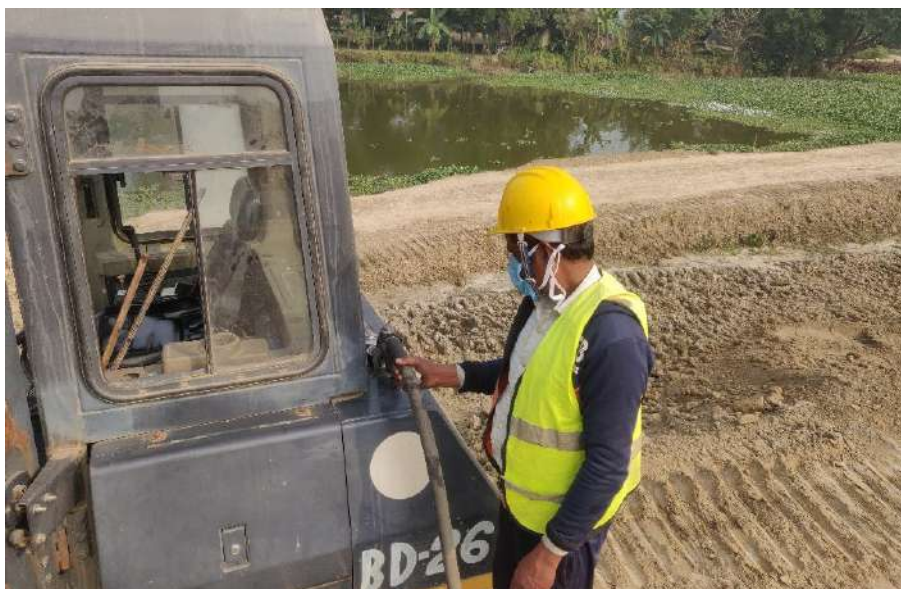
Plate 13. Photograph of a heavy equipment being filled at the construction site. Picture taken on 23 December 2021.

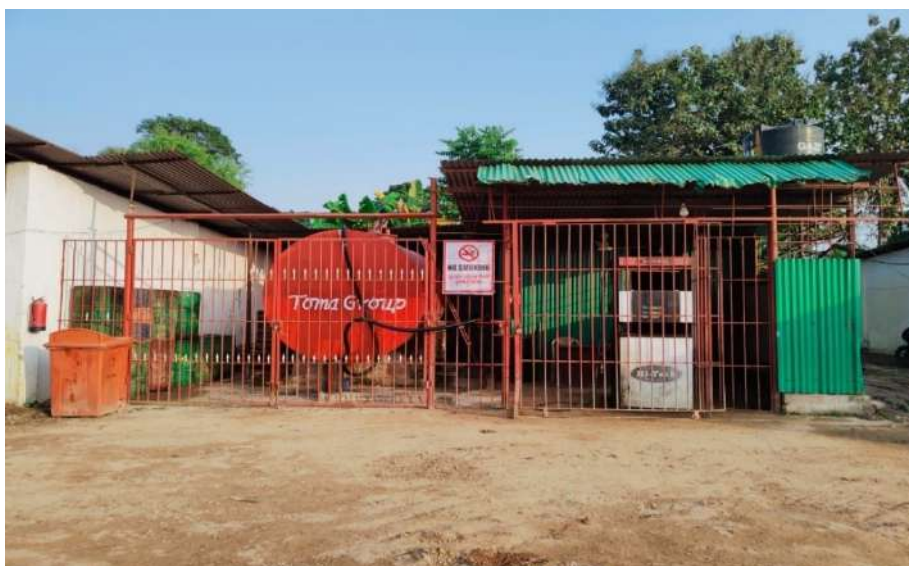
Plate 14. Photograph of the fuel filling station at the Gumti bridge Construction yard. Picture taken on 22 December 2021.

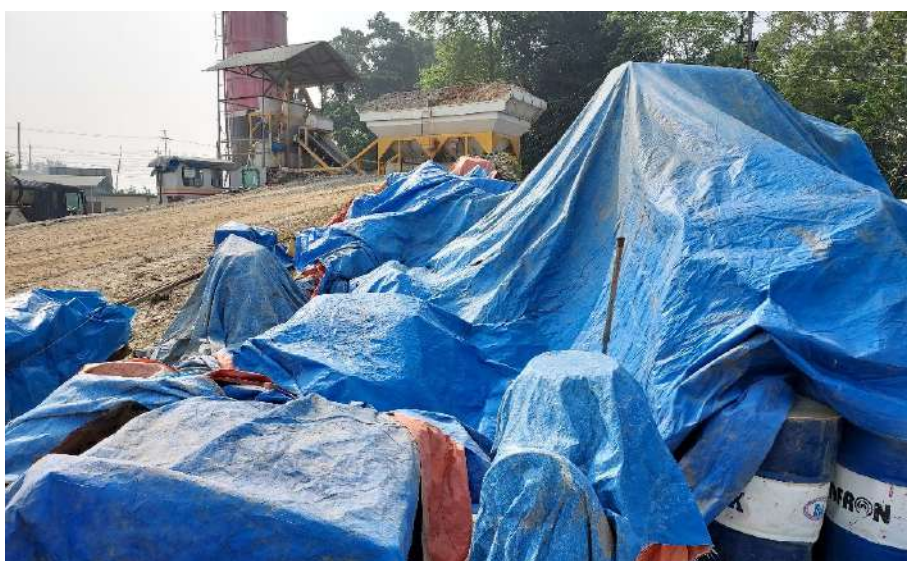
Plate 15. Photograph of the covered drums filled with waste oil awaiting disposal at the Gumti bridge Construction yard. Picture taken on 20 December 2021.

71. Waste oil and other petroleum products are collected by the Contractor, and temporarily stored in the used oil storage facilities at the above mentioned stations, to await their collection for proper treatment/disposal by a licensed contractor. The spent oil/lubricants are kept in steel drums, and stored in concrete floor with roofing. There were instances observed that spillages occur in the storage area maybe due to mishandling of the drums, and clean-up takes time to be completed. The Contractor spread sand over the concrete floored storage area, which they intend to absorb spilled waste oil. The contaminated sand will be collected and properly disposed of at the authorized local government disposal site. There are however some station where no proper storage area is available. The waste oil-filled drums are exposed to the elements, no concrete flooring and only protected with polyethylene cover from rain. To these sites, the attention of the Contractor had been called to transfer the drums to a compliant storage area, until these are collected by licensed contractors.

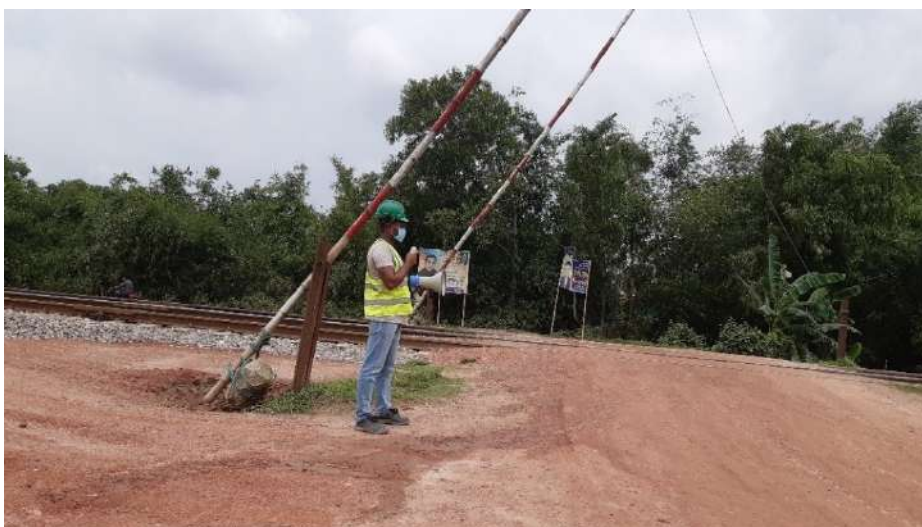
Plate 18. Gateman deployed at a temporary rail level crossing where active construction work is on-going, to regulate the movement of traffic Picture taken on 6 August 2021.

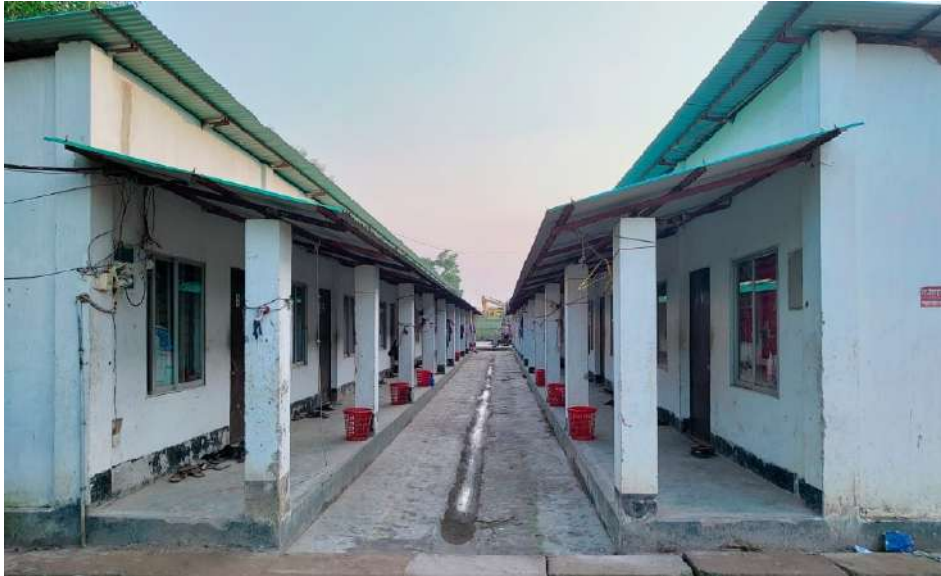
Plate 19. Maintenance of cleanliness at the worker's camps. Picture taken on 22 December 2021.

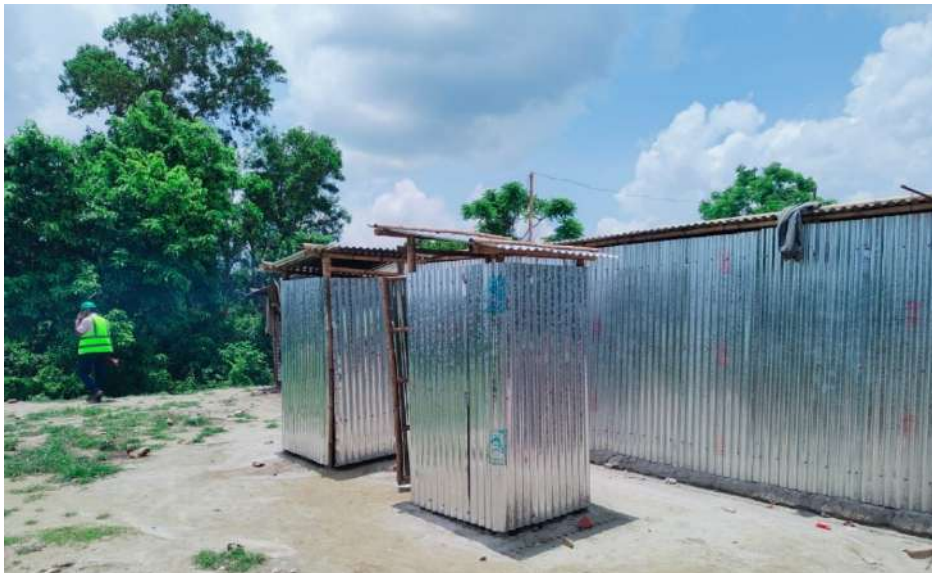
Plate 20. Toilets installed at the construction site. Picture taken on 08 August 2021.

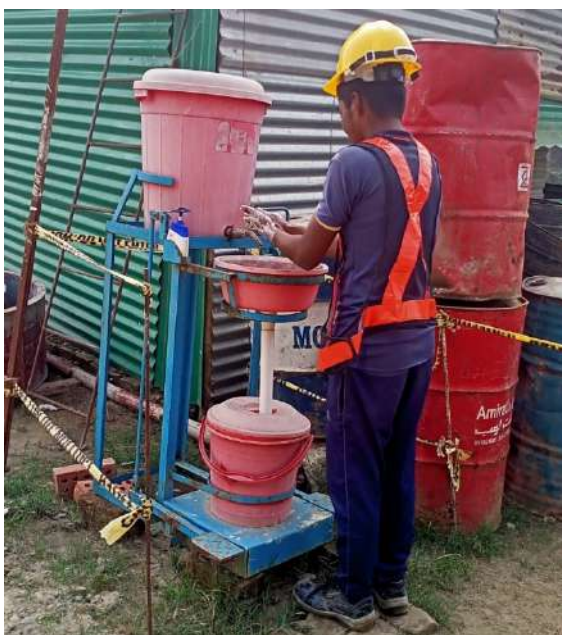
Plate 21. Hand washing station installed at the construction site. Picture taken on 21 December 2021.

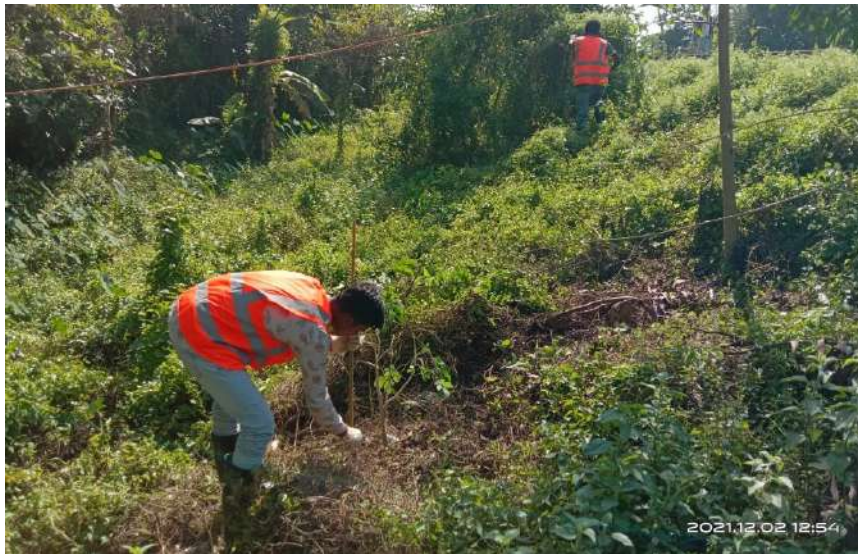
Plate 22. Ring weeding done at the plantation in chainage km138+000. Photograph taken on 02 December 2021.

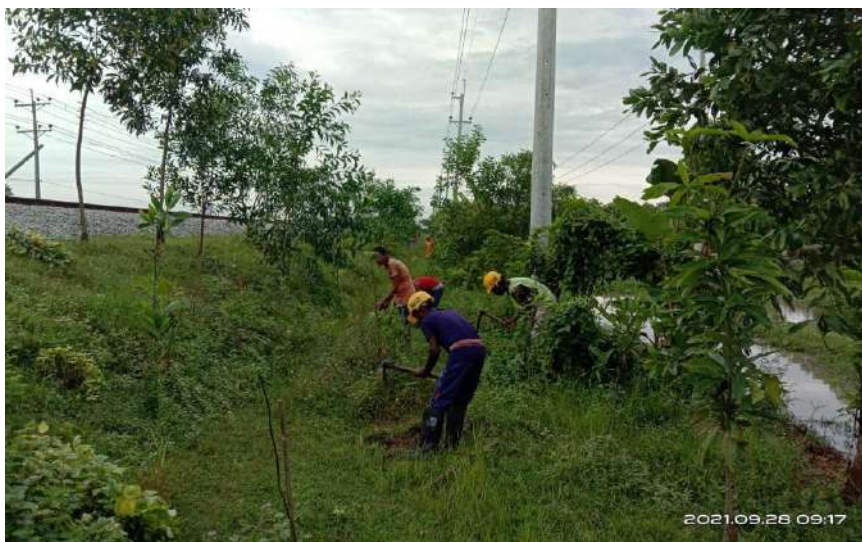
Plate 23. Ring weeding done at the plantation in chainage km134+000. Photograph taken on 28 September 2021.

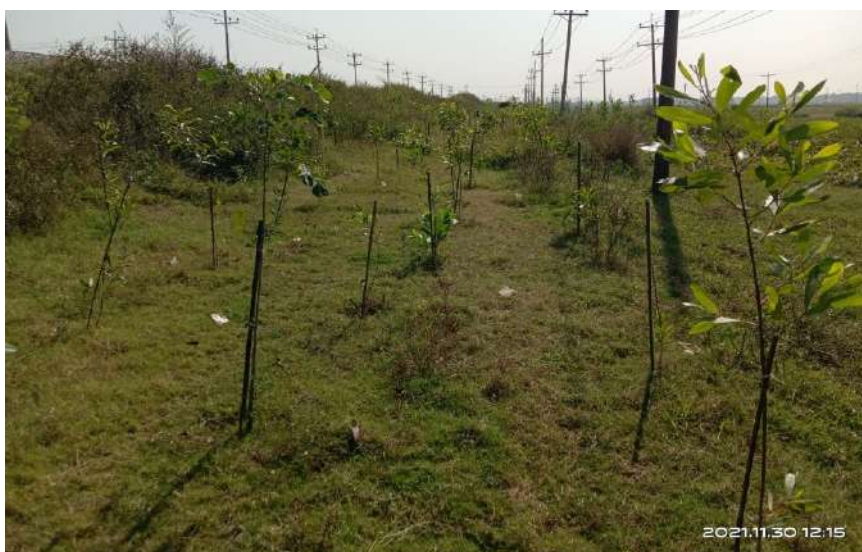
Plate 24. Tree plantation at chainage km146+000 that had already undergone maintenance work. Photograph taken on 30 November 2021.

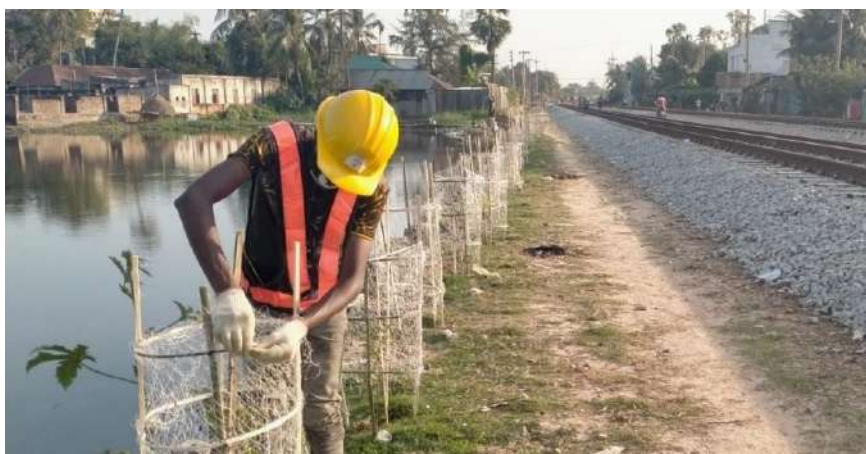
Plate 25. Individual fencing installed at planted saplings at chainage km151+000. Photograph taken on 06 December 2021.

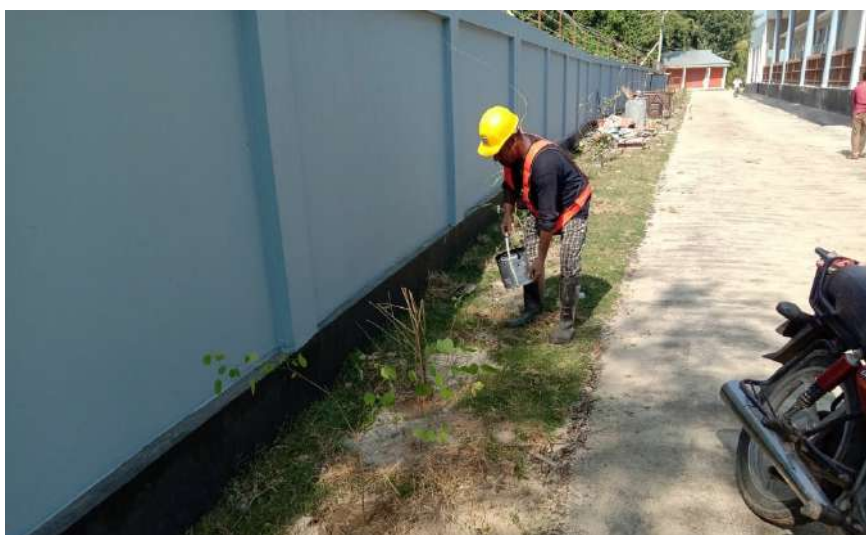
Plate 26. Worker watering a newly established plantation site at Alishahar station. Photograph taken on 6 December 2021.
