**URBAN SEISMIC VULNERABILITY IN BANGLADESH: AN  
ASSESSMENT OF RC BUILDINGS IN SYLHET CITY**

**BACHELOR OF SCIENCE IN CIVIL ENGINEERING**

A thesis submitted to the Department of Civil Engineering,  
Sylhet Engineering College, Sylhet, in partial fulfillment for the degree of  
BACHELOR OF SCIENCE IN CIVIL ENGINEERING

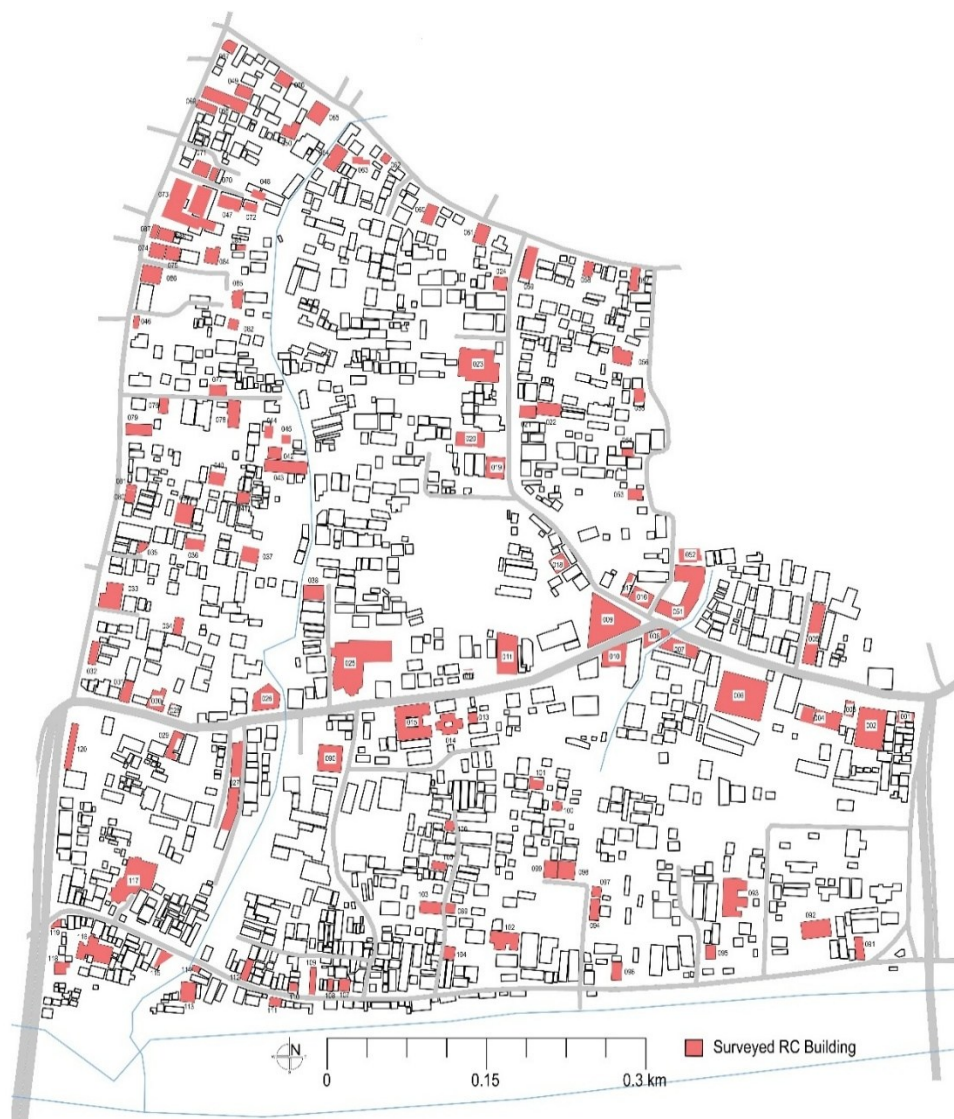
**Figure 4.1: Map showing the locations of all surveyed buildings in Ward 13, SCC**

Ward 13 of Sylhet City Corporation, selected for this study, is a densely developed urban area featuring diverse building uses and structural types. The ward includes both residential and mixed-use zones, with surveyed buildings strategically spread across different neighborhoods to reflect its spatial diversity. The topography is predominantly flat with some gentle slopes, influencing foundation choices. Most structures date from the 1980s to present, indicating a range of construction standards and code compliance. The building stock comprises mainly low- to mid-rise reinforced concrete (RC) buildings, generally two to six stories high, supporting a mix of residential, commercial, and institutional uses. The precise locations of all surveyed buildings in Ward 13 are presented in Figure 4.1.

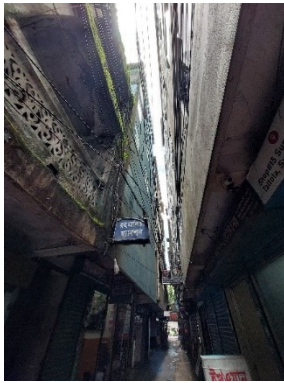
**Figure 6.1: Pounding effect.**

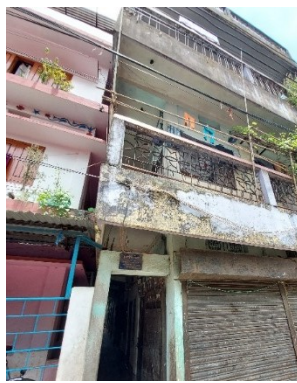
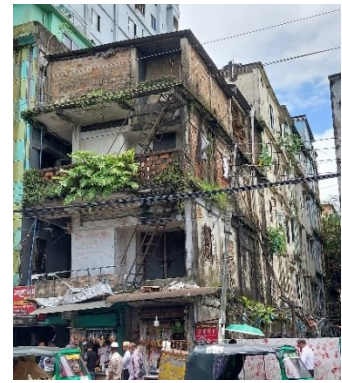
**Figure 6.2: Apparent quality (Poor).**

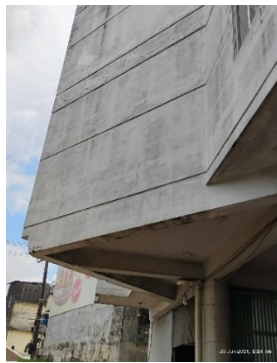
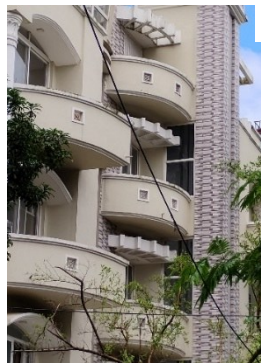
**Figure 6.4: Heavy overhang.**

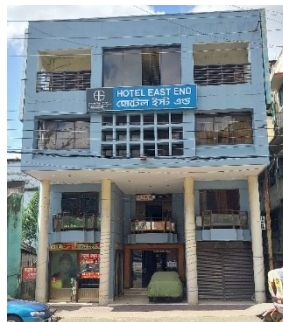
**Figure 6.5: Irregularity in height**

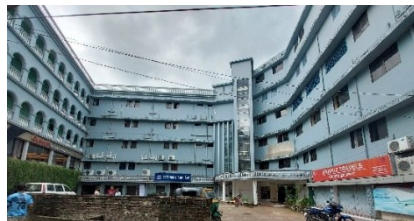
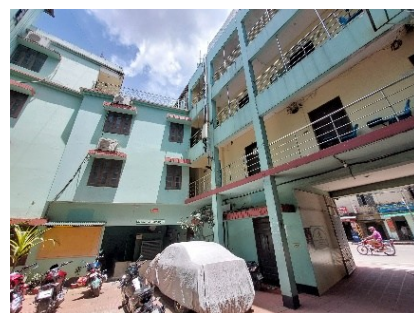
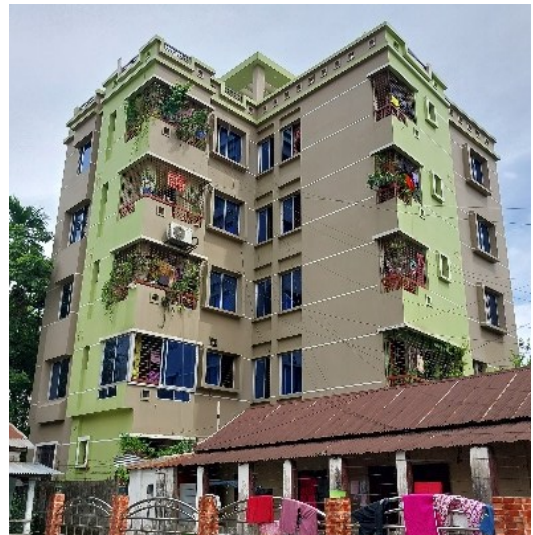
**Figure 6.3: Irregularity in plan.**

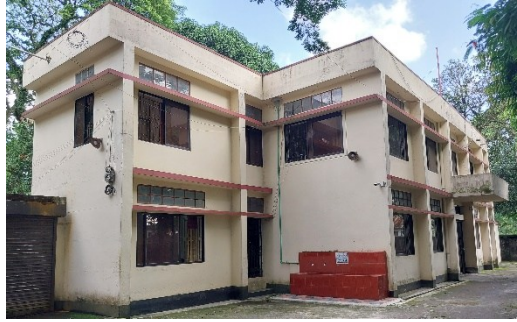
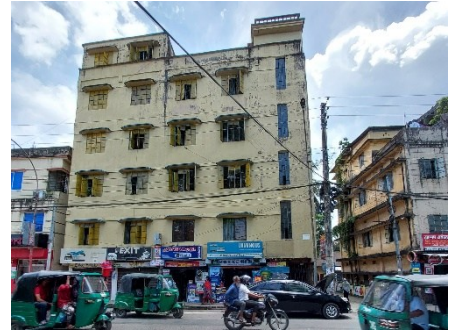
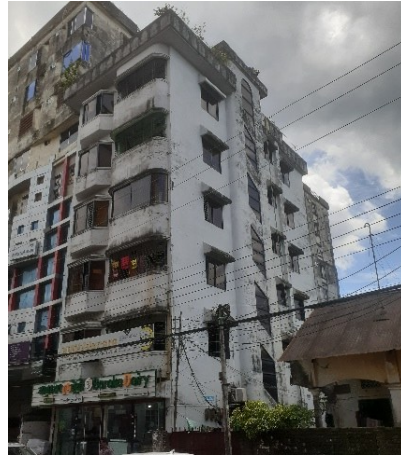
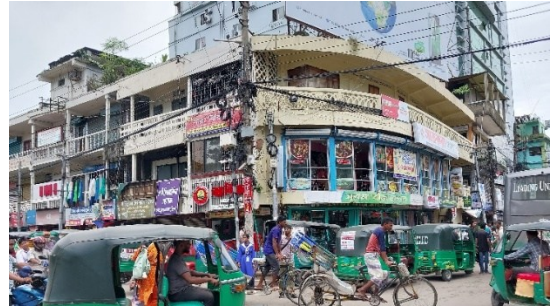
**Figure 6.6: Buildings in different position.**
