REPORT ON
DETAILED
ROAD SAFETY AUDIT
OF FIVE ROAD SECTIONS
(500 KM)

ROAD SAFETY AUDIT REPORT FY 2017-2018

Road Design & Safety Circle
Roads & Highways Department
Government of the People's Republic of Bangladesh
SARM Associates and HeptaTech Limited JV

Detailed Road Safety Audit of Road Sections of Joydebpur – Mymensingh (N3), Kanchpur- Daudkandi (N1) and Chattogram – Cox's Bazar (N1), Kashinathpur – Rajshahi (N6) and Dhaka – Aricha (N5) (Total 500 km) National Highway During FY 2017 -2018

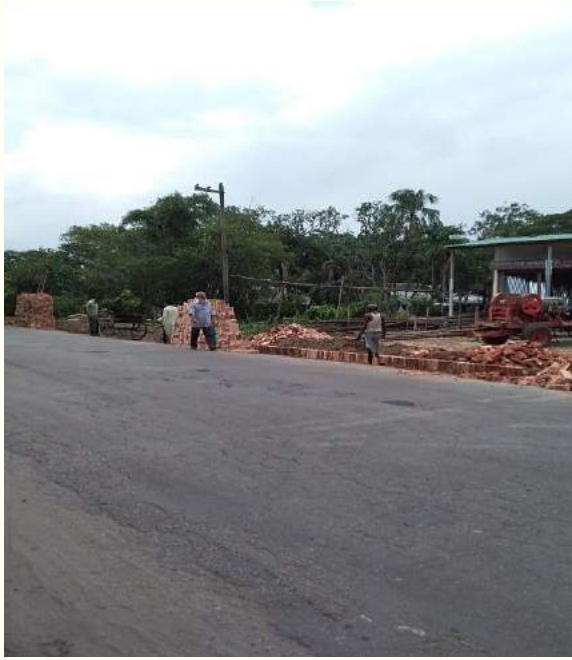
Illegal roadside activity within Ch.+ 252.5 to Ch.+255

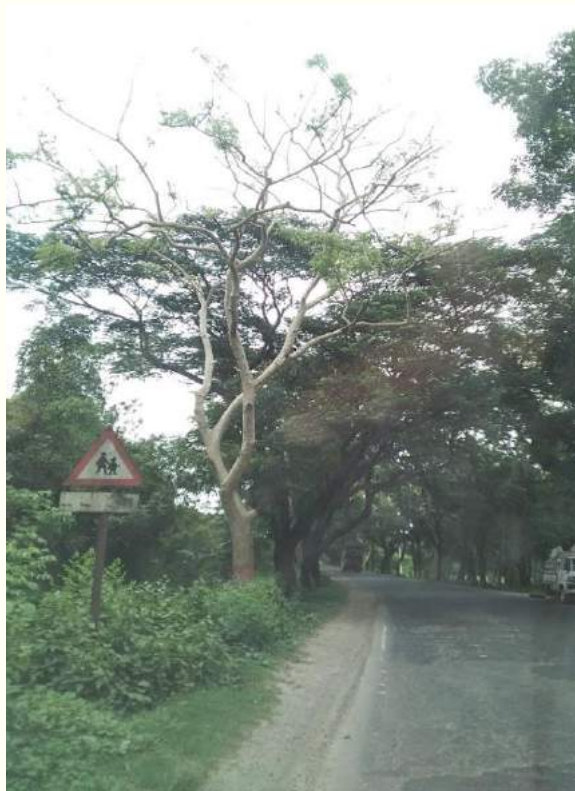
Road sign within Ch.+255 to Ch.+257 is not clear

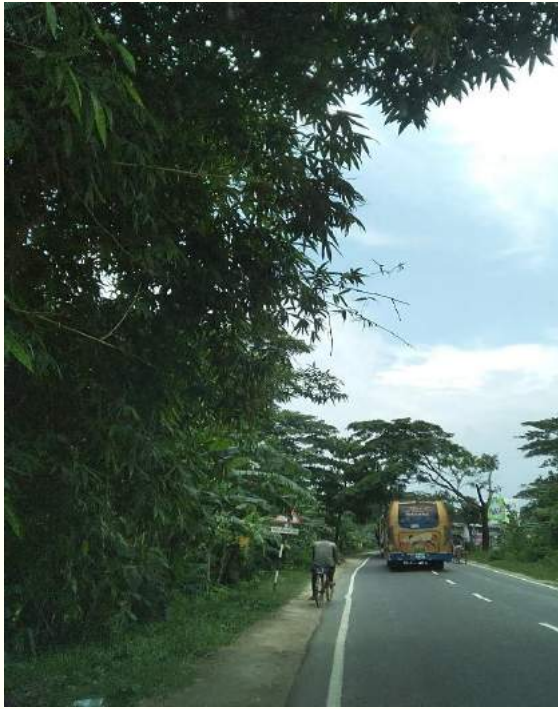
Poor visibility of road sign within Ch.+257 to Ch.+259

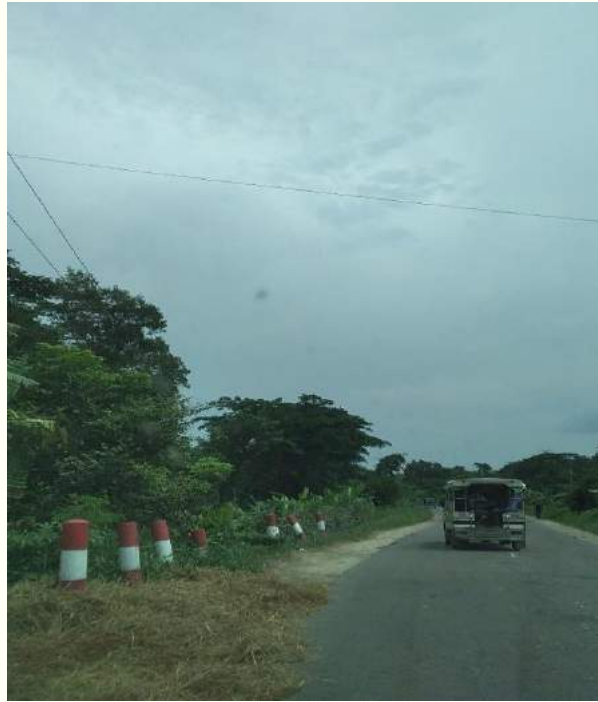
Unauthorized roadside activity within Ch.+ 259 to Ch.+261

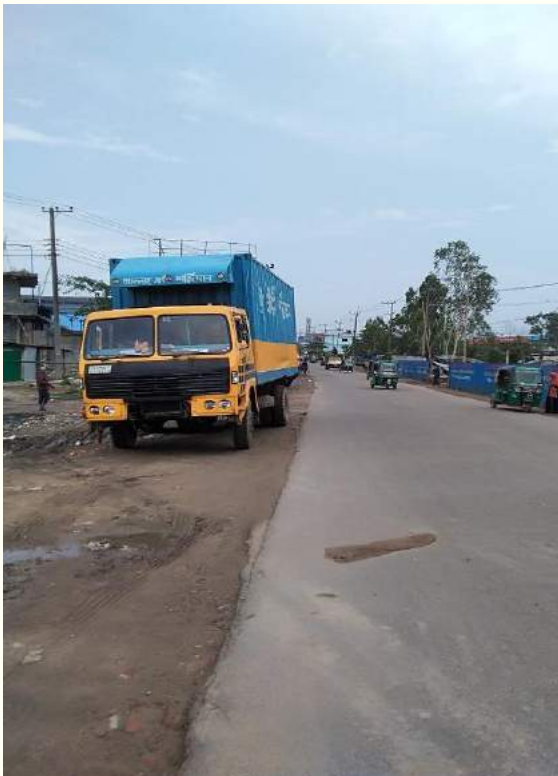
Unauthorized risky parking and shoulder drop within Ch.+ 261 to Ch.+263

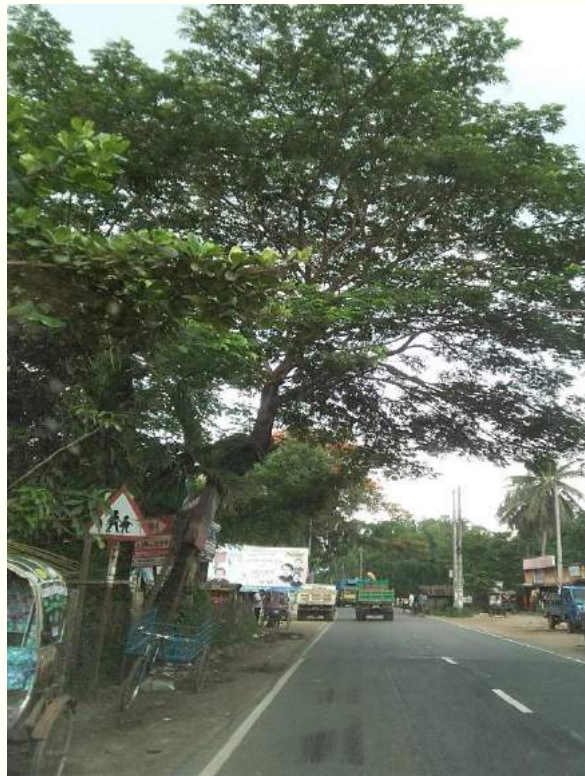
Disturbed road sign at Ch.+ 265 to Ch.+267

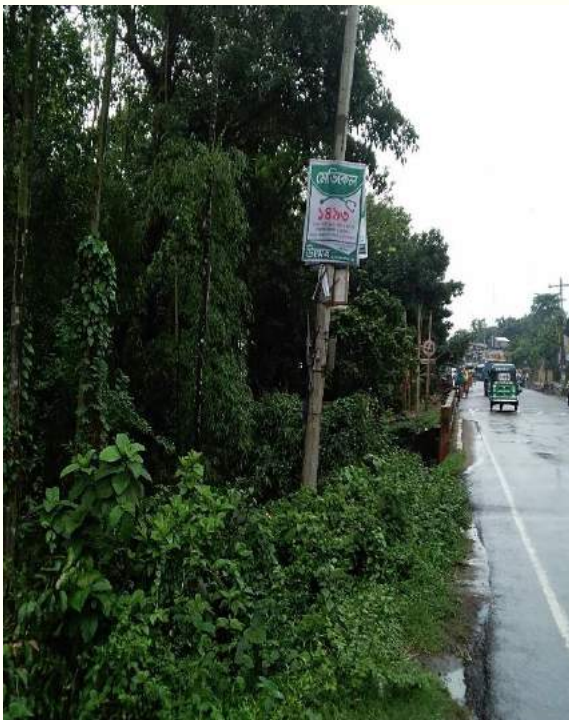
Roadside bushes occupying earthen shoulder at Ch.+ 272 to Ch.+274

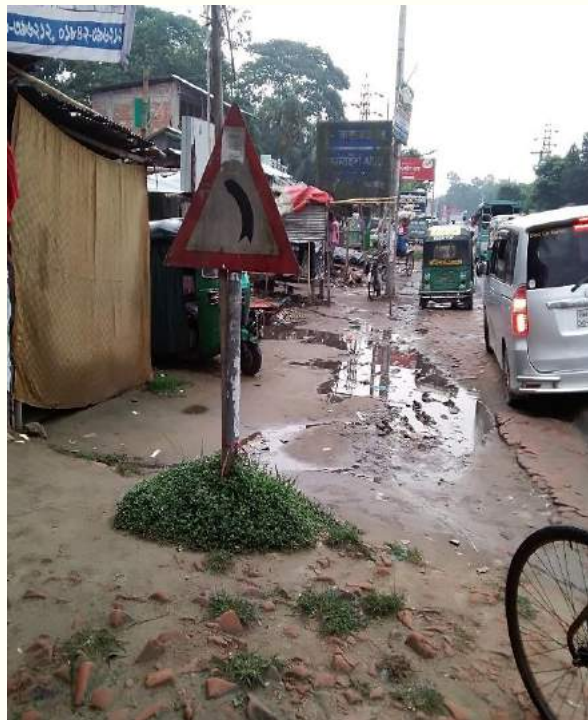
Unknown road sign at Ch.+274.5 to Ch.+276.5

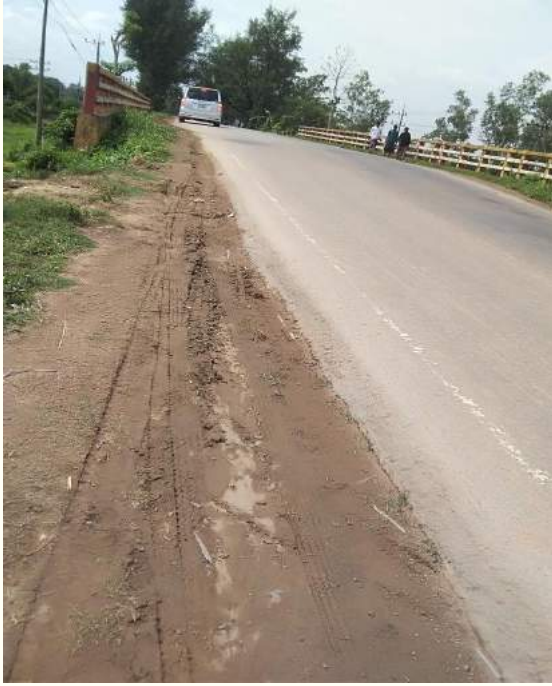
No warning sign and marking across the bridge within.Ch.+287 to Ch.+289

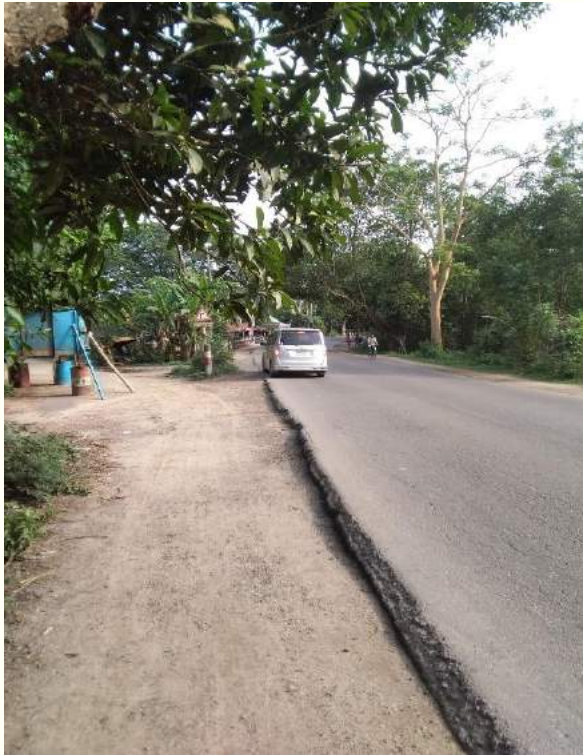
Risky shoulder drop at Ch.+299 to Ch.+301

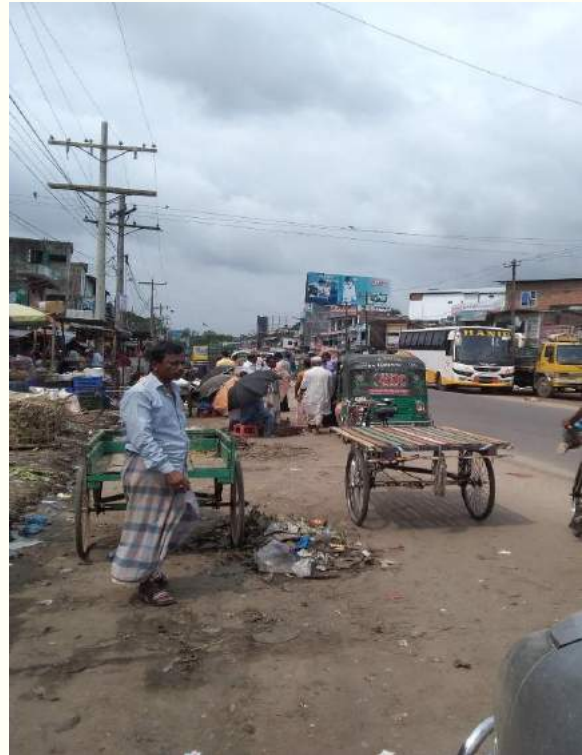
Unauthorized roadside business within Ch.+ 301 to Ch.+303

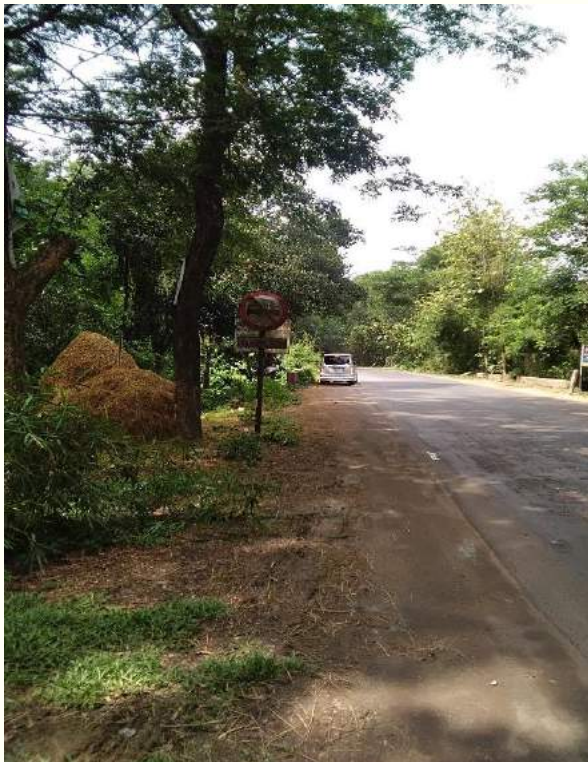
Less visible road sign at Ch.+311 to Ch.+313

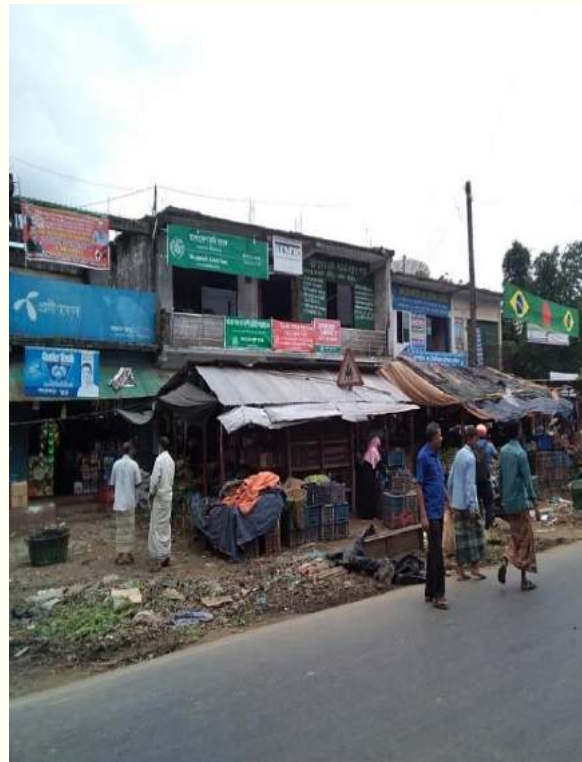
Roadside business in shoulder within Ch.+321 to Ch.+323

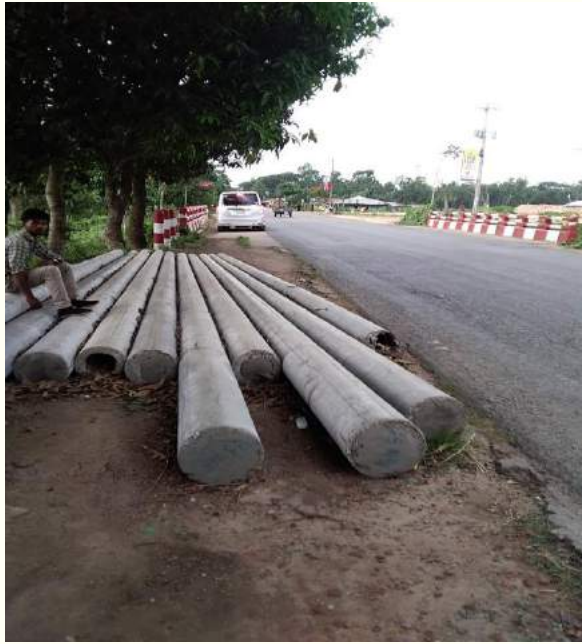
Risky concrete pole on shoulder within Ch.+323 to Ch.+325

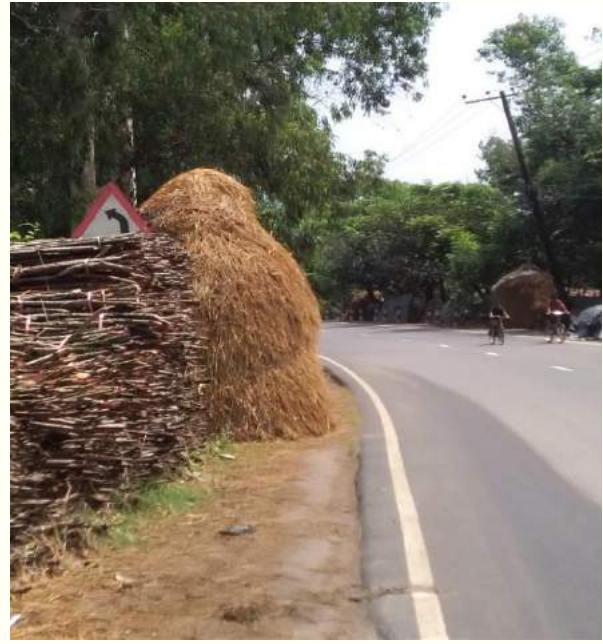
Sign covered by roadside business , creating serious obstruction within Ch.+329 to Ch.+331

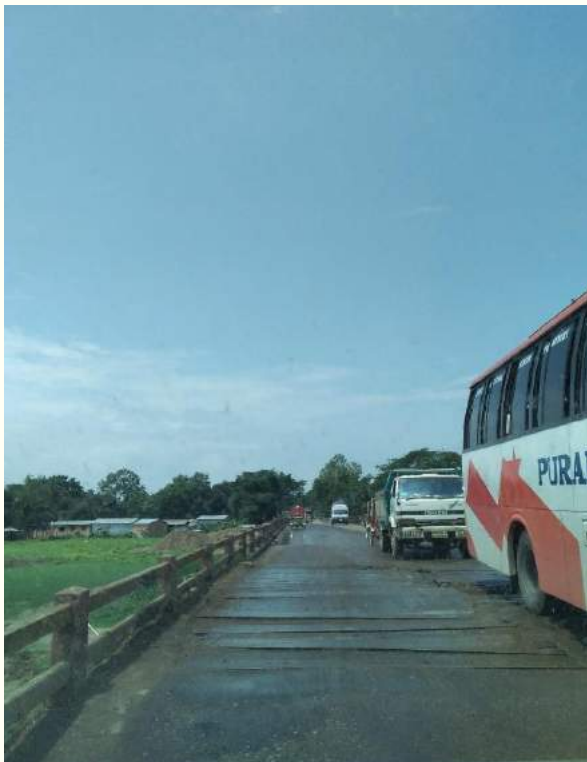
Bridge having no footpath and delineation at Ch.+ 331 to Ch.+333

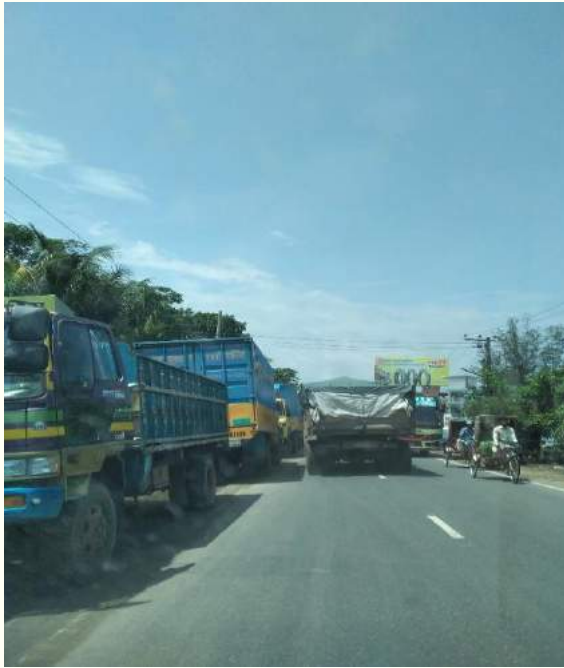
Illegal truck parking within Ch.+331 to Ch.+333

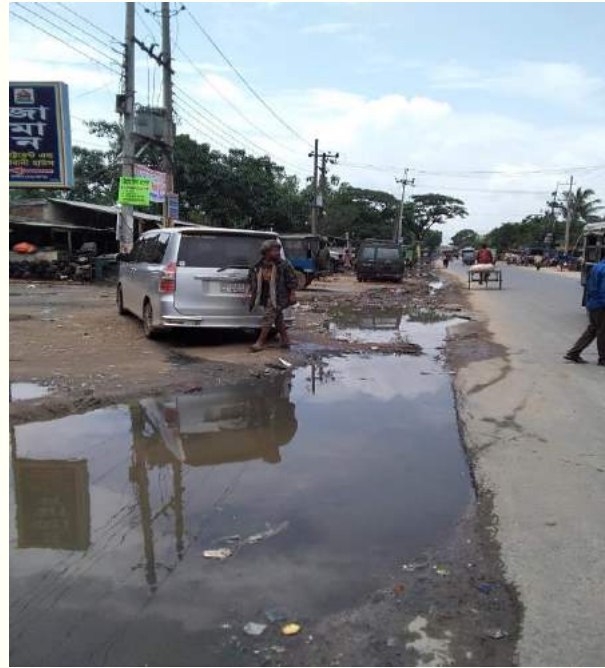
Water logging at Ch.+ 331 to Ch.+333

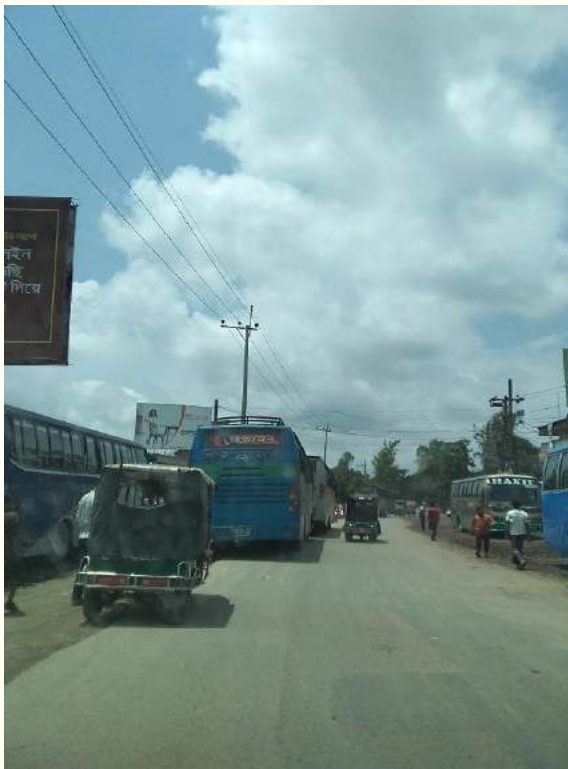
Bus parking within Ch.+333 to Ch.+335 in an illegal manner

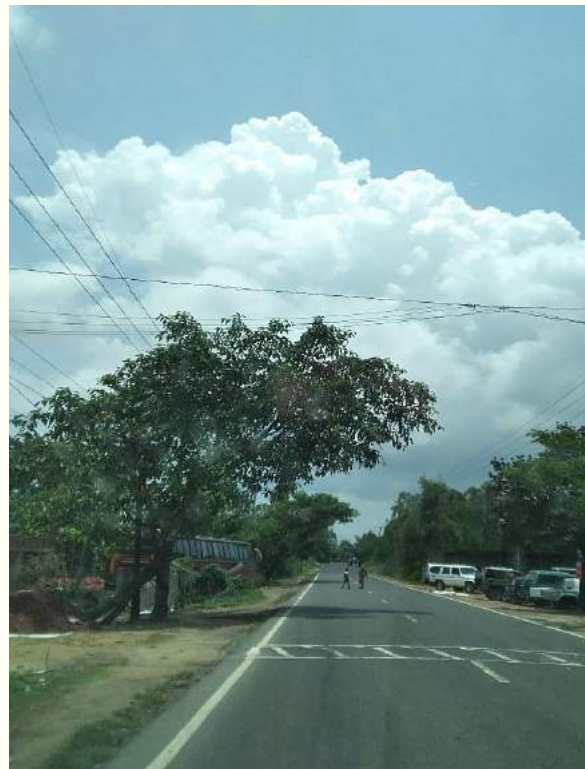
Below standard zebra crossing without speed calming arrangement within Ch.+ 335 to Ch.+337

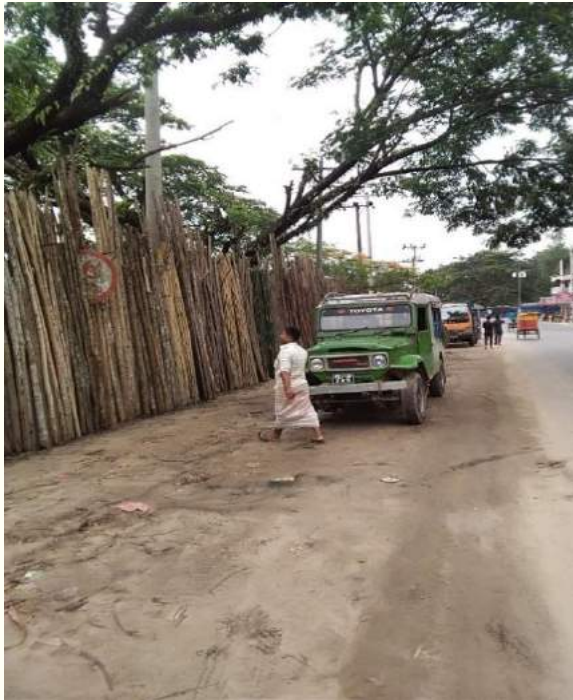
Blockage in the road side area by unauthorized business within Ch.+ 343 to Ch.+345

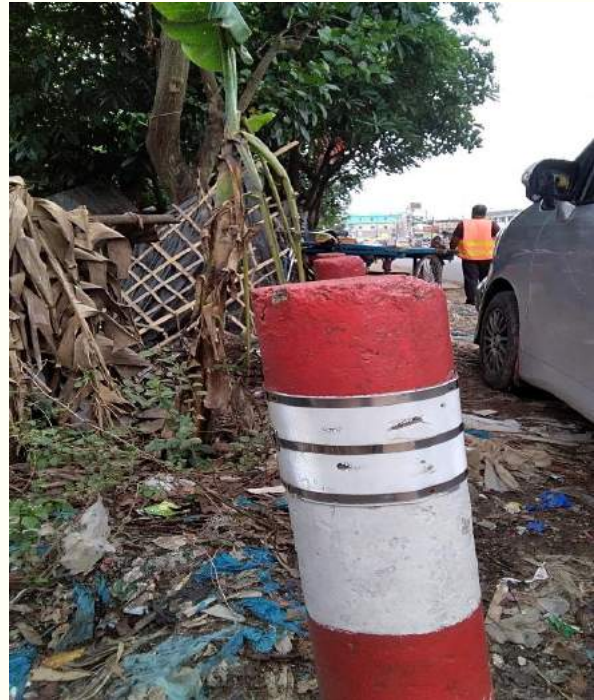
Disturbed concrete pole at Ch.+ 355 to Ch.+357

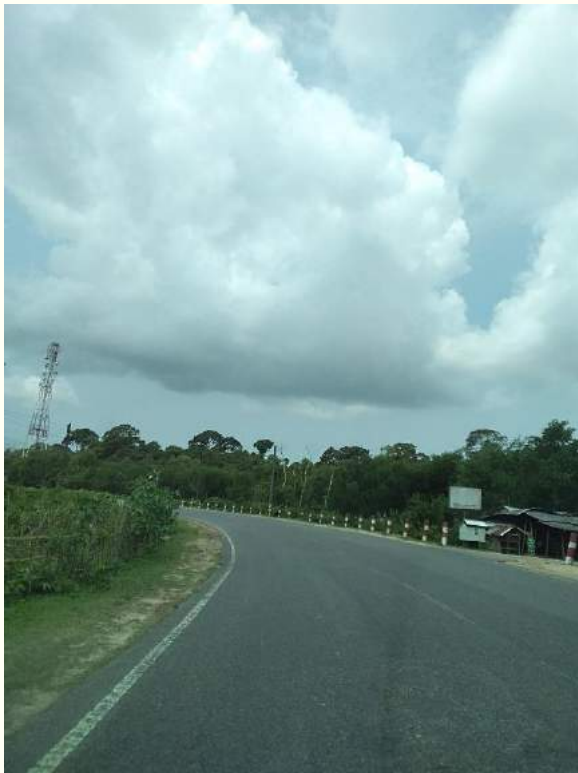
Curve section without chevron sign at Ch.+369 to Ch.+371

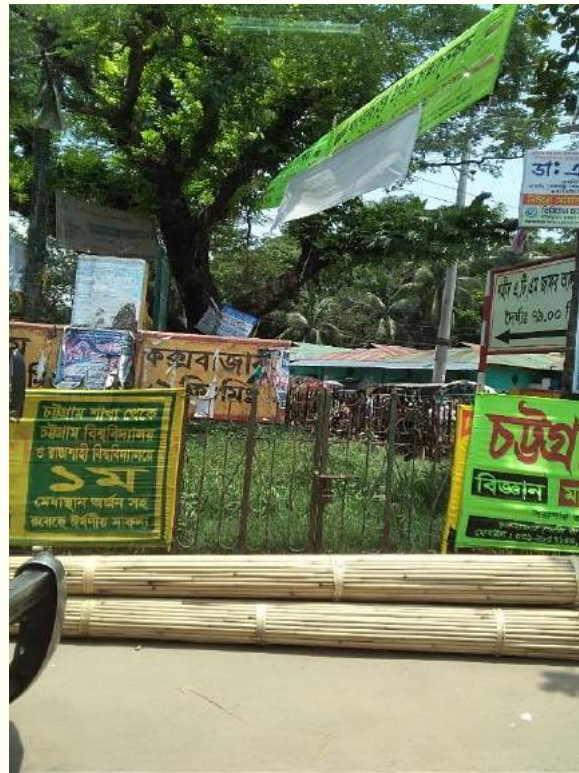
Number of banners in roadside area creating visibility obstruction within Ch.+ 381 to Ch.+383

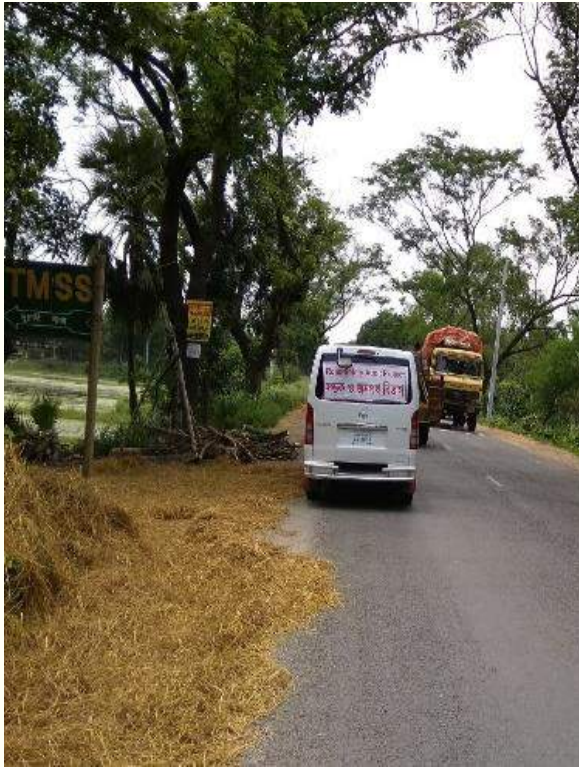
Unauthorized roadside activity within Ch.+8 to Ch.+10

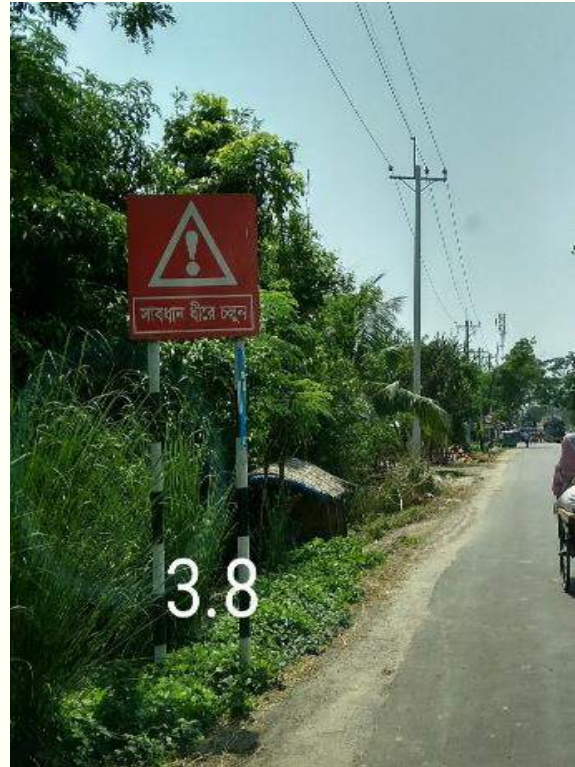
Warning sign post in shoulder within Ch.+10 to Ch.+12

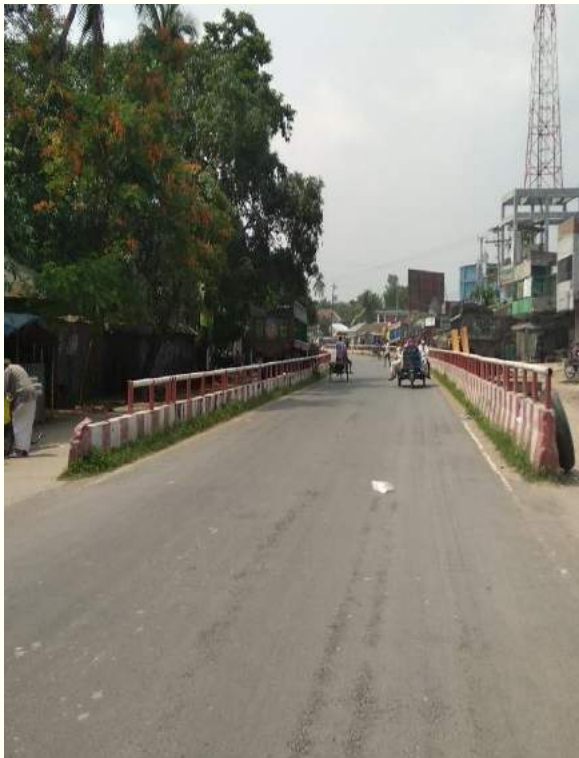
No marking and sign at barrier within Ch.16 to Ch.+18

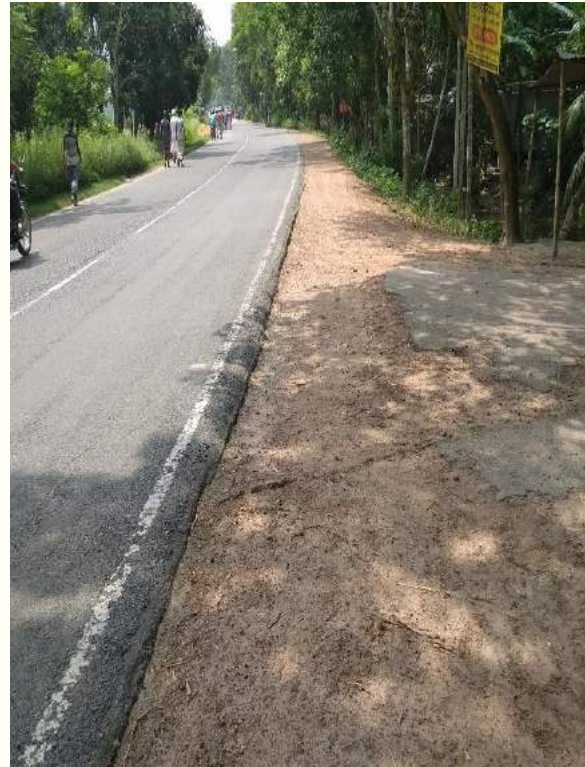
Lack of shoulder forcing pedestrian to walk on carriageway within Ch.+18 to Ch.+20

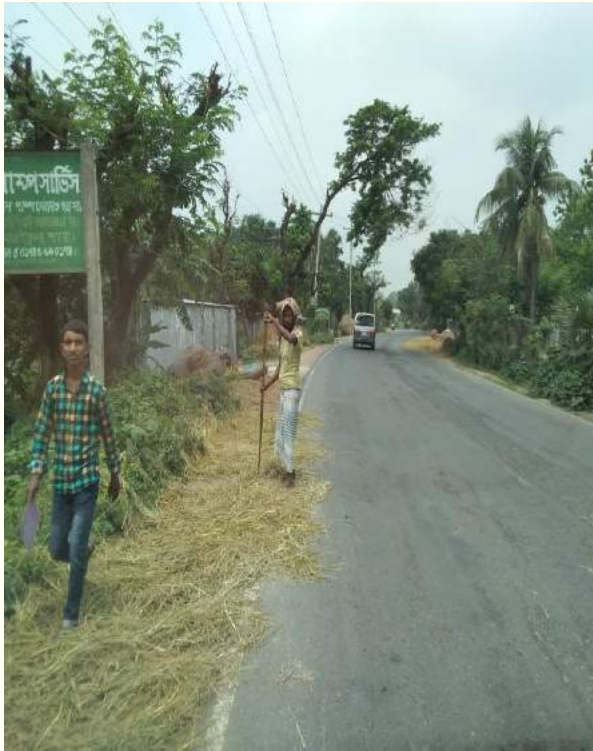
Illegal roadside activity within Ch.+ 22 to Ch.+24

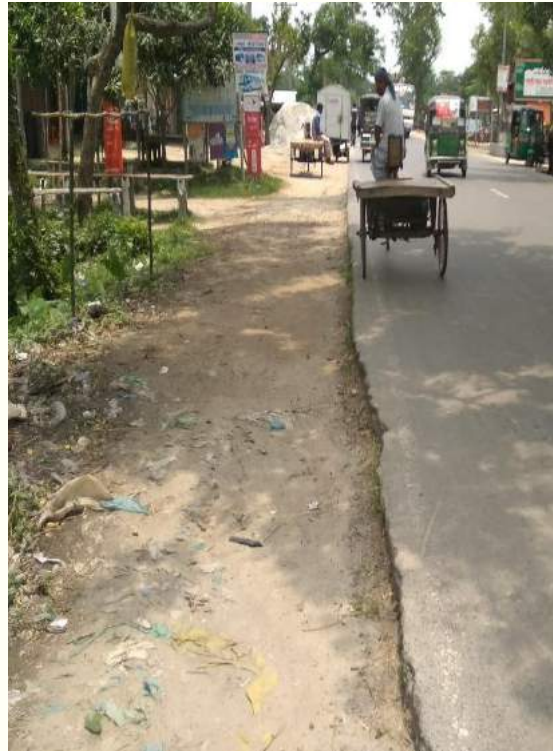
Risky shoulder drop within Ch.+26 to Ch.+28

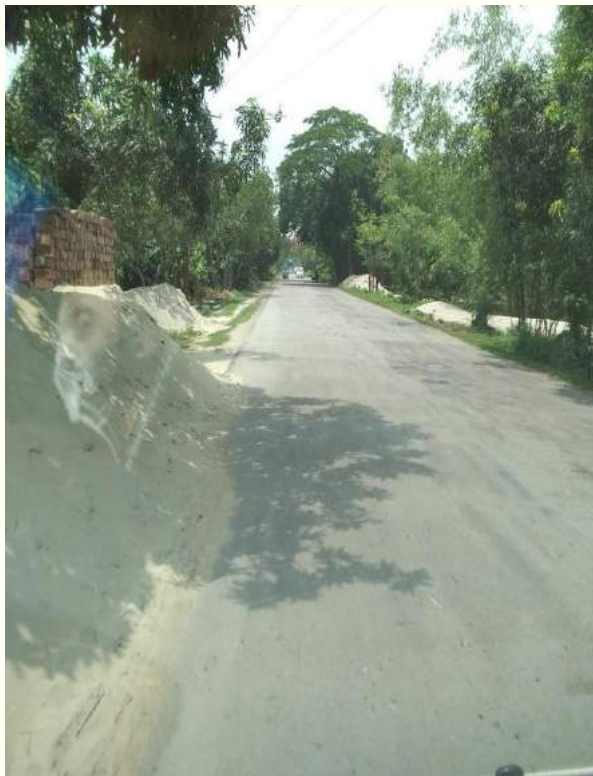
Construction materials over carriageway are kept illegally within within Ch.+28 to Ch.+30

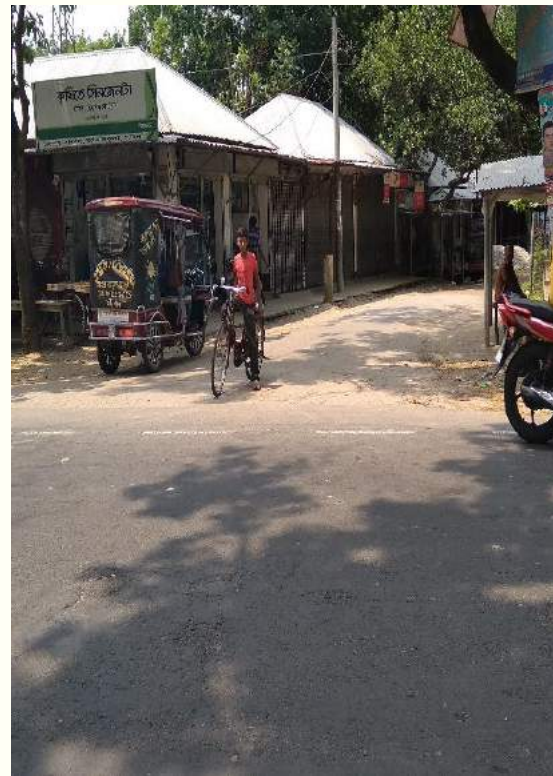
Side road without proper treatment within Ch.+ 30 to Ch.+32

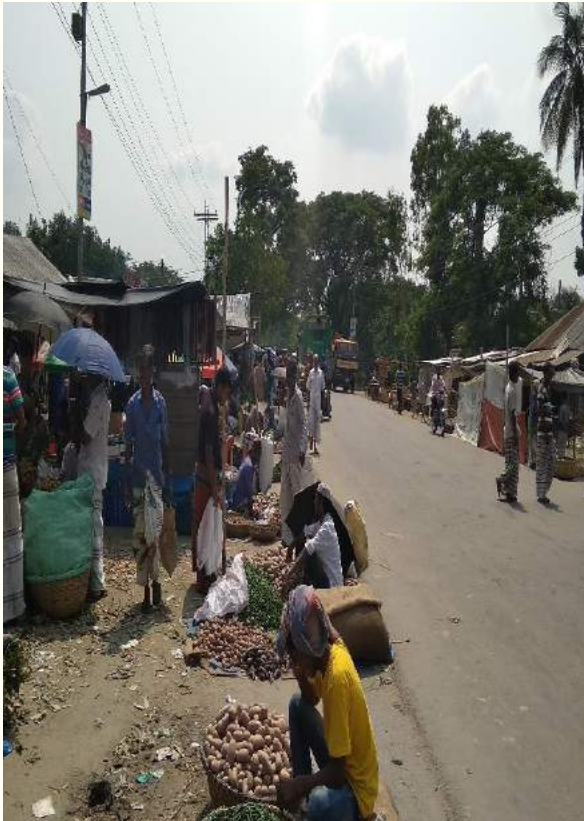
Unauthorized roadside business within Ch.+ 32 to Ch.+34

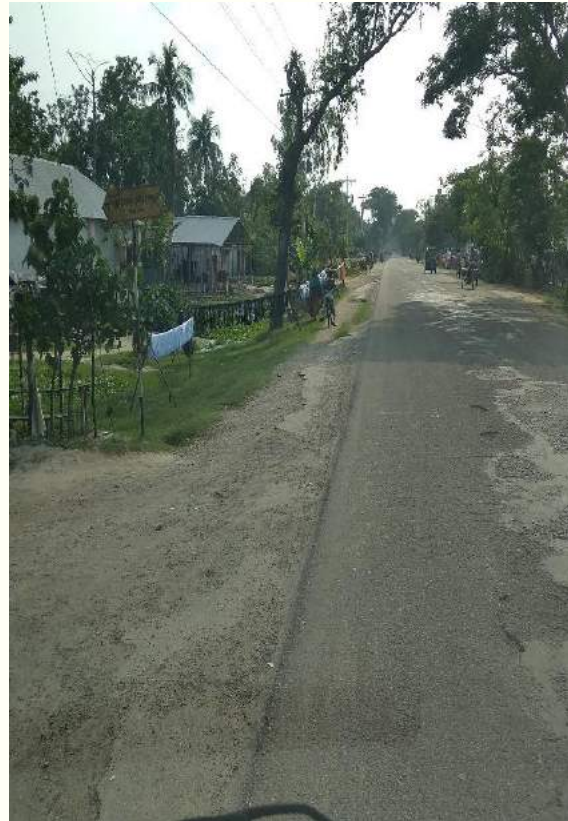
Poor pavement and shoulder within Ch.+36 to Ch.+38

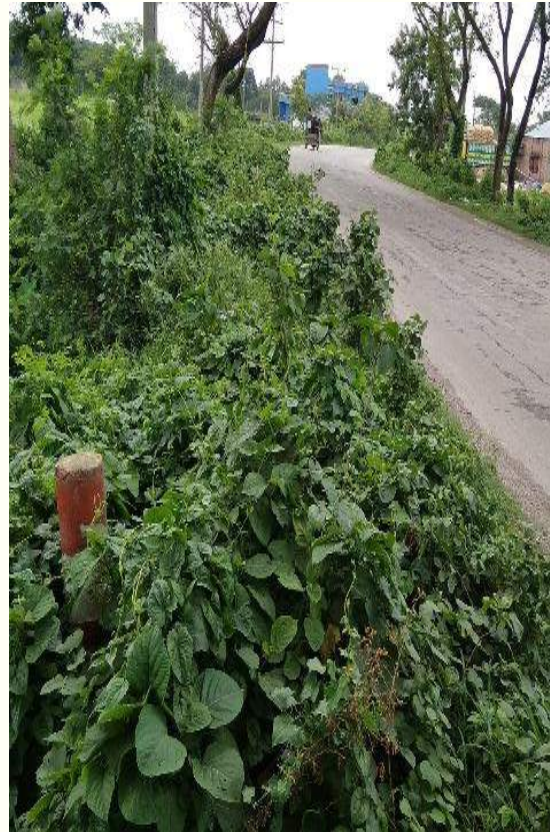
Roadside bushes within Ch.+58 to Ch.+60

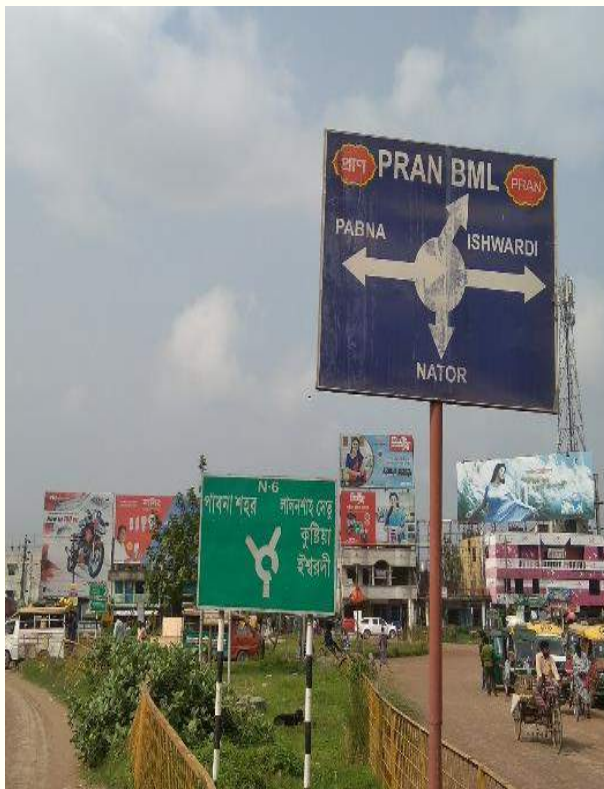
Confusing sign within Ch.+ 60 to Ch.+62

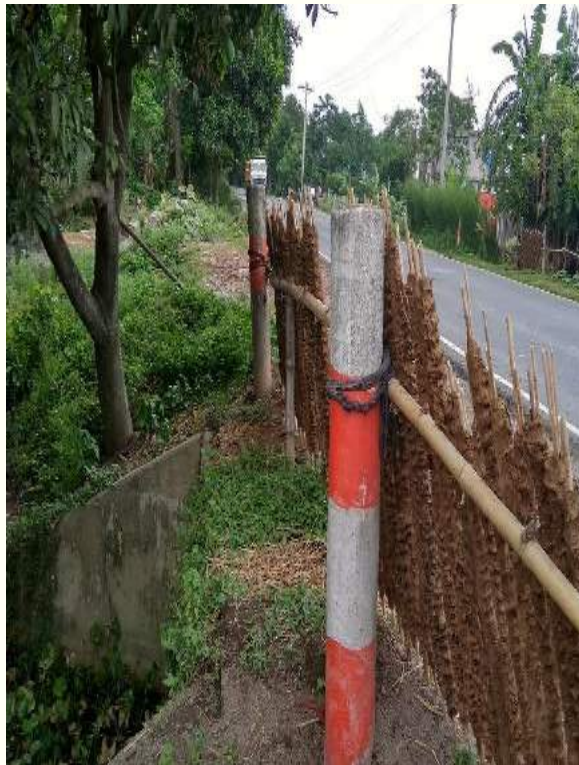
Unauthorized road side activities within Ch.+72 to Ch.+74

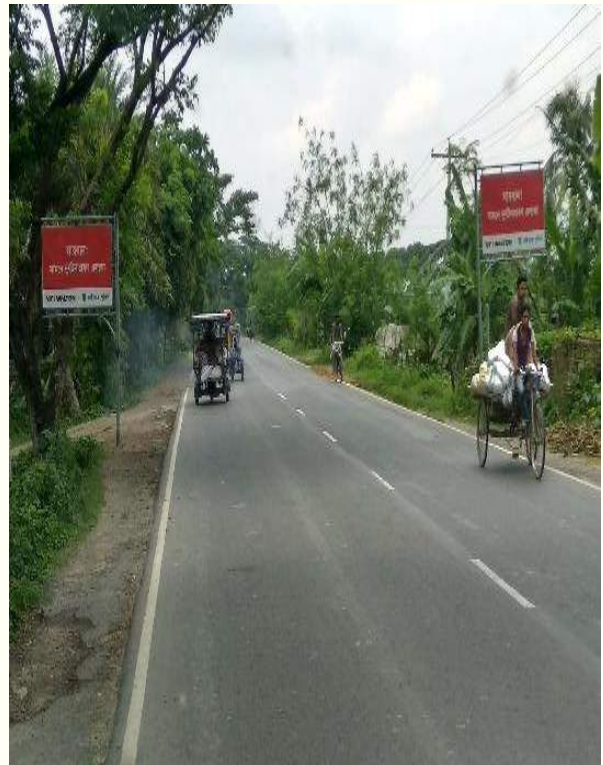
Risky, unknown sign post within clear zone within Ch.+ 72 to Ch.+74

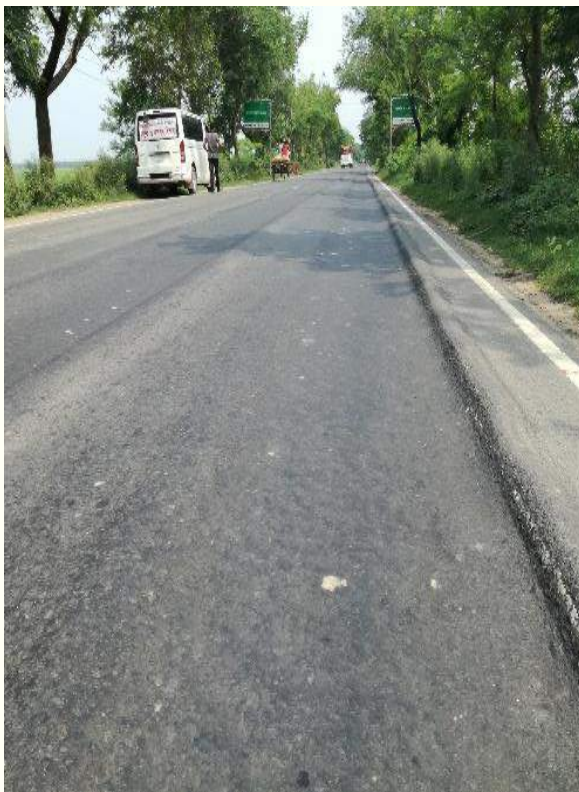
Distressed pavement within Ch.+74 to Ch.+76

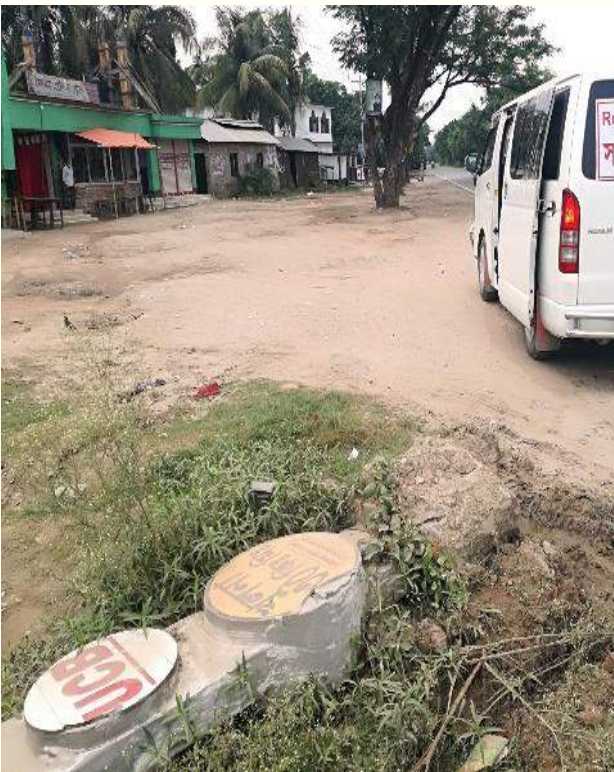
Unknown and disturbed km sign post within Ch.+84 to Ch.+86

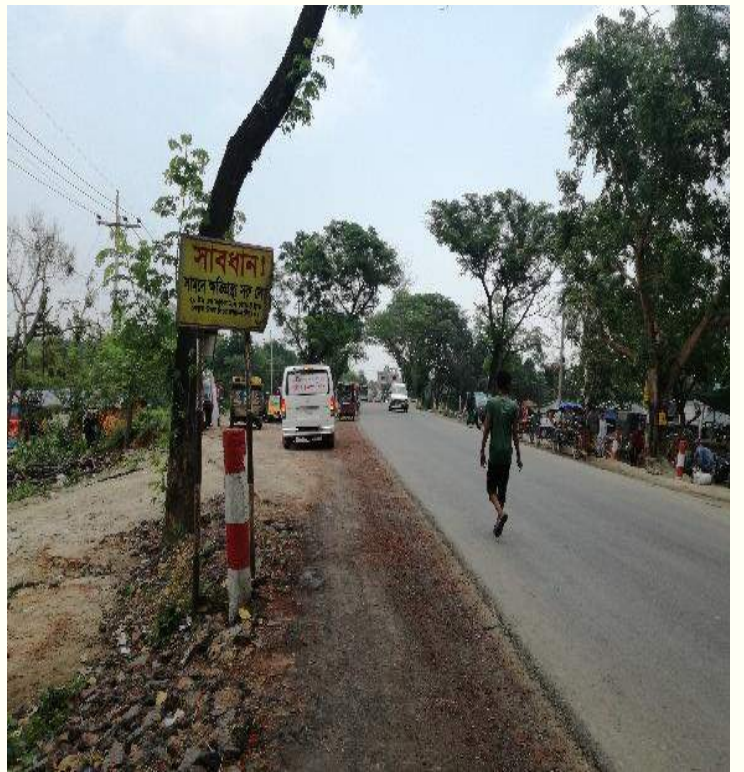
Disturbed sign within Ch.+96 to cjh.+98

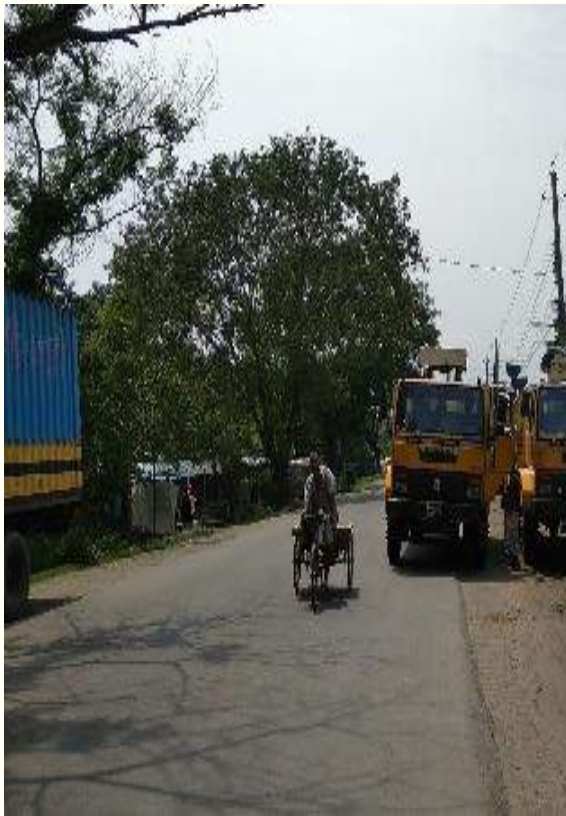
Unauthorized parking within Ch.+ 98 to Ch.+100

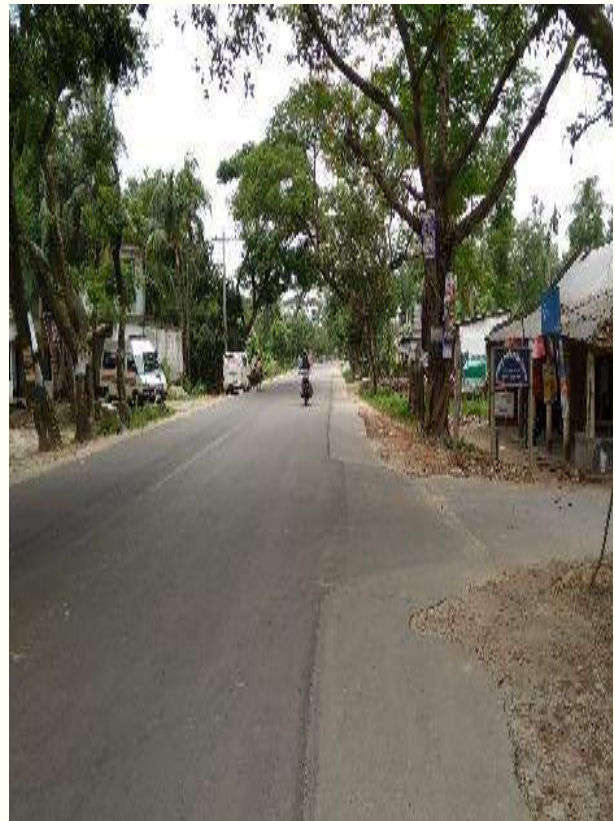
Side road without advanced warning sign within Ch.+106 to Ch.+108

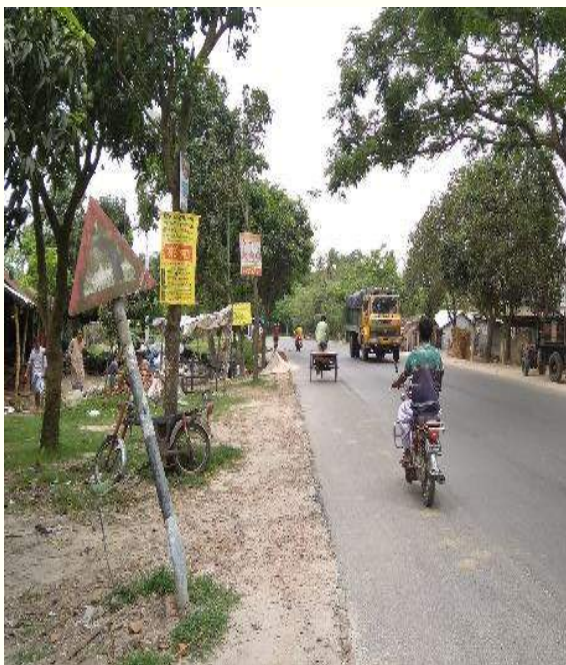
Disturbed road sign within Ch.+110 to Ch.+112

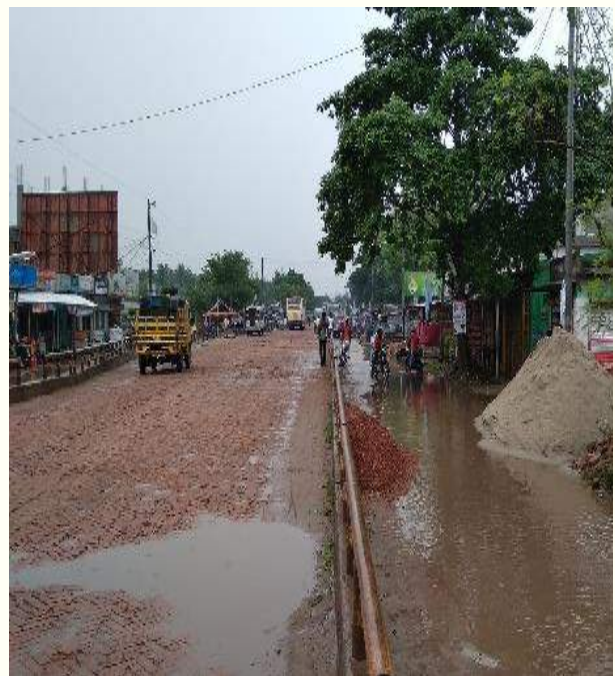
Pavement without DBS within Ch.+ 118 to Ch.+120

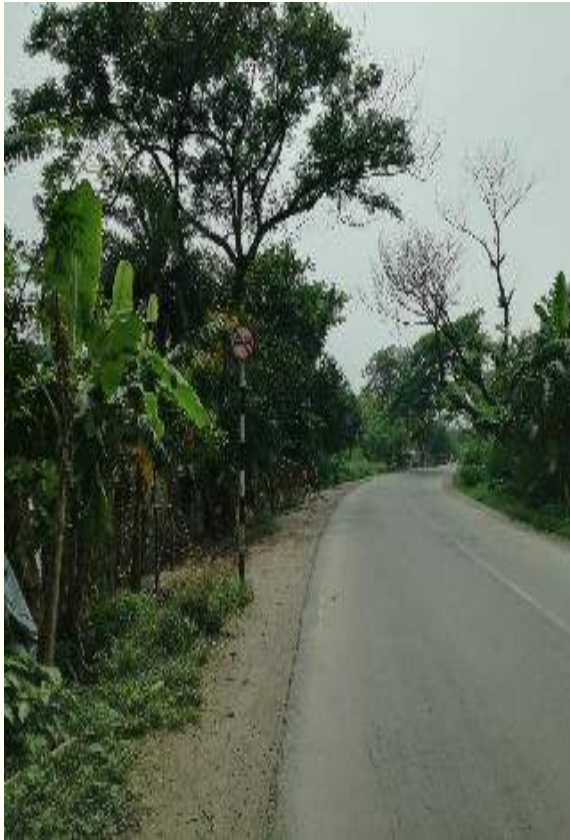
Wrong dimension of road sign within Ch.+124 to Ch.+126

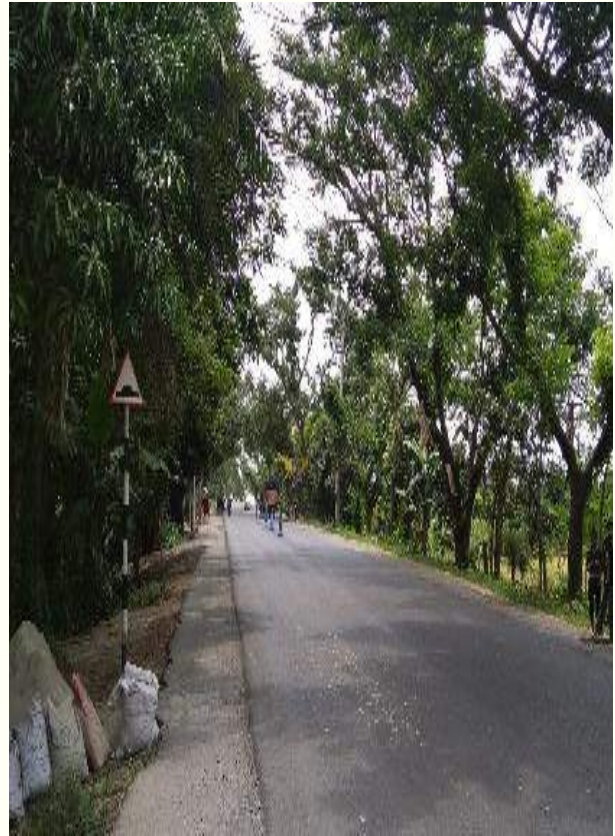
Wrong dimension of road sign within Ch.+130 to Ch.+132

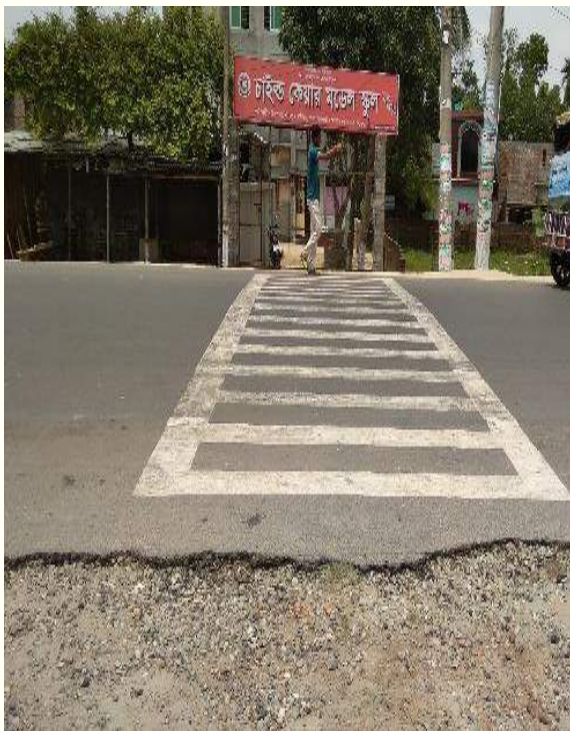
Unauthorized zebra crossing without traffic calming device within Ch.+ 138 to Ch.+140

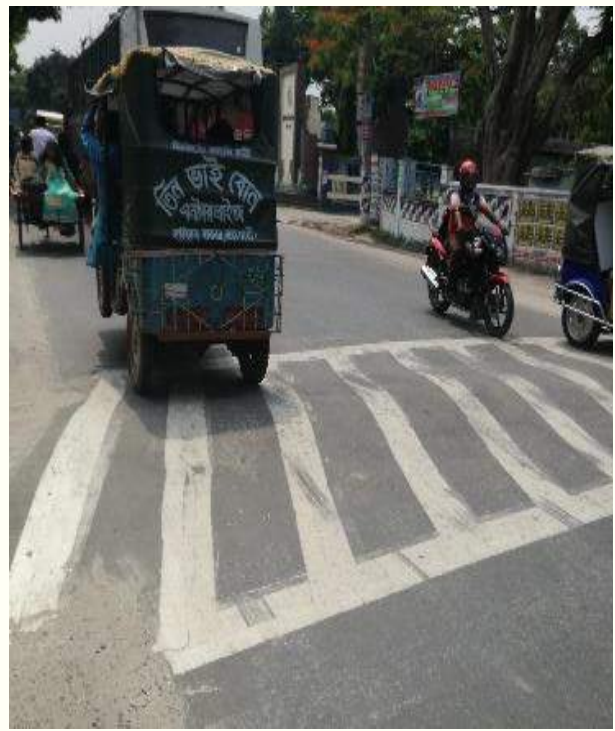
Wrong designed raised pedestrian crossing within Ch.+140 to Ch.+142

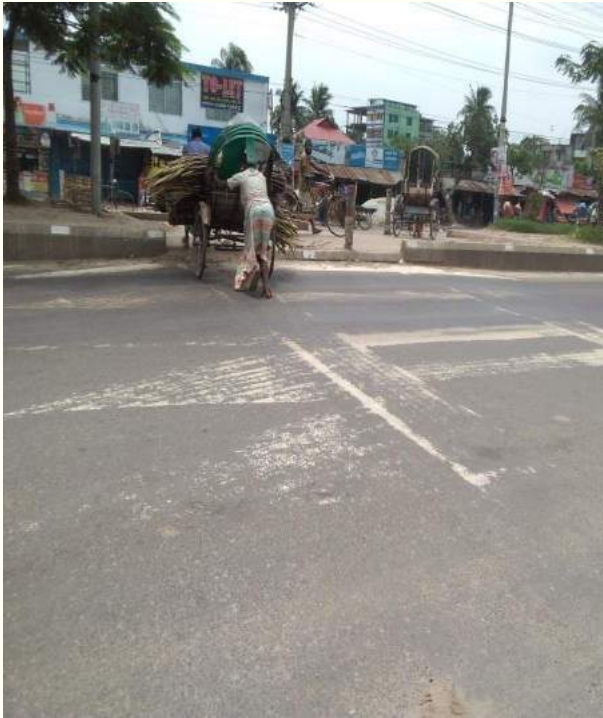
Faded pedestrian crossing within Ch.+21.8 to Ch.+23.8
