REPORT ON
DETAILED
ROAD SAFETY AUDIT
OF FIVE ROAD SECTIONS
(500 KM)

ROAD SAFETY AUDIT REPORT FY 2017-2018

Road Design & Safety Circle
Roads & Highways Department
Government of the People's Republic of Bangladesh
SARM Associates and HeptaTech Limited JV

Detailed Road Safety Audit of Road Sections of Joydebpur – Mymensingh (N3), Kanchpur- Daudkandi (N1) and Chattogram – Cox's Bazar (N1), Kashinathpur – Rajshahi (N6) and Dhaka – Aricha (N5) (Total 500 km) National Highway During FY 2017 -2018

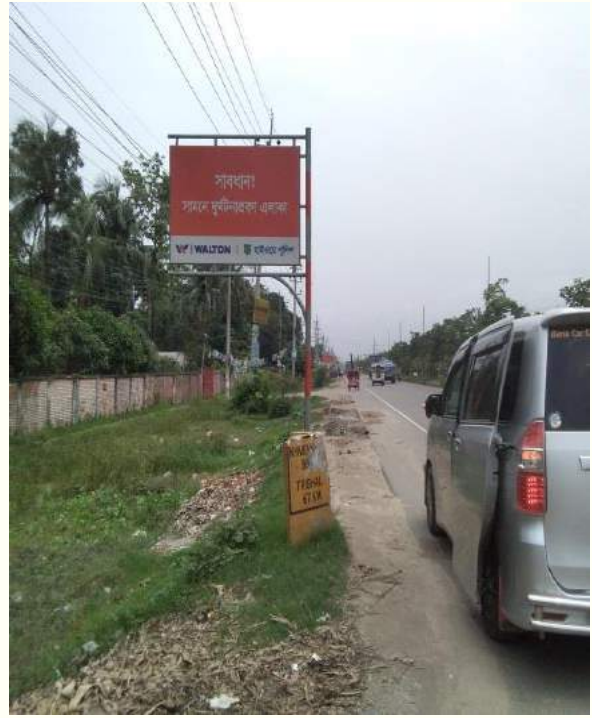
Risky km post and unknown sign post in earthen shoulder within Ch.+21.8 to Ch.+23.8

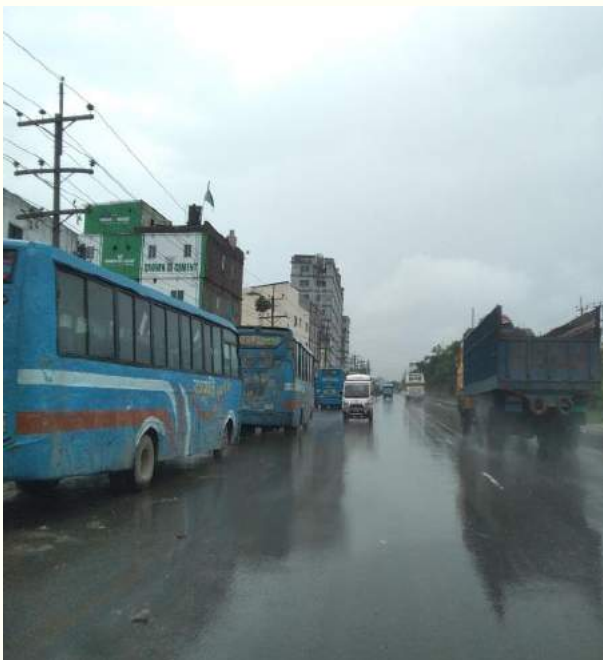
Unauthorized parking within Ch.+21.8 to Ch.+23.8

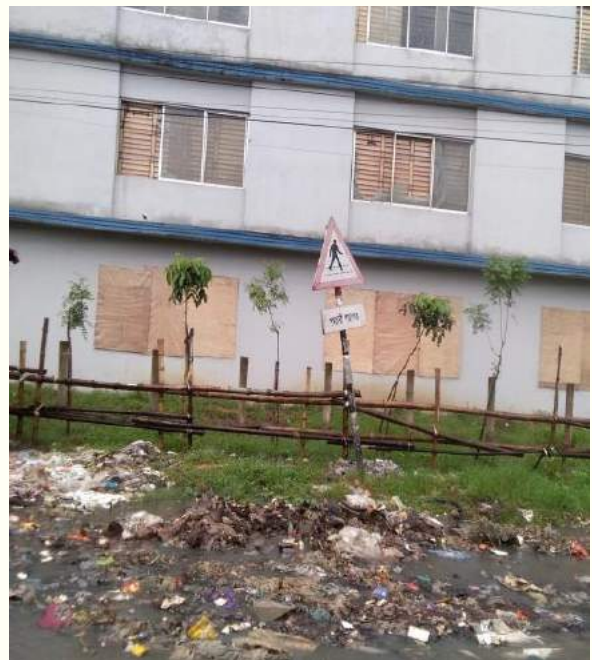
Disturbed and faded road sign within Ch.+21.8 to Ch.+23.8

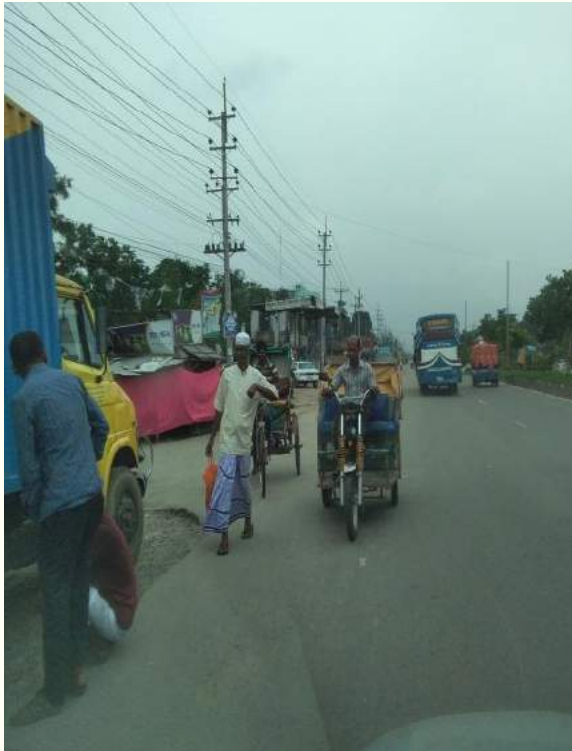
Unauthorized vehicle movement within Ch.+23.8 to Ch.+25.8

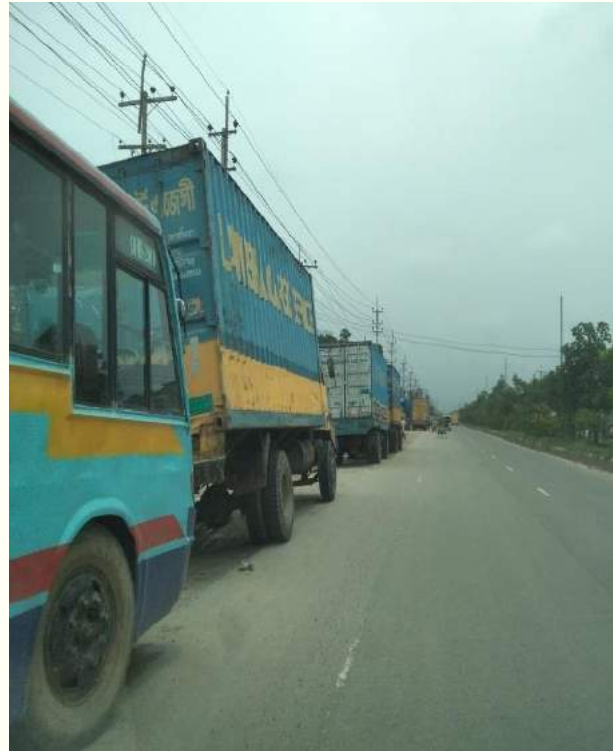
Illegal parking within Ch.+23.8 to Ch.+25.8

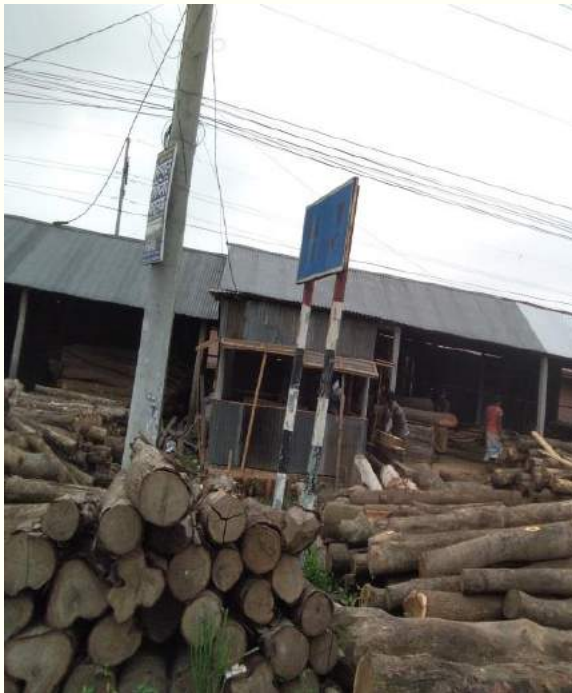
Unauthorized roadside business and non-reflective sign within Ch.+23.8 to Ch.+25.8

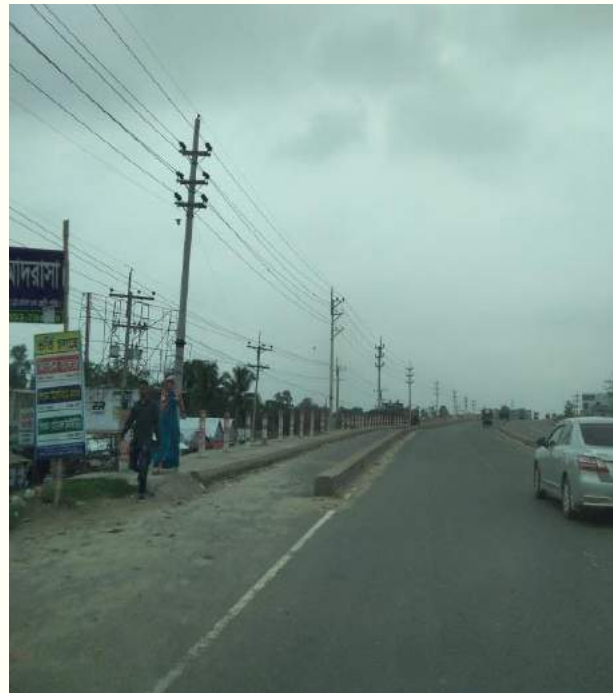
Divider without warning sign at Ch.+23.8 to Ch.+25.8

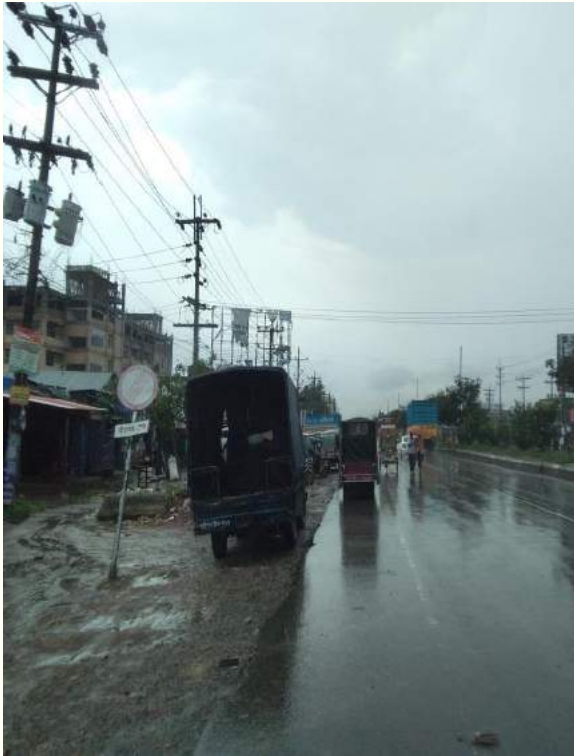
Disturbed road sign and risky shoulder drop within Ch.+23.8 to Ch.+25.8

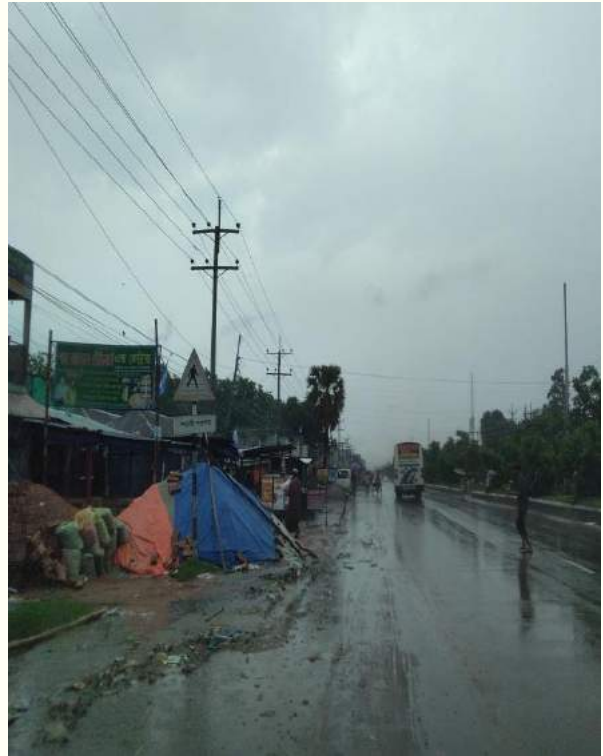
Unauthorized road side business within Ch.+23.8 to Ch.+25.8

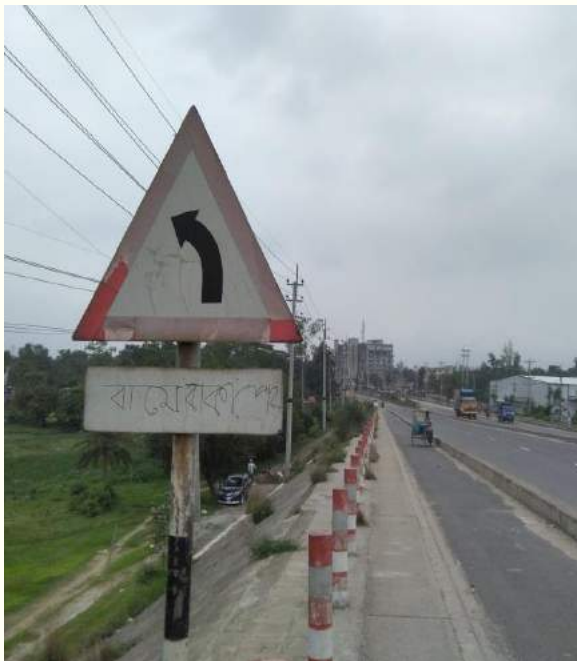
Faded and non-reflective sign within Ch.+25.8 to Ch.+27.8

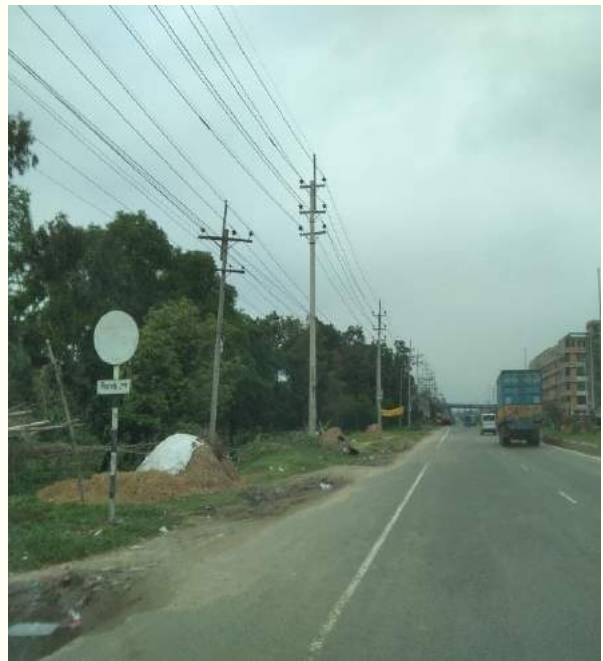
Faded road sign and marking within Ch.+25.8 to Ch.+27.8

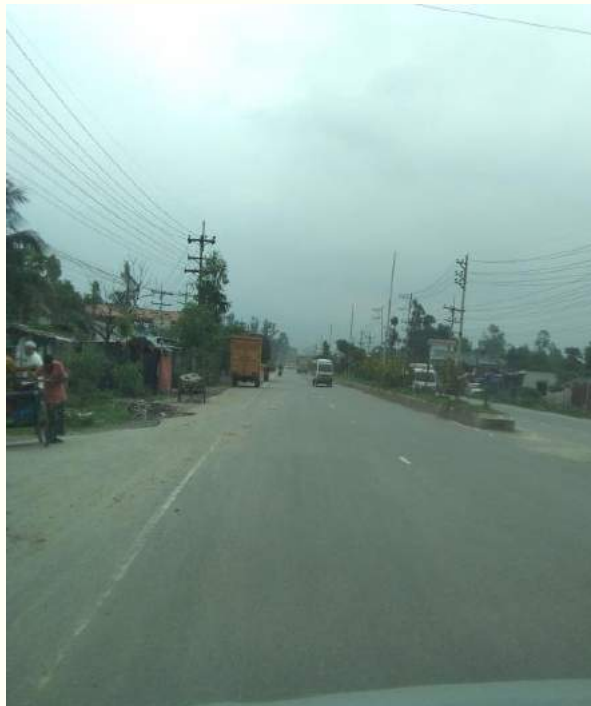
Poor road marking within Ch.+27.8 to Ch.+29.8

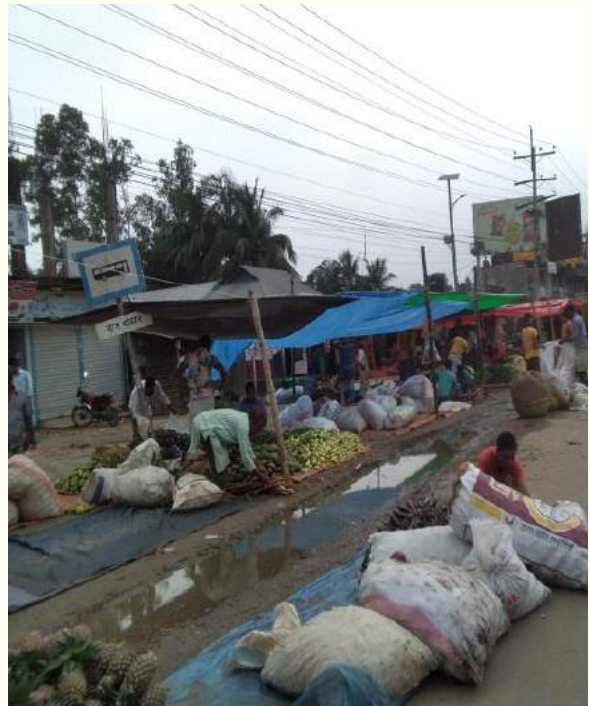
Unauthorized roadside business at Ch.+27.8 to Ch.+29.8

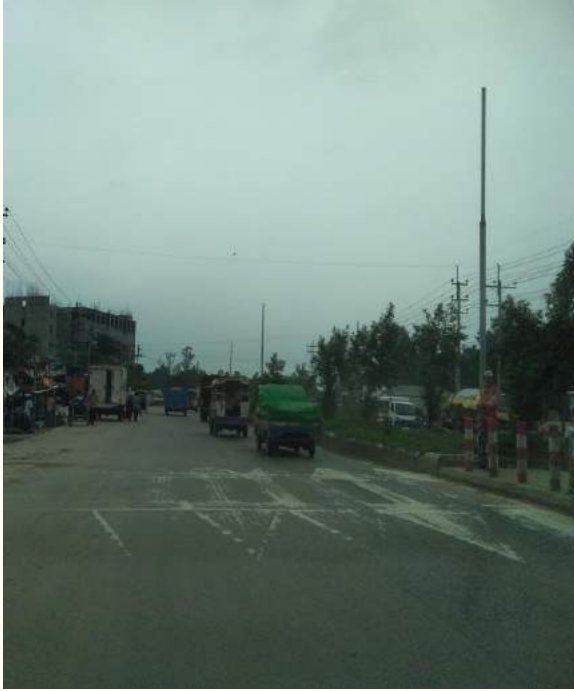
Faded zebra crossing within Ch.+27.8 to Ch.+29.8

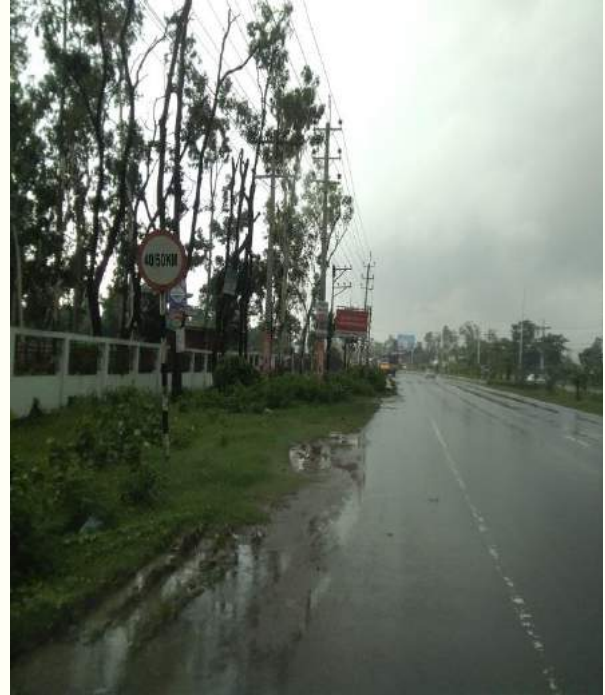
Unknown road sign within Ch.+27.8 to Ch.+29.8

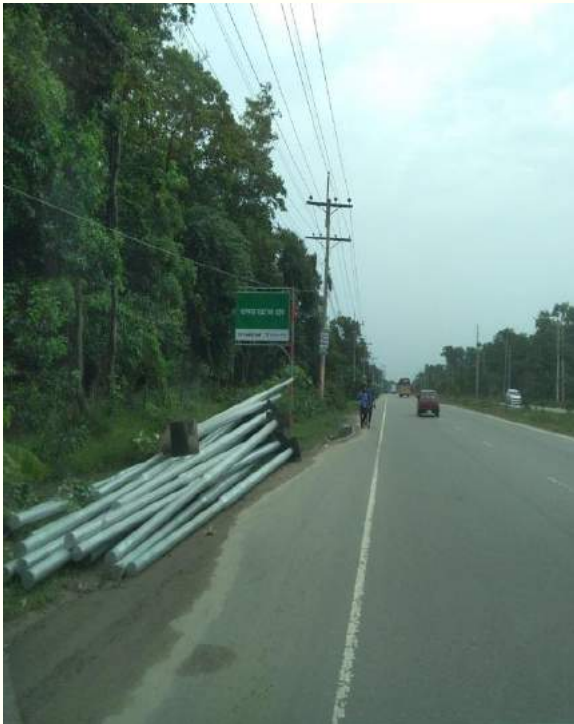
Unauthorized roadside occupancy within Ch.+29.8 to Ch.+31.8

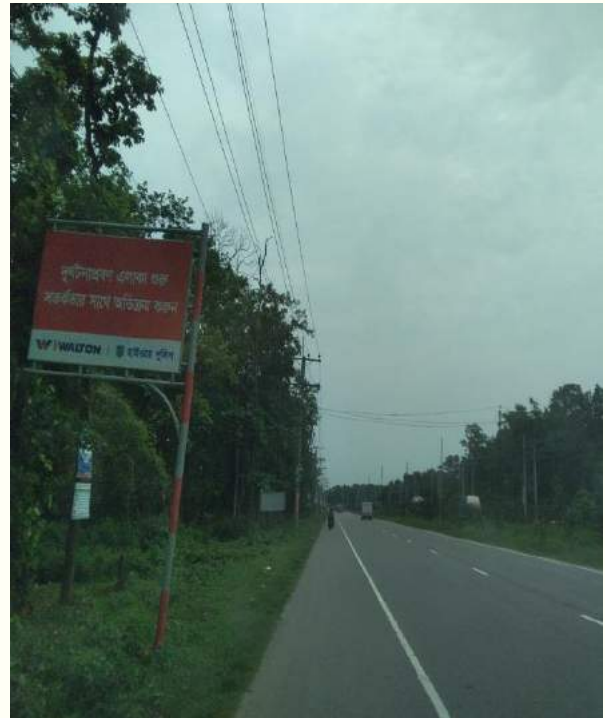
Unknown road sign at earthen shoulder at Ch.+31.8 to Ch.+33.8

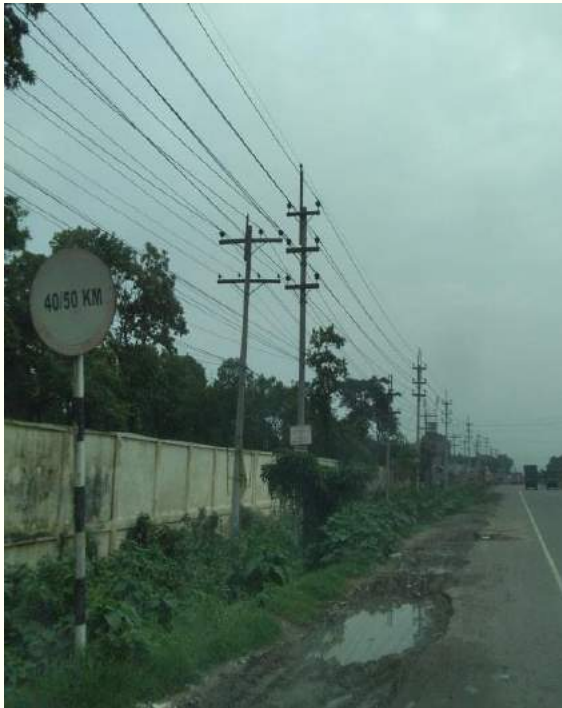
Risky edge drop and faded road sign within Ch.+35.8 to Ch.+37.8

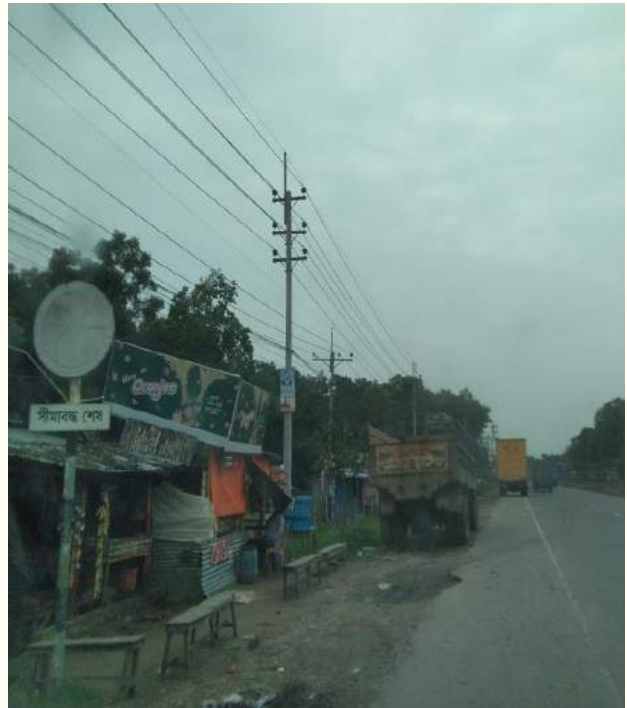
Faded sign and illegal parking within Ch.+35.8 to Ch.+37.8

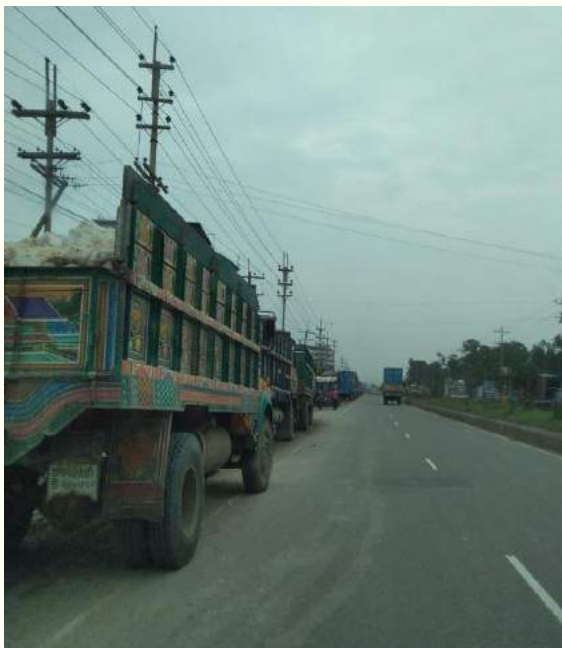
Illegal roadside parking within Ch.+35.8 to Ch.+37.8

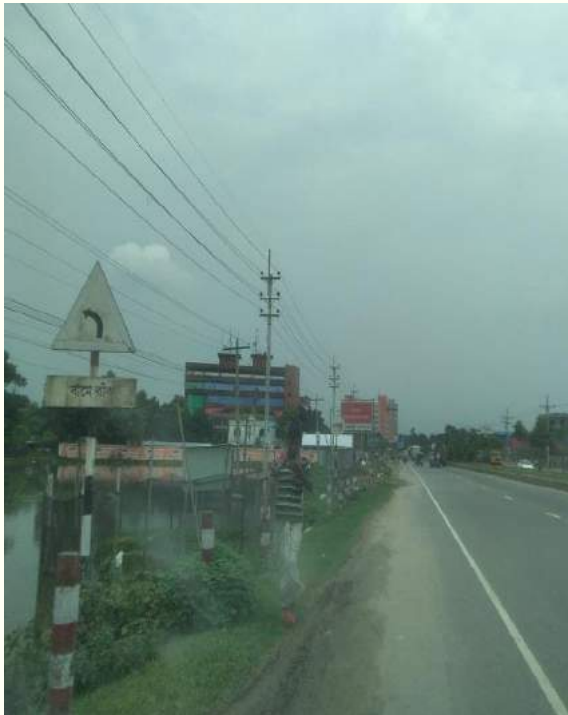
Faded road sign within Ch.+39.8to Ch.+41.8

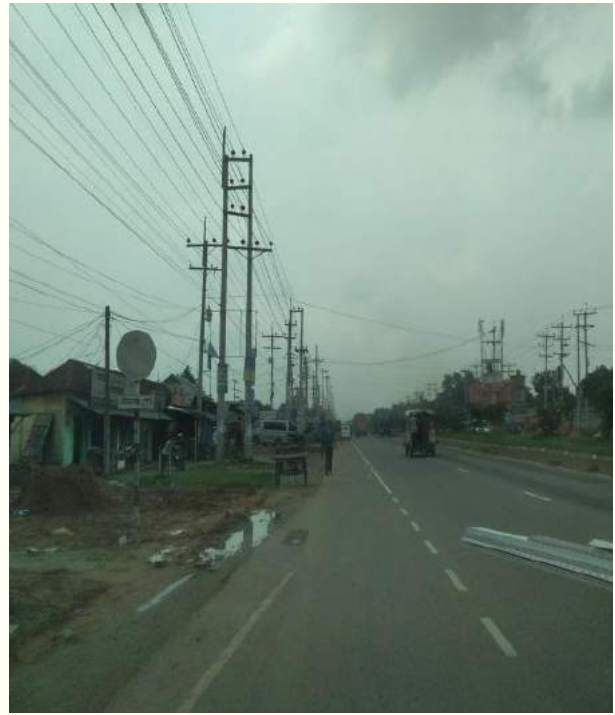
Faded road sign within Ch.+43.8 to Ch.+45.8

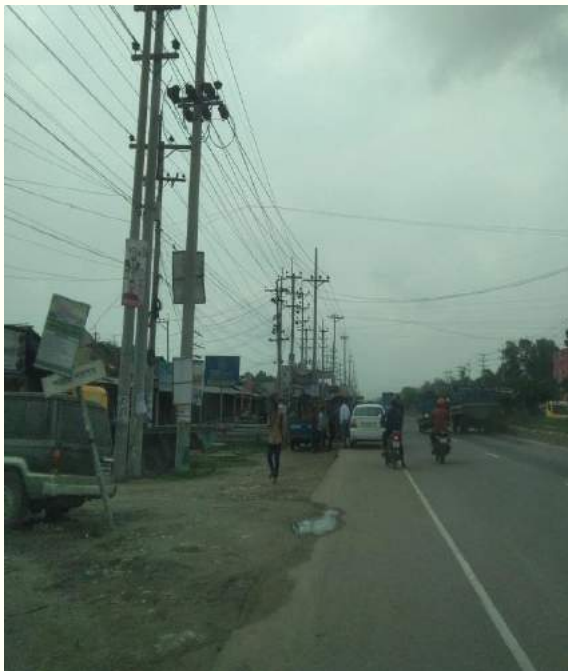
Disturbed road sign within Ch.+43.8 to Ch.+45.8

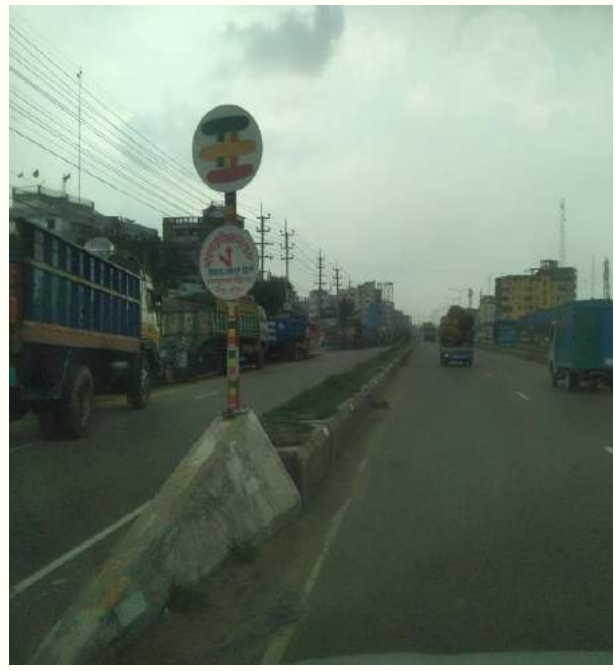
Unknown road sign within Ch.+45.8 to Ch.+47.8

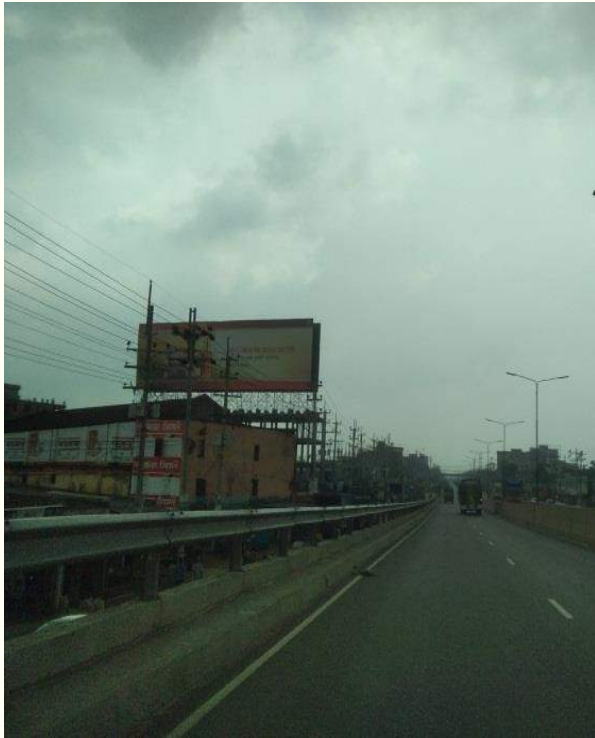
**Wrong placement of guard rail within
Ch.+47.8 to Ch.+49.8**

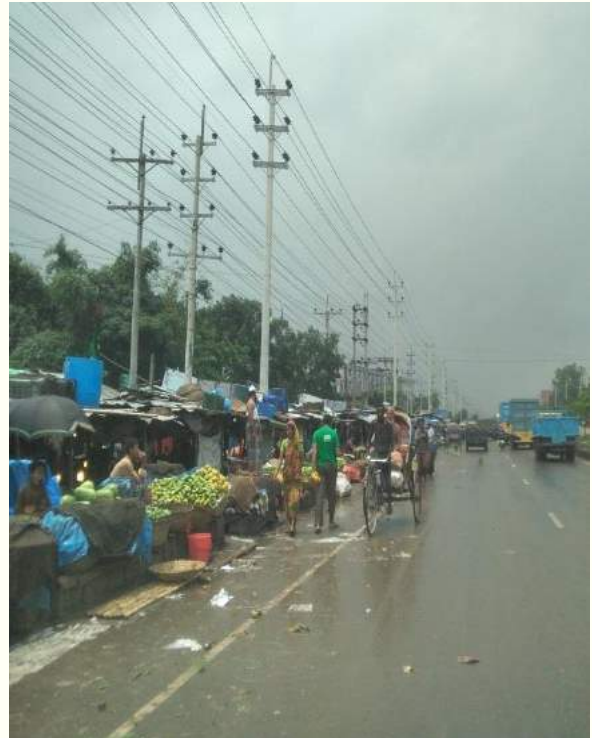
**Illegal roadside activity within
Ch.+49.8 to Ch.+51.6**

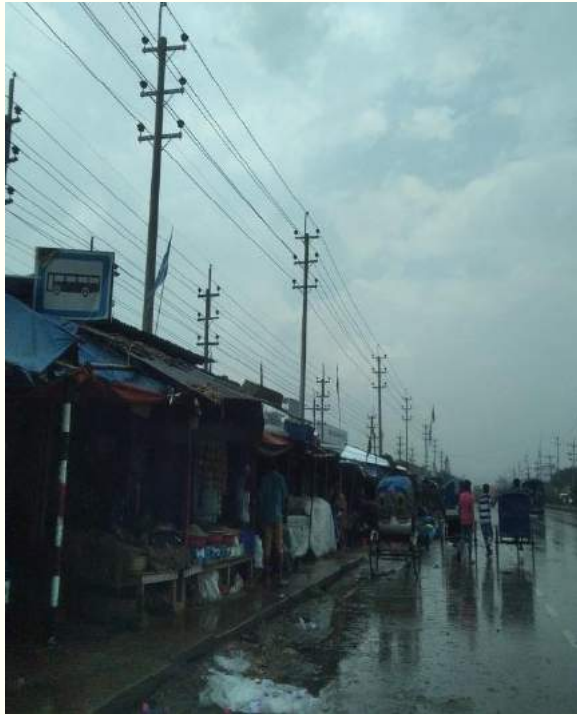
Unauthorized roadside business within Ch.+51.6 to Ch.+53.6

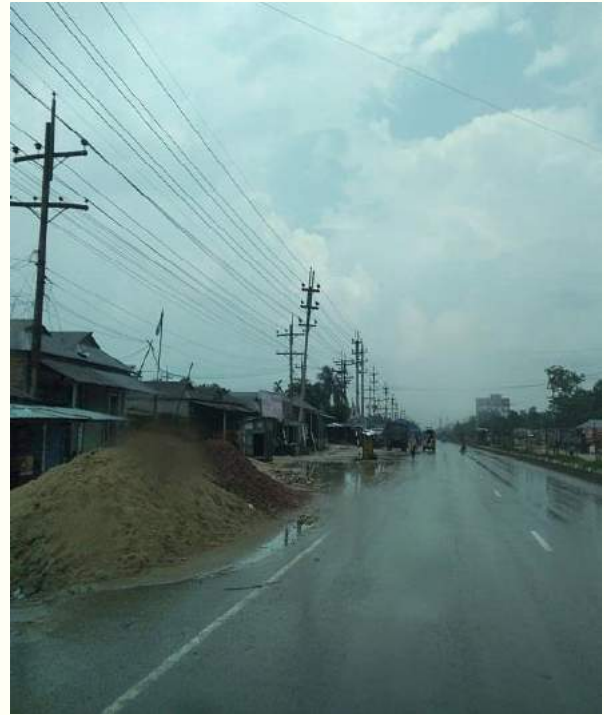
Construction materials kept on roadside area illegally within Ch.+51.6 to Ch.+53.6

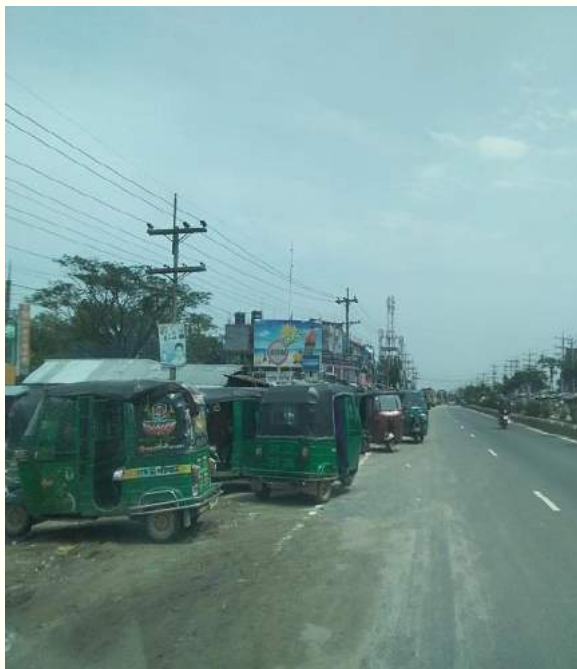
Unauthorized parking within Ch.+53.6 to Ch.+55.6

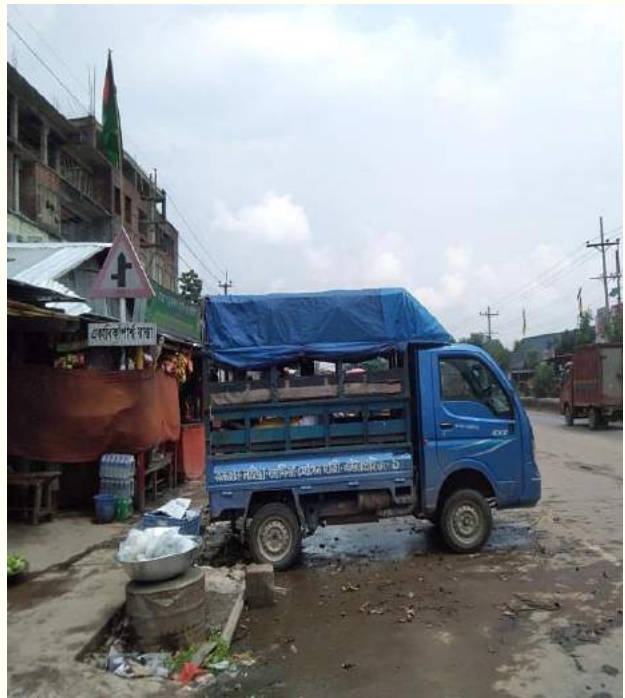
Unauthorized occupancy within Ch.+55.6. to Ch.+57.6

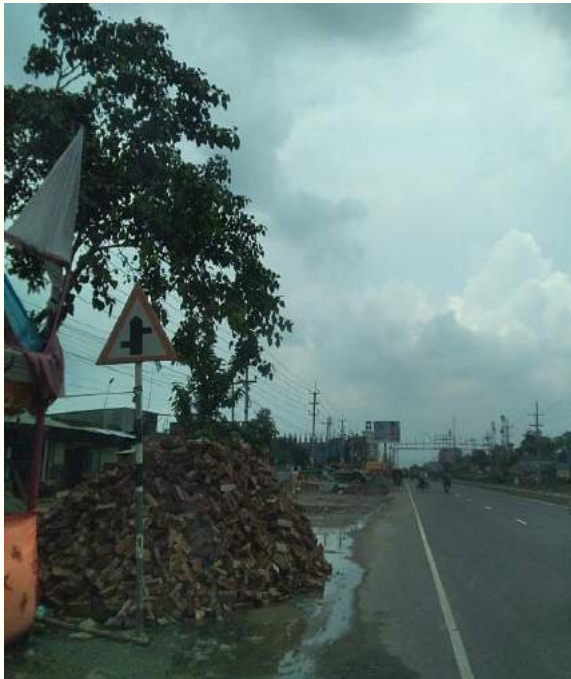
Construction materials kept on roadside area illegally within Ch.+59.6 to Ch.+61.6

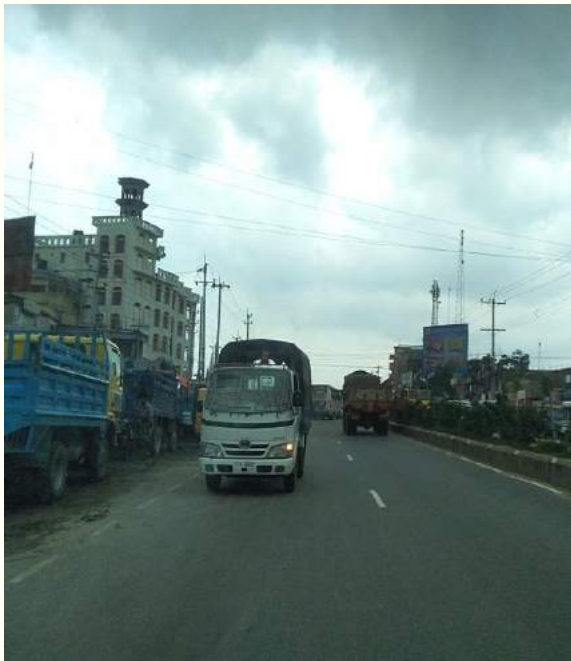
Contra flow within Ch.+59.6 to Ch.+61.6

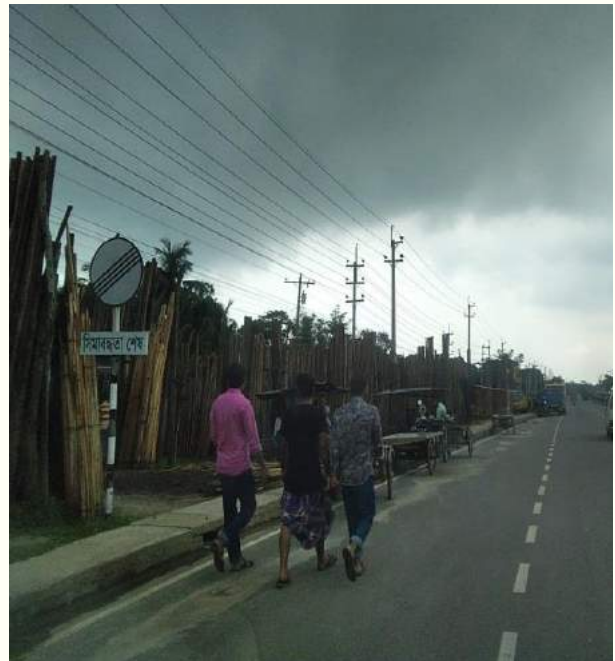
Illegal pedestrian movement within Ch.+59.6 to Ch.+61.6

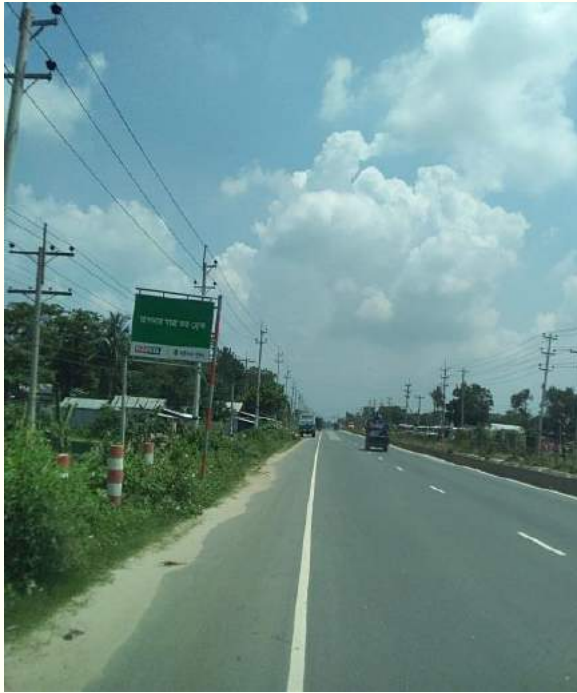
Roadside bushes within Ch.+63.6 to Ch.+65.6

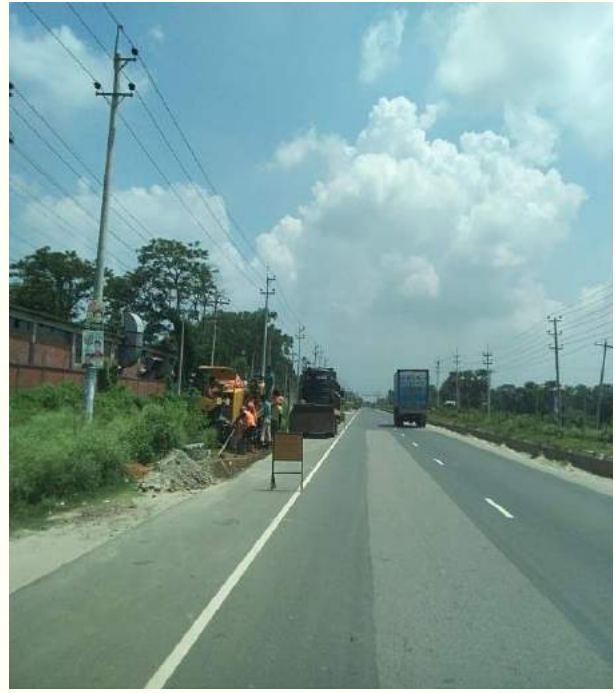
Road construction work along roadside area within Ch.+63.6 to Ch.+65.6 causing high risk

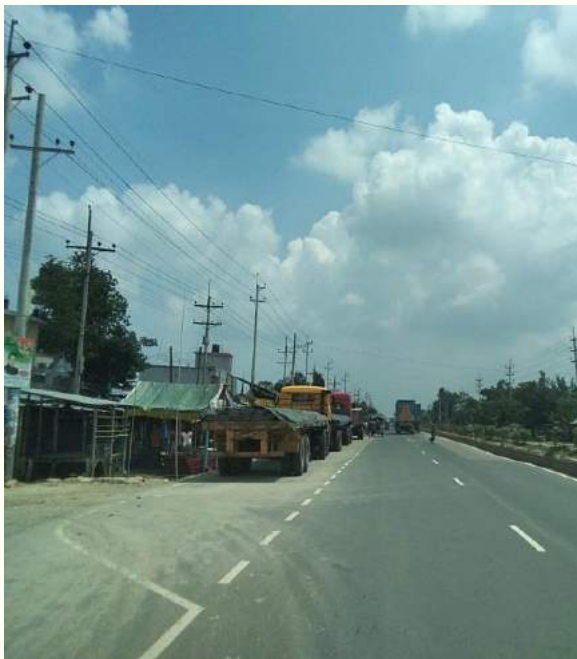
Bus bay occupied by heavy loaded trucks within Ch.+63.6 to Ch.+65.6

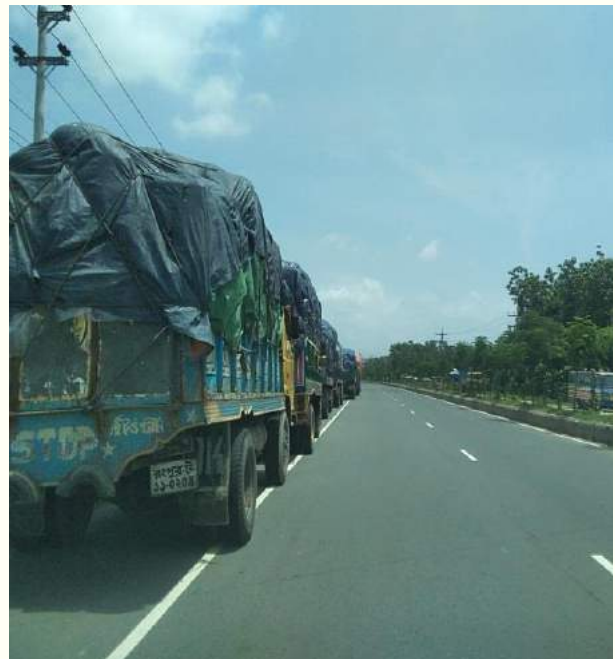
Unauthorized parking at Ch.+65.6 to Ch.+67.5

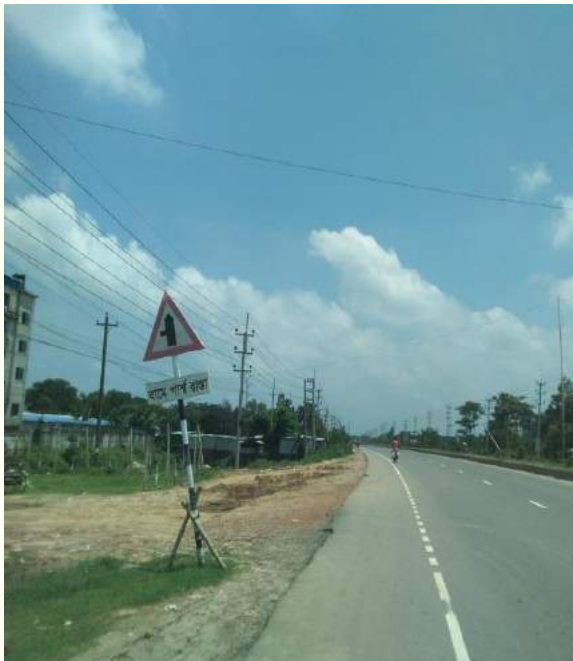
Disturbed sign post within Ch.+71.5 to Ch.+73.5

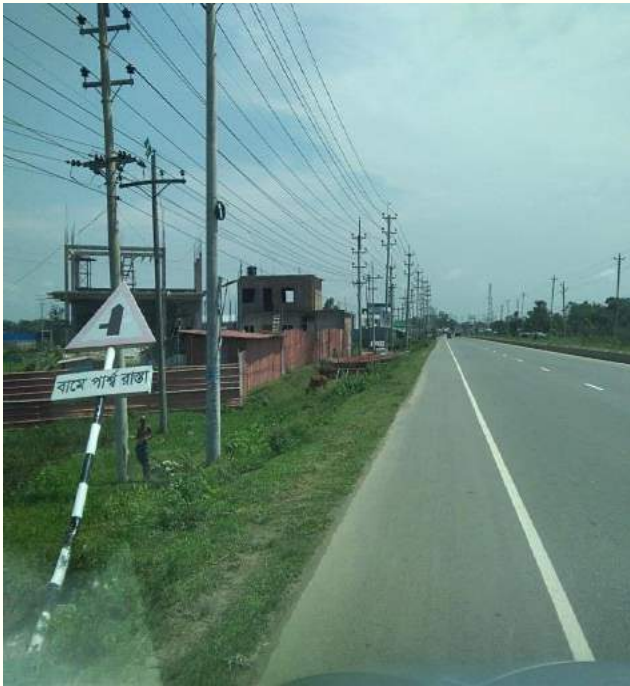
Disturbed sign post within Ch.+75.5 to Ch.+77.5

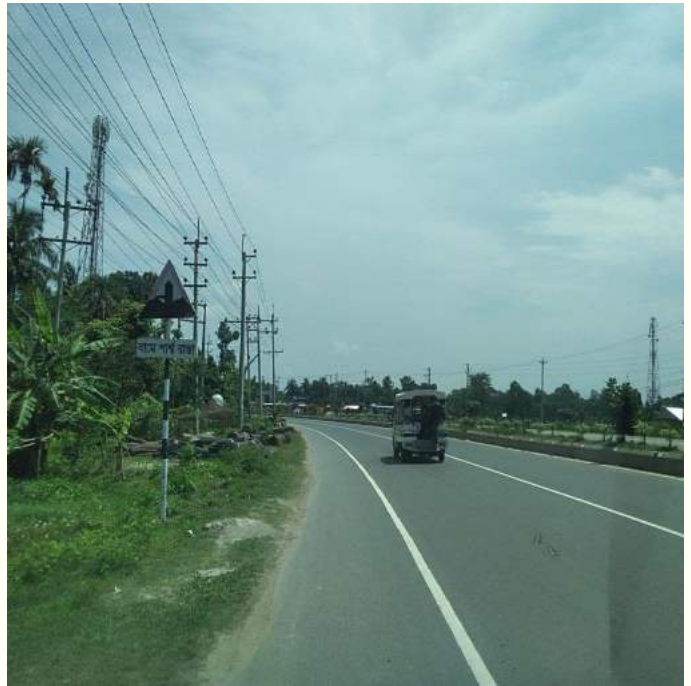
Disturbed sign post within Ch.+77.5 to Ch.+79.5

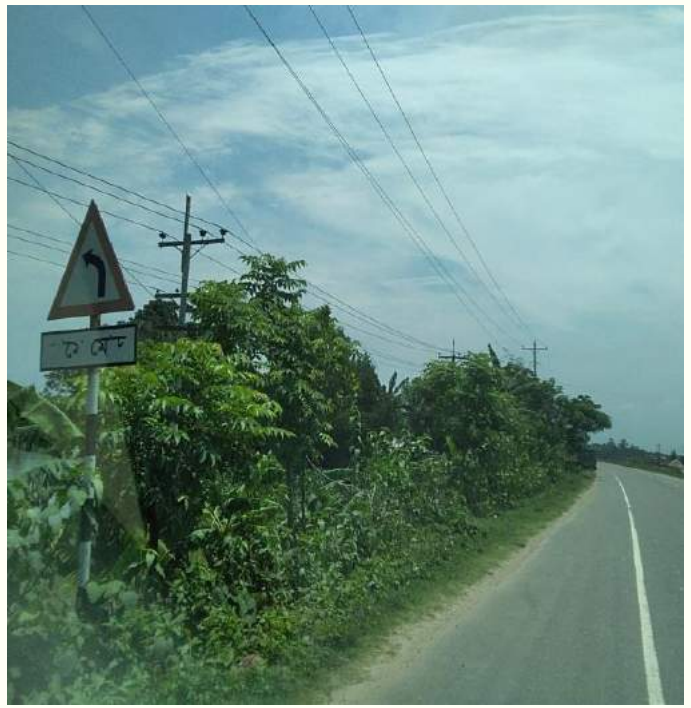
Faded & invisible sign within Ch.+81.5 to Ch.+83.5

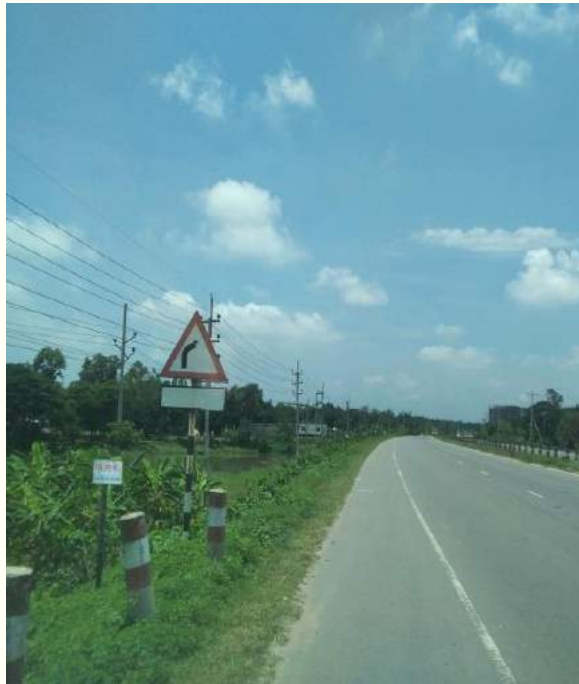
**Faded sign and name plate within
Ch.+81.5 to Ch.+83.5**

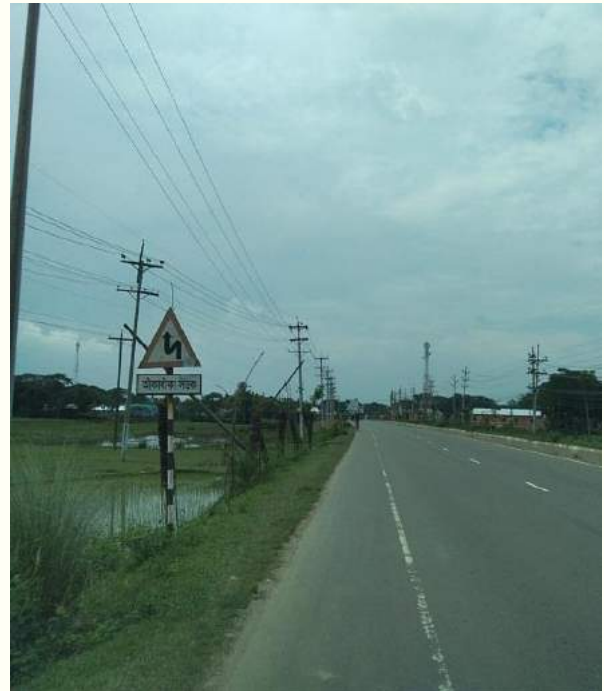
**Faded road marking within
Ch.+83.5 to Ch.+85.5**

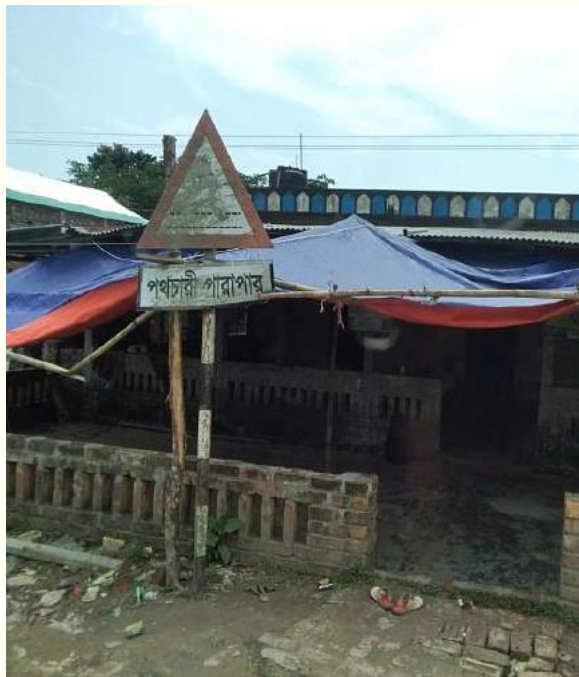
**Unauthorized occupancy & faded sign within
Ch.+85.5 to Ch.+87.5**

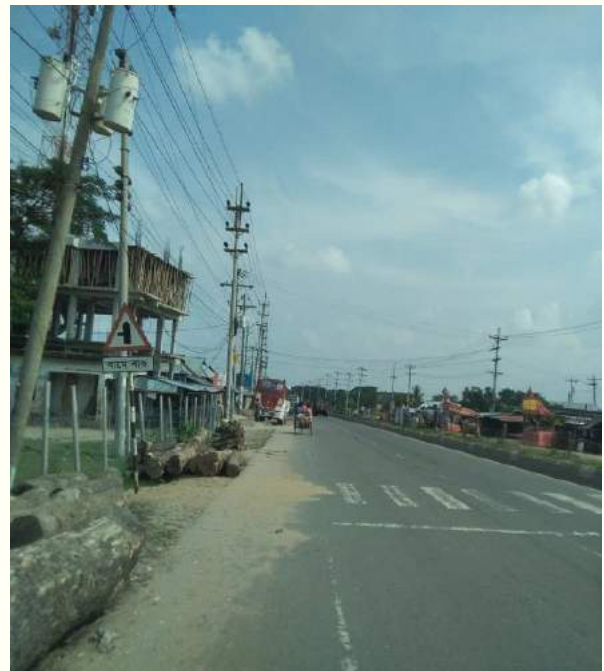
**Faded road marking & unauthorized occupancy
within Ch.+85.5 to Ch.+87.5**

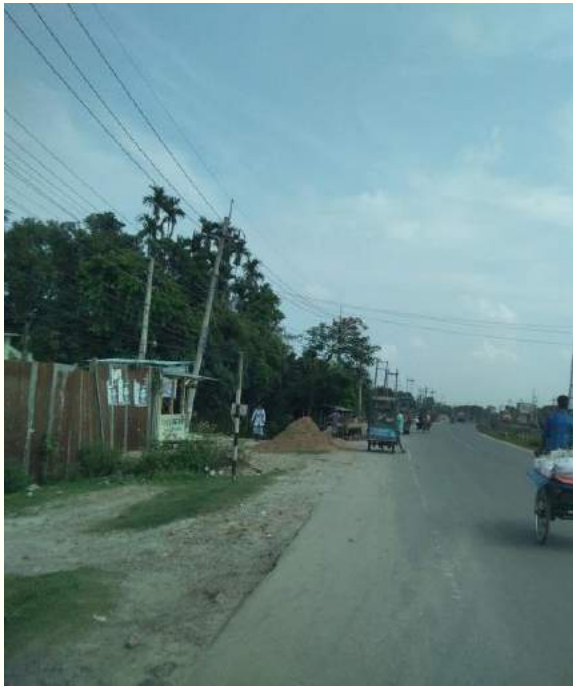
Faded road marking within Ch.+87.5 to Ch.+89.5

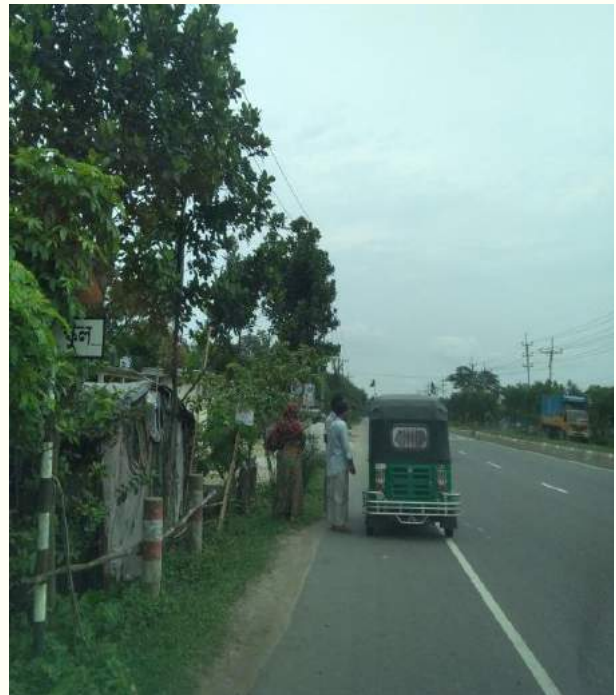
Invisible sign post & insufficient earthen shoulder within Ch.+93.5 to Ch.+95.5

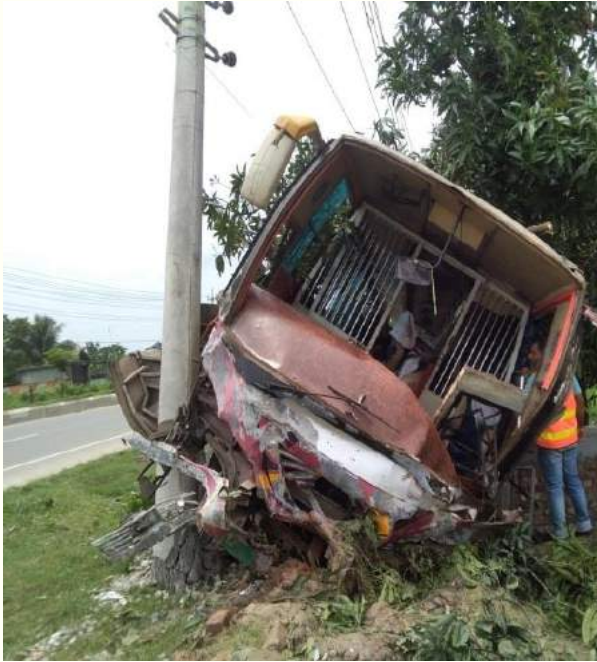
**Crash with electric pole within
Ch.+97.5 to Ch.+99.5**

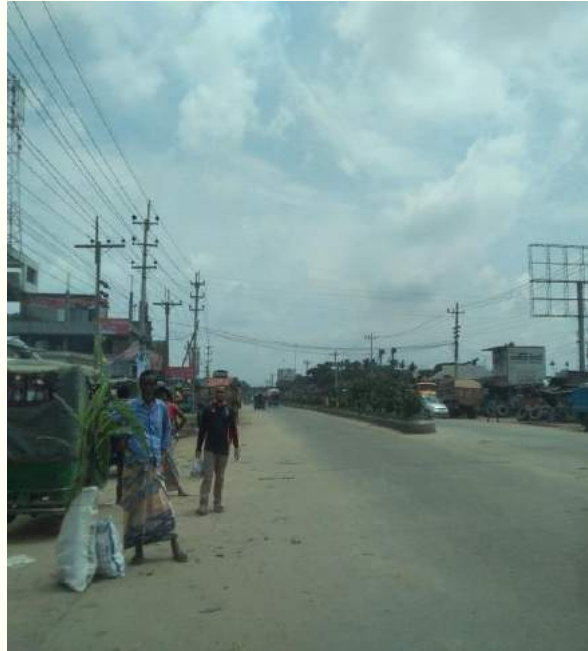
**No road marking & unauthorized parking
within Ch.+99.5to Ch.+101.5**

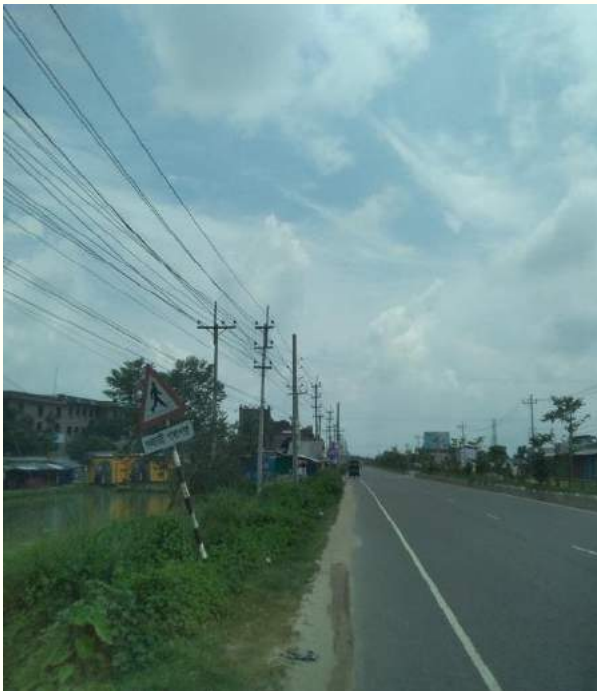
Disturbed sign post within Ch.+99.5to Ch.+101.5

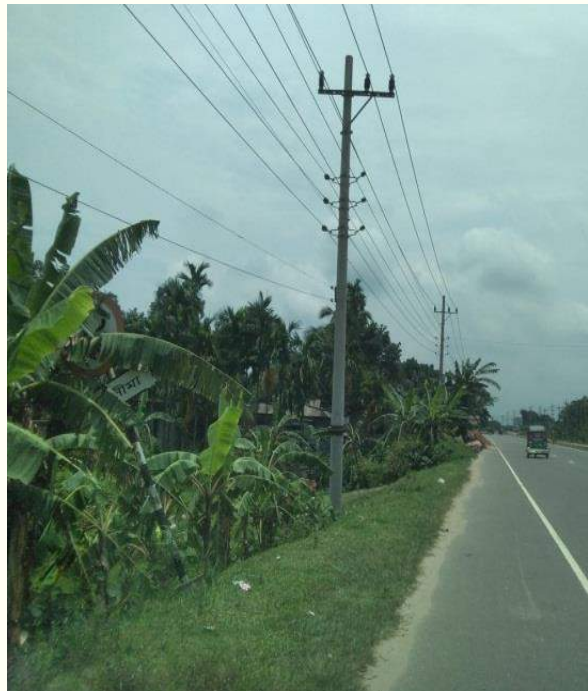
**Disturbed & not visible sign post within
Ch.+101.5 to Ch.+103.5**

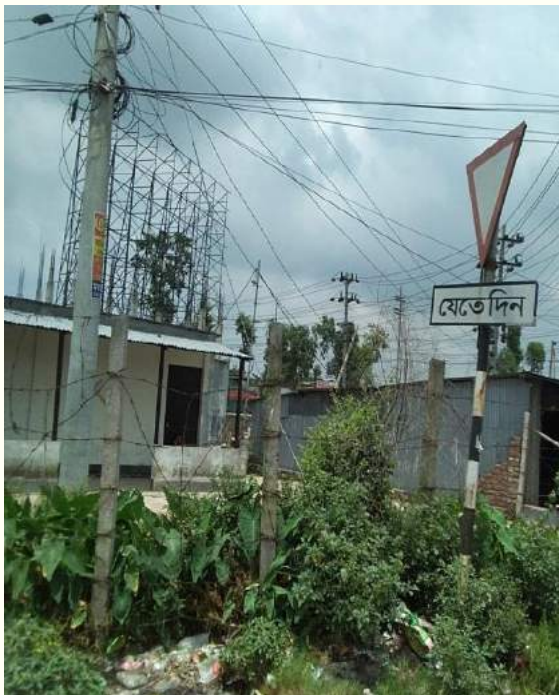
Disturbed sign within Ch.+103.5 to Ch.+105.5

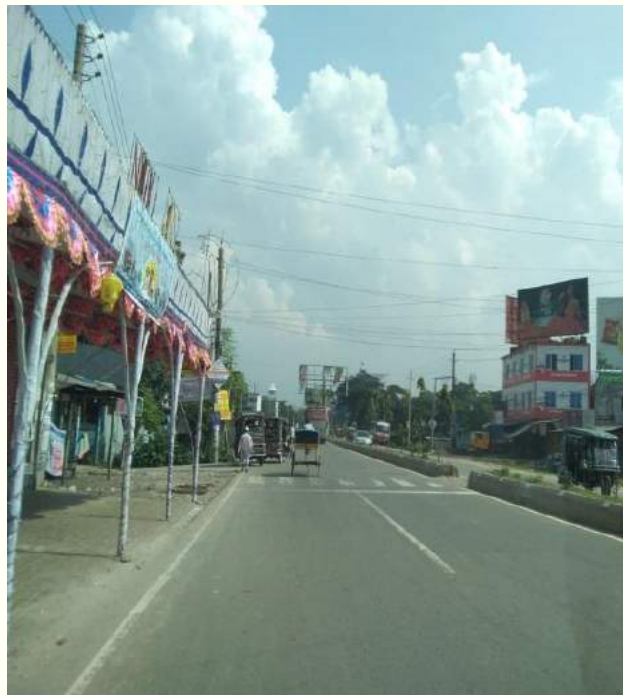
Illegal structure & faded road marking at Ch.+105.5 to Ch.+107.5

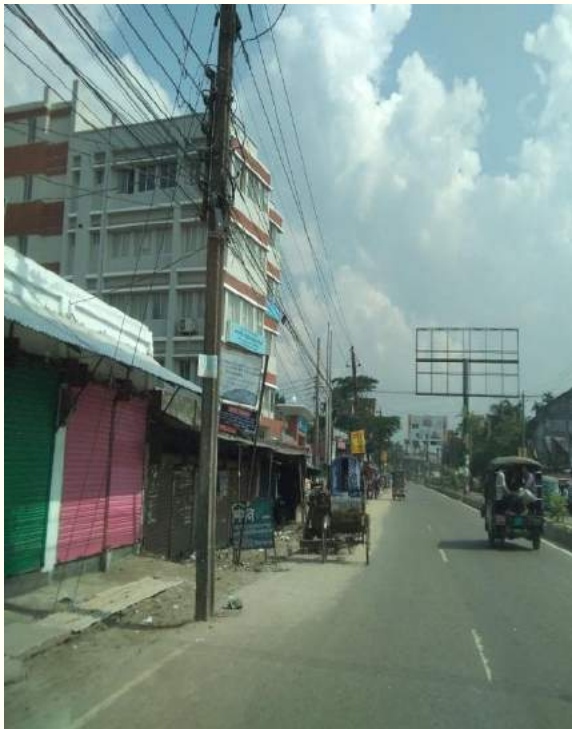
Electric pole on road at Ch.+105.5 to Ch.+107.5
