REPORT ON
DETAILED
ROAD SAFETY AUDIT
OF FIVE ROAD SECTIONS
(500 KM)

ROAD SAFETY AUDIT REPORT FY 2017-2018

Road Design & Safety Circle
Roads & Highways Department
Government of the People's Republic of Bangladesh
SARM Associates and HeptaTech Limited JV

Detailed Road Safety Audit of Road Sections of Joydebpur – Mymensingh (N3), Kanchpur- Daudkandi (N1) and Chattogram – Cox's Bazar (N1), Kashinathpur – Rajshahi (N6) and Dhaka – Aricha (N5) (Total 500 km) National Highway During FY 2017 -2018

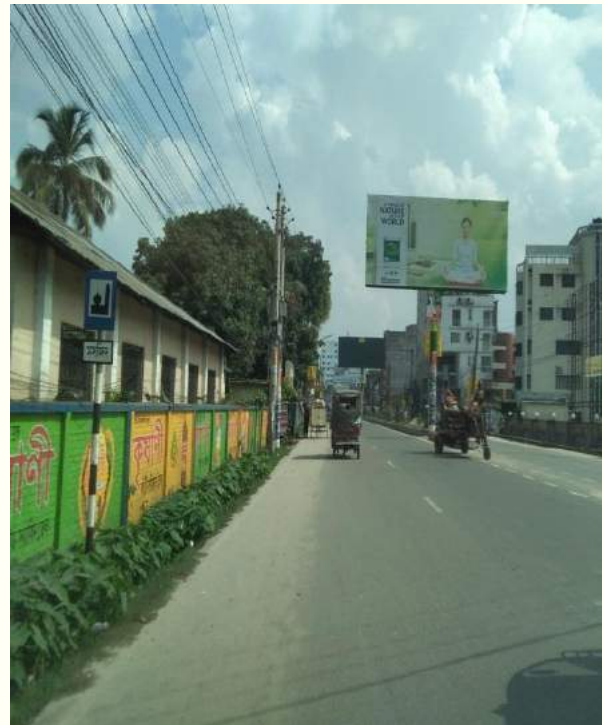
Roadside electric pole & faded road marking within Ch.+107.5 to Ch.+109.5

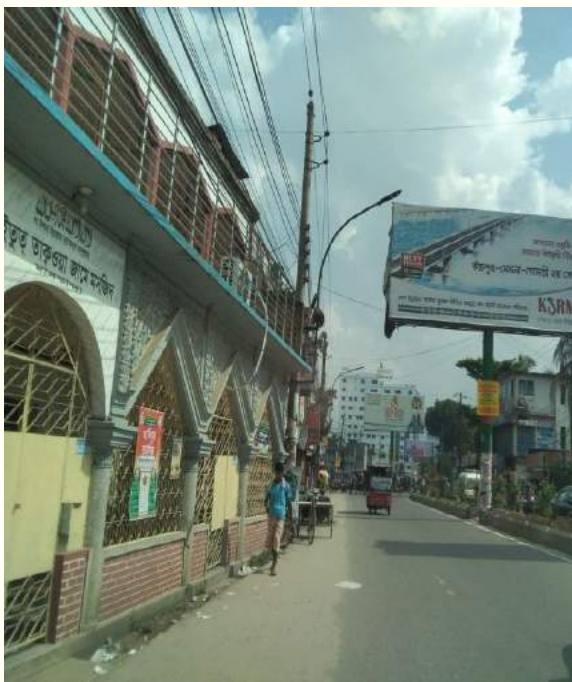
Permanent structure established on roadside area within Ch.+107.5 to Ch.+109.5

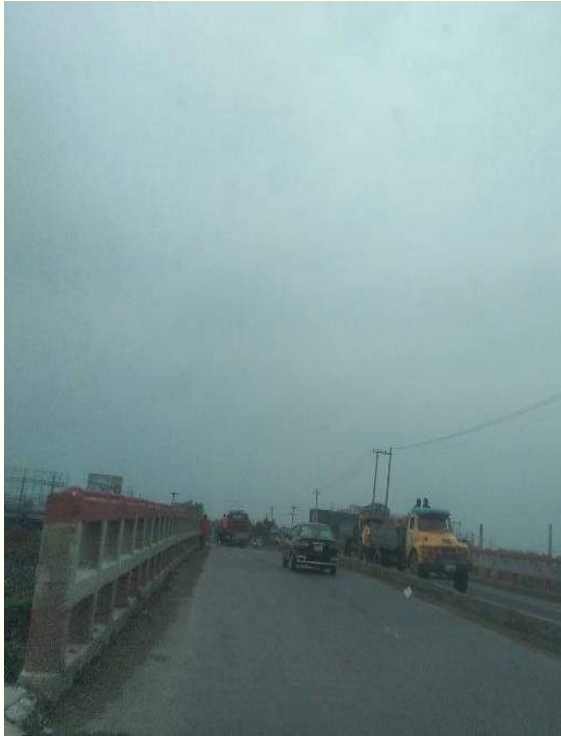
No pedestrian crossing facility on the bridge at Ch.+0 to Ch.+2

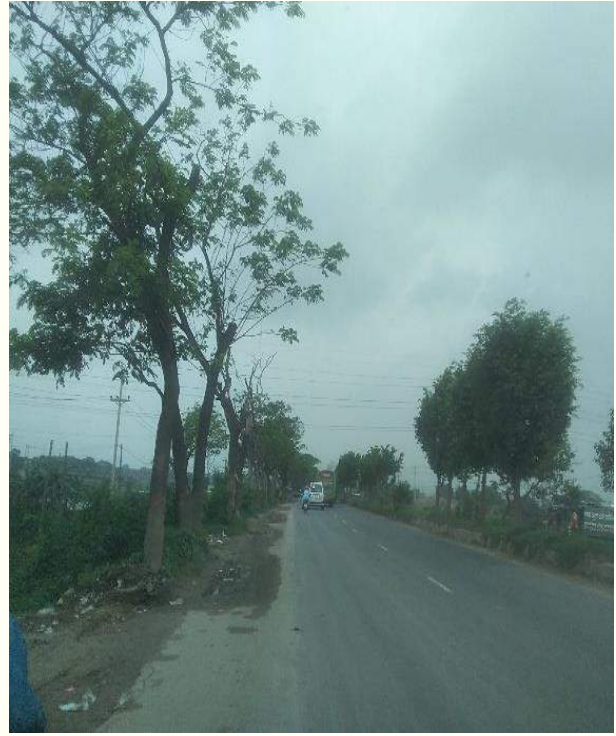
Earthen shoulder within Ch.+2 to Ch.+4 is at risk due to roadside tree

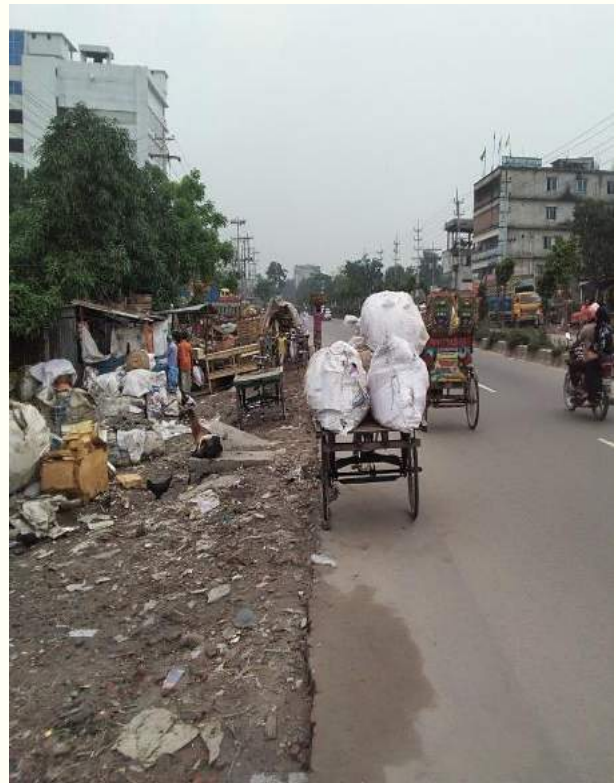
Risky shoulder within Ch.+12 to Ch.+14

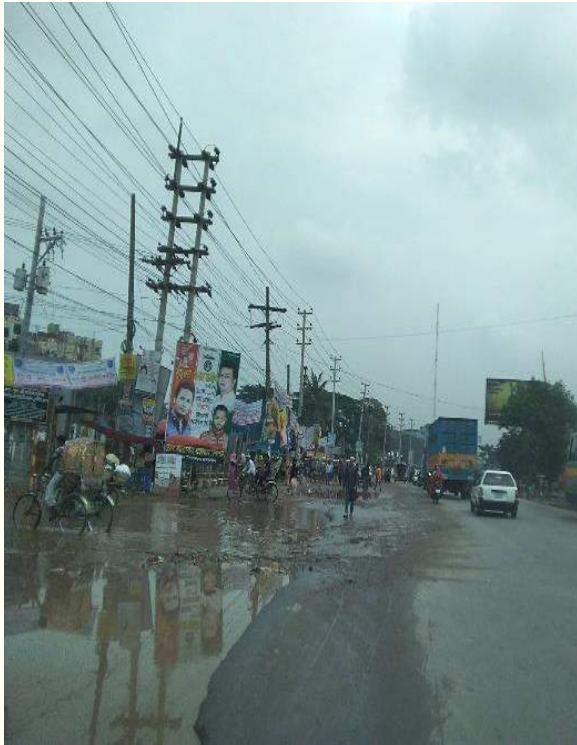
Water logging within Ch.+14 to Ch.+16

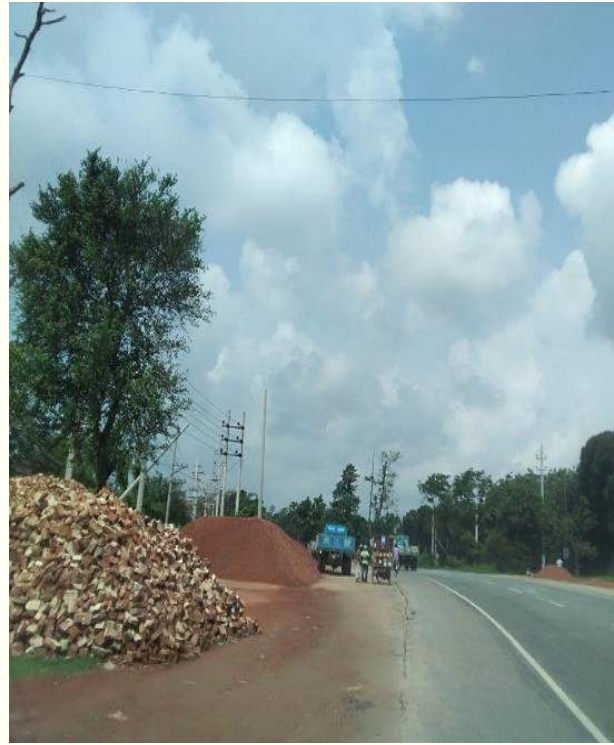
Unauthorized roadside business within Ch.+24 to Ch.+26

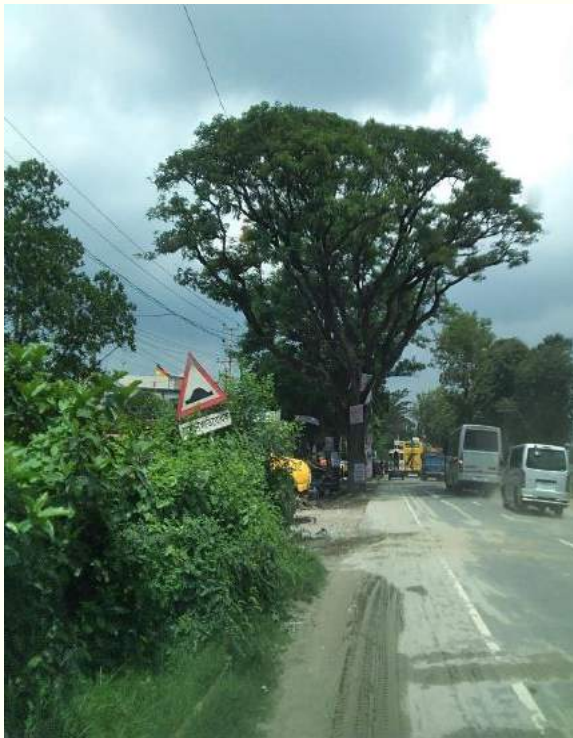
Disturbed road sign within Ch.+26 to Ch.+28 is misplaced and less visible

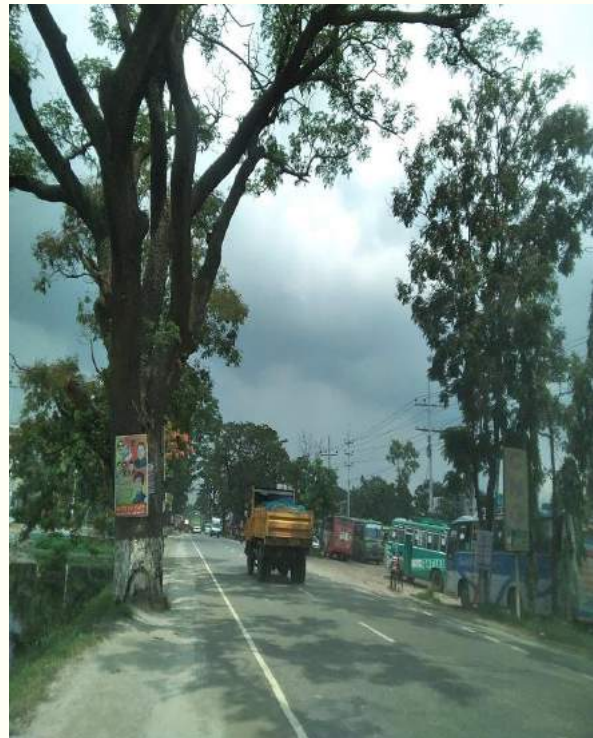
Earthen shoulder within Ch.+26 to Ch.+28 gets blocked by roadside large tree

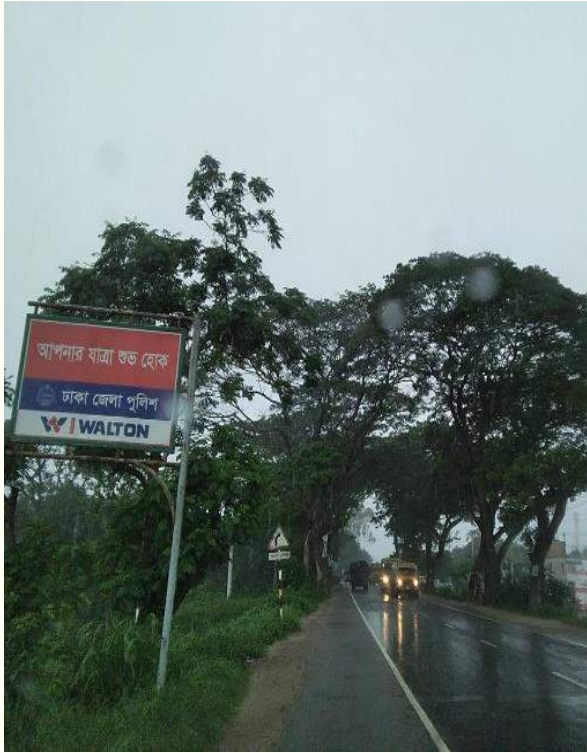
Risky concrete pole in earthen shoulder within Ch.+26 to Ch.+28

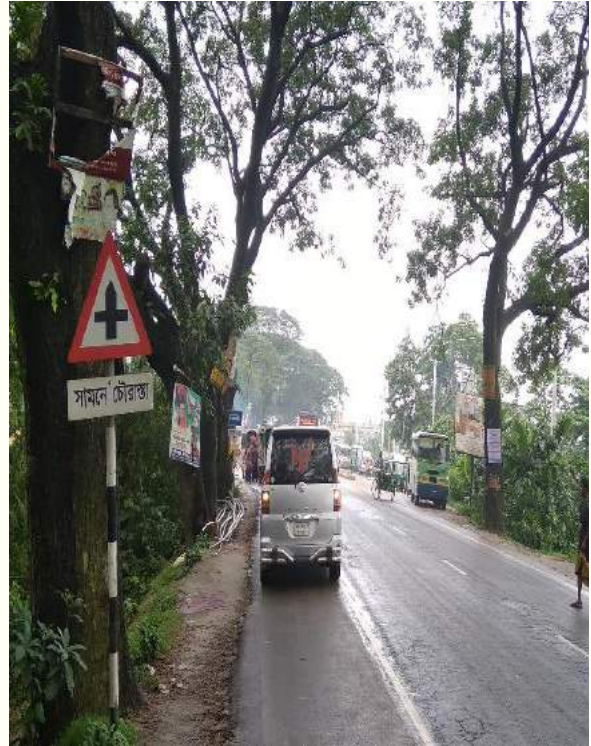
Road Sign in earthen shoulder within Ch.+28 to Ch.+30

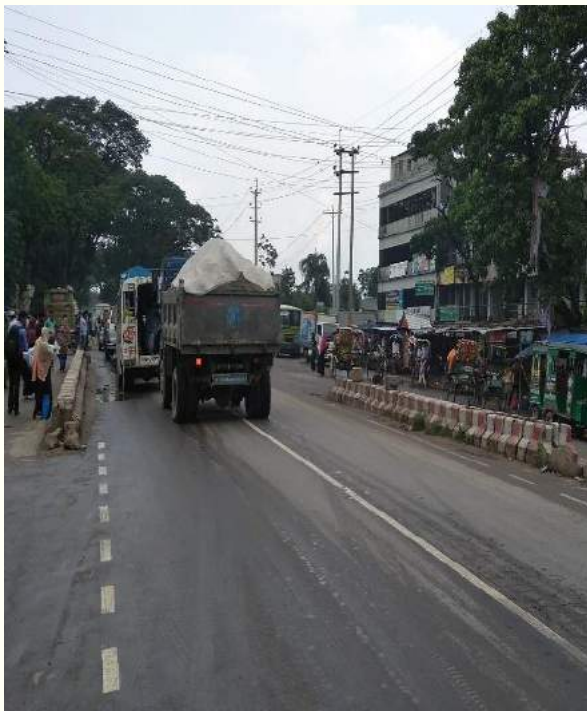
Absence of warning sign at median within Ch.+28 to Ch.+30

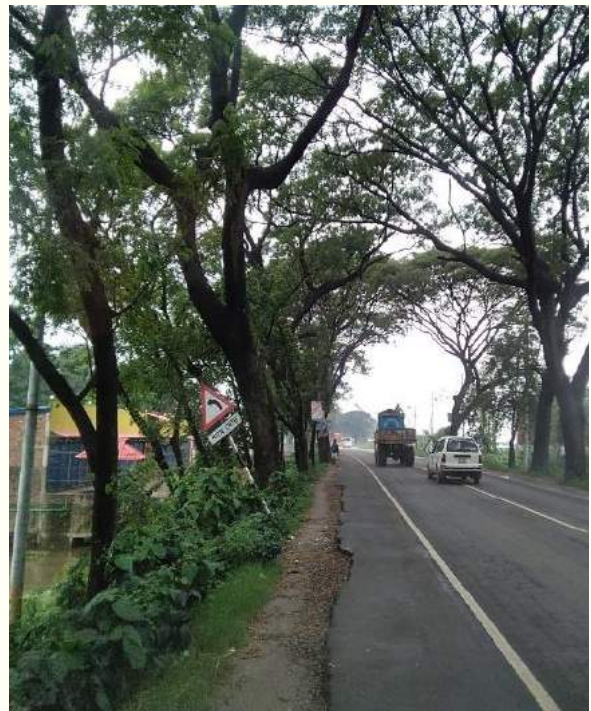
Risky edge drop within Ch.+30 to Ch.+32

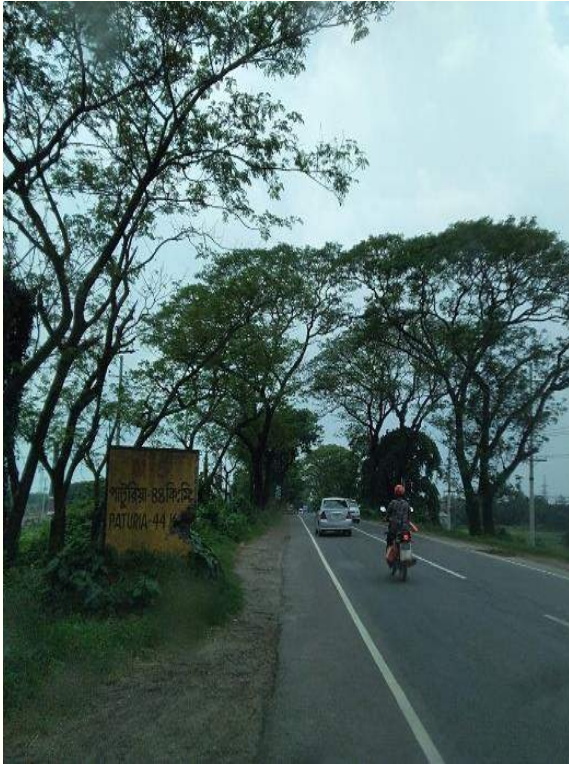
Unknown km post at earthen shoulder within Ch.+32 to Ch.+34

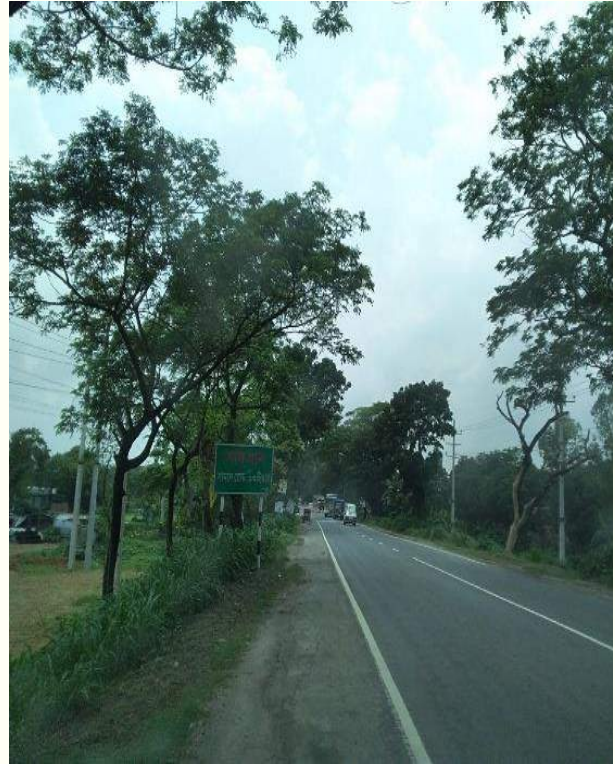
Sign post on earthen shoulder within Ch.+34 to Ch.+36 causing risk

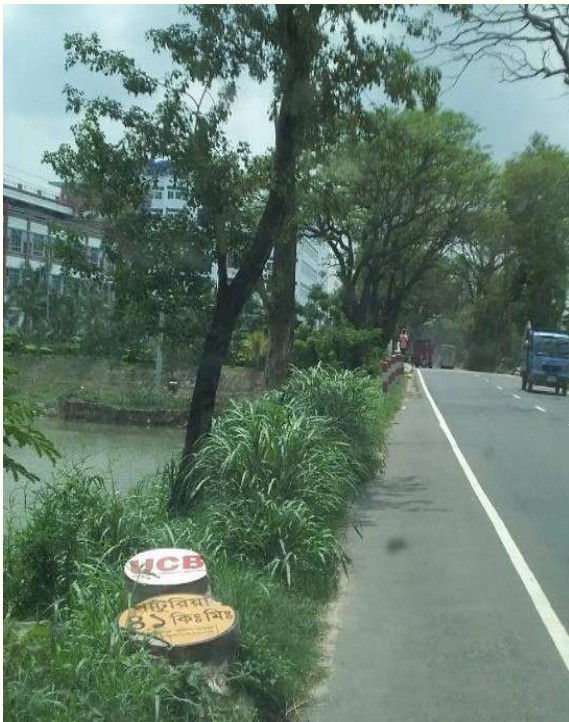
Disturbed, unknown km post within Ch.+36 to Ch.+38

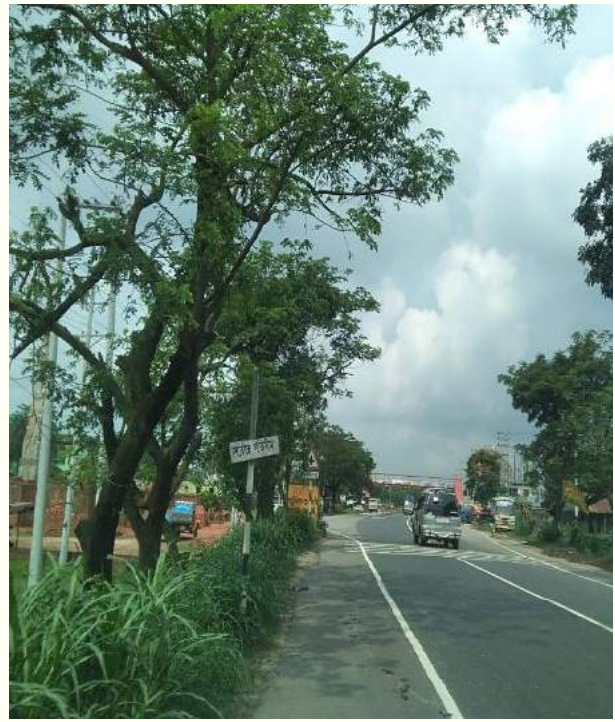
Disturbed road sign within Ch.+38 to Ch.+40

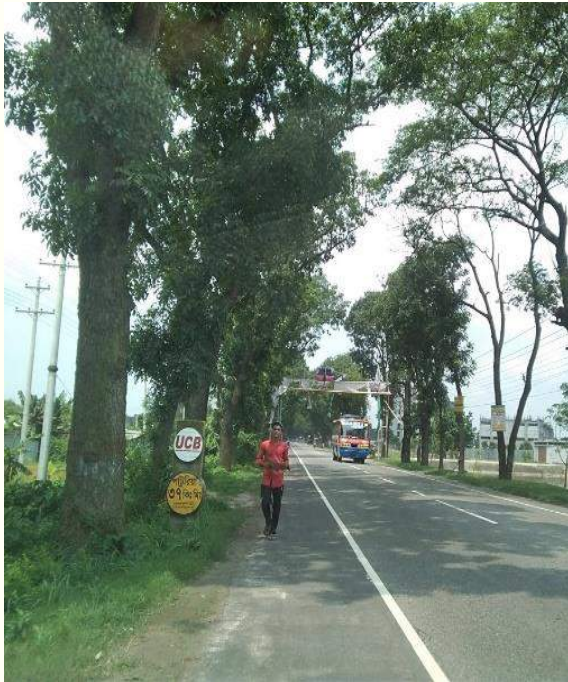
Unknown km post in earthen shoulder within Ch.+40 to Ch.+42

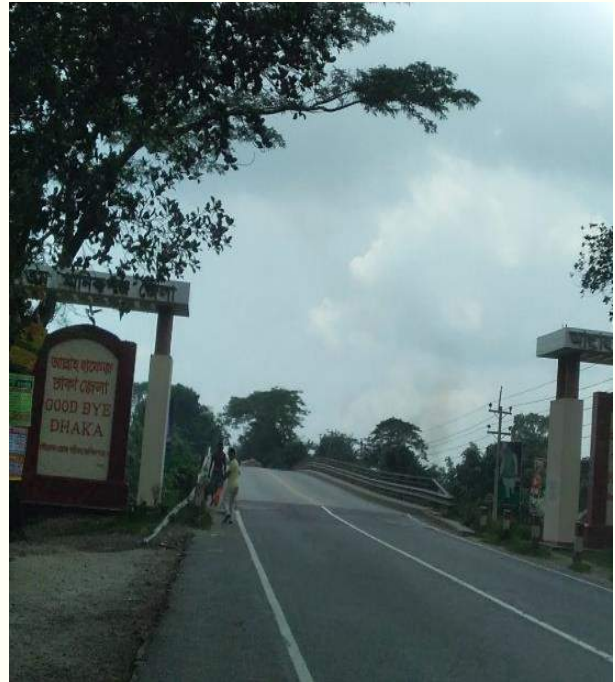
Risky structure at earthen shoulder within Ch.+42 to Ch.+44

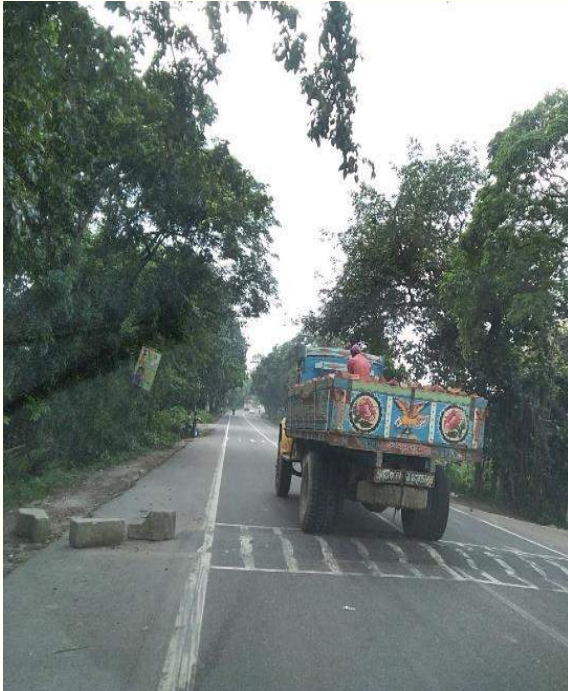
Risky concrete block placed within Ch.+42 to Ch.+44

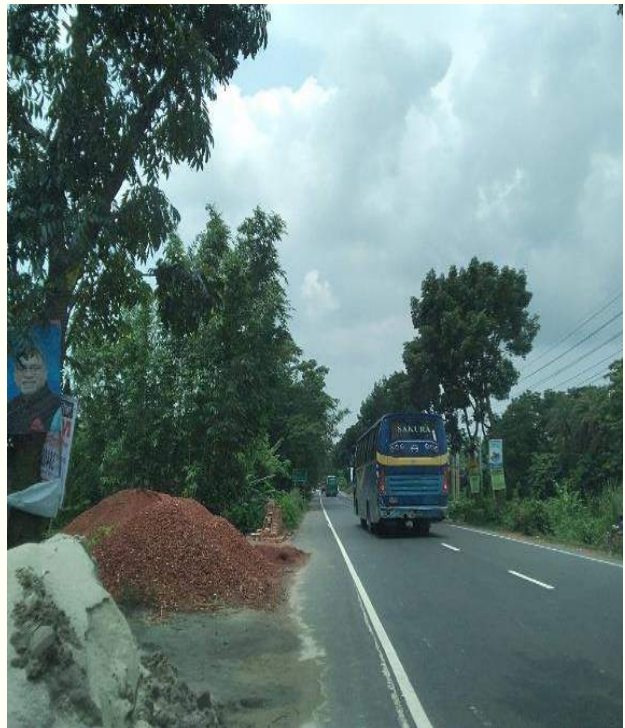
Unauthorized roadside business within Ch.+44 to Ch.+46

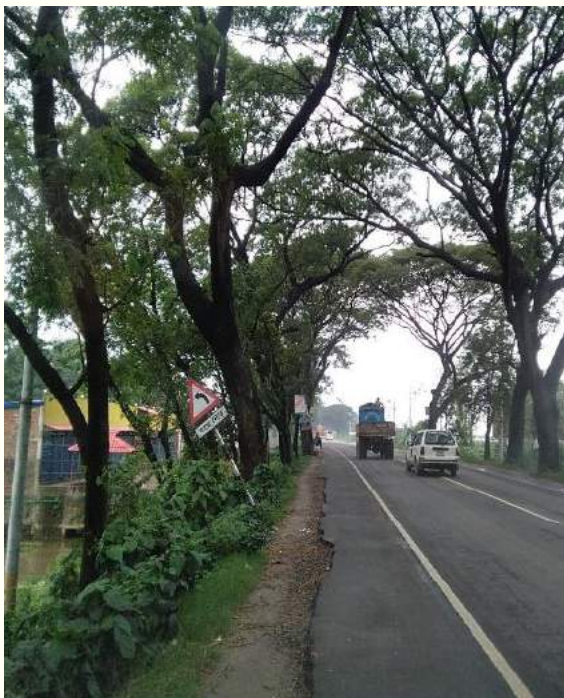
Risky shoulder drop within Ch.+46 to Ch.+48

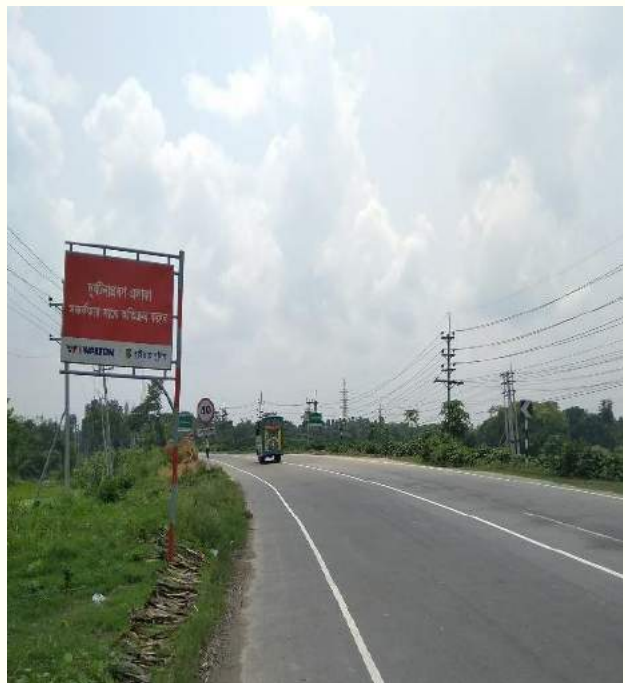
Risky, unknown road sign within Ch.+48 to Ch.+50

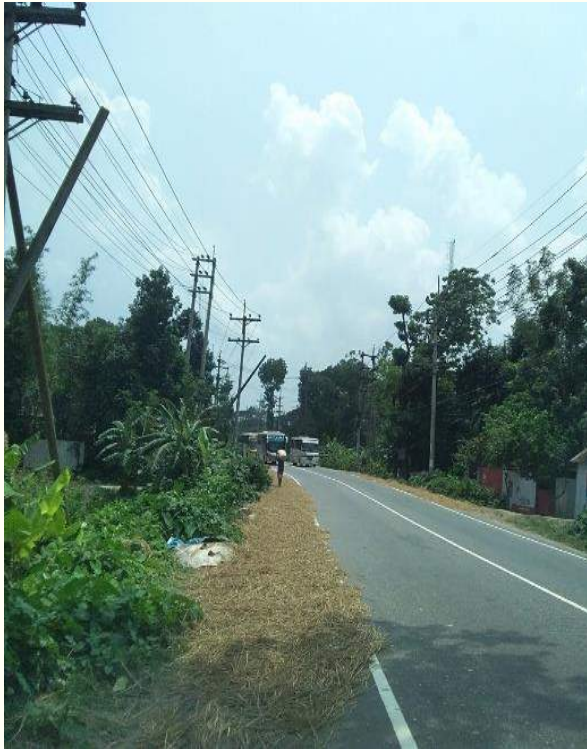
Unauthorized roadside business within Ch.+48 to Ch.+50

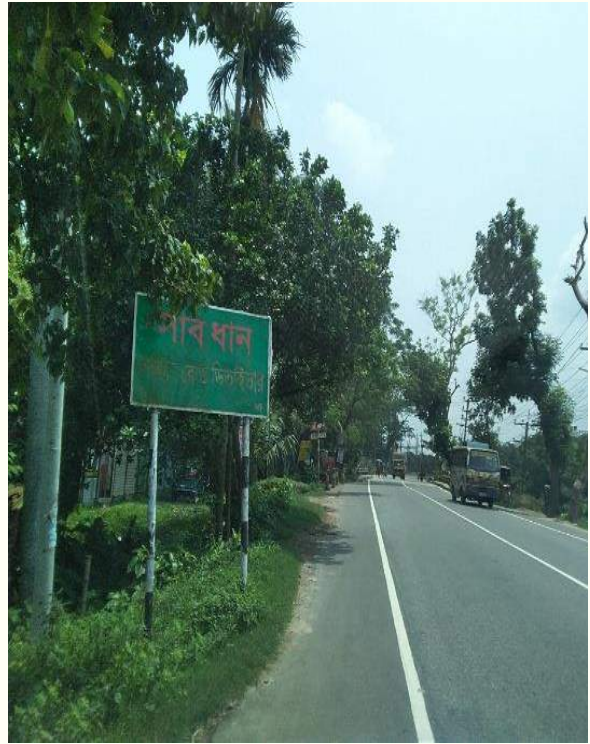
Risky sign post on shoulder within Ch.+48 to Ch.+50

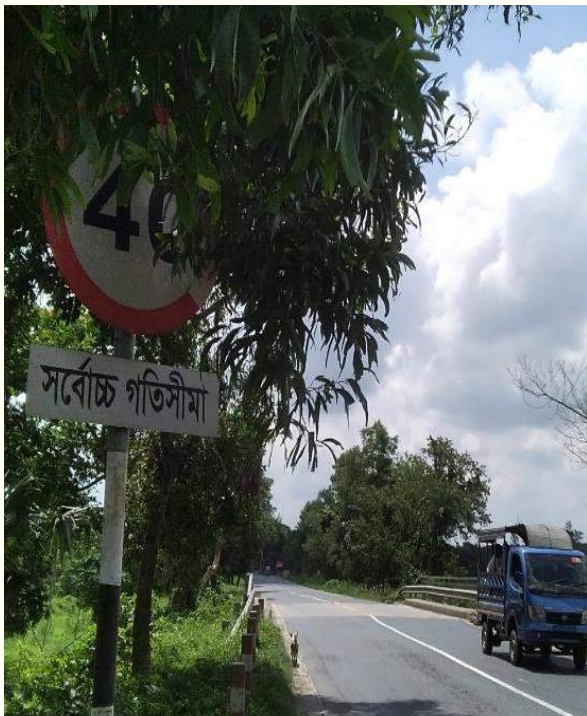
Less visible road sign within Ch.+58 to Ch.+60

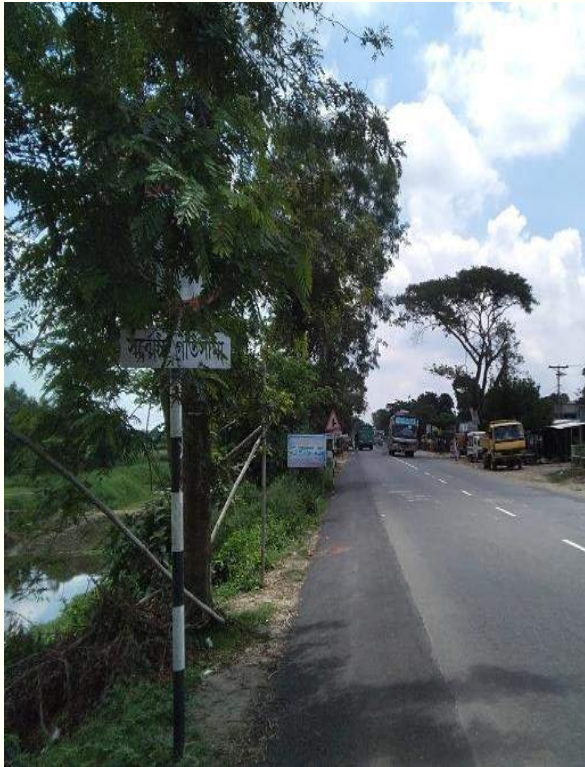
Less visible road sign within Ch.+60 to Ch.+62

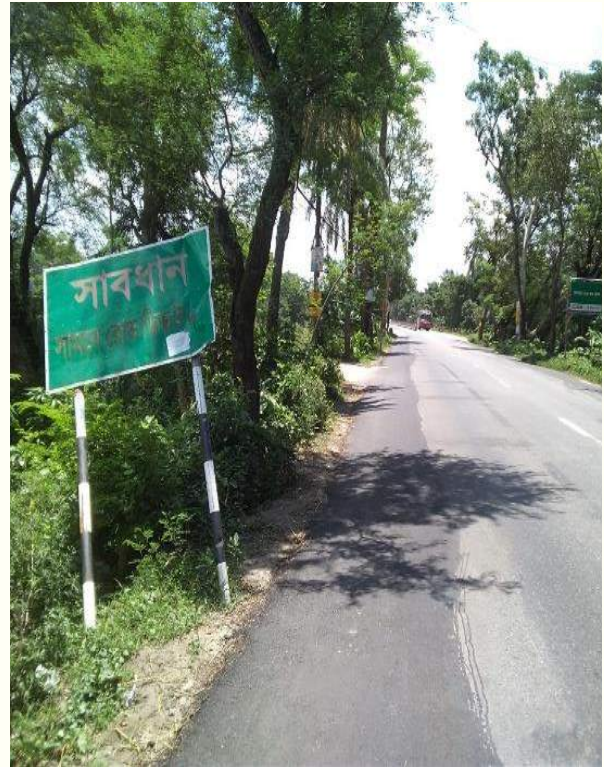
Disturbed road sign within Ch.+62 to Ch.+64

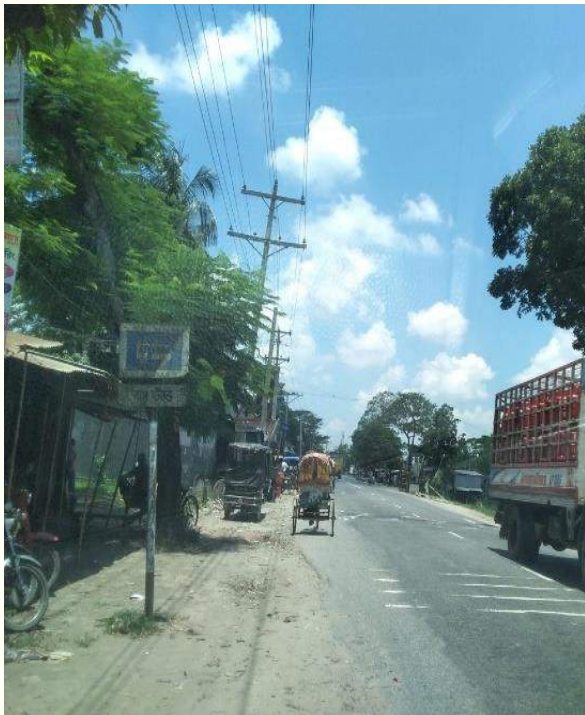
Less visible road sign within Ch.+64 to Ch.+66

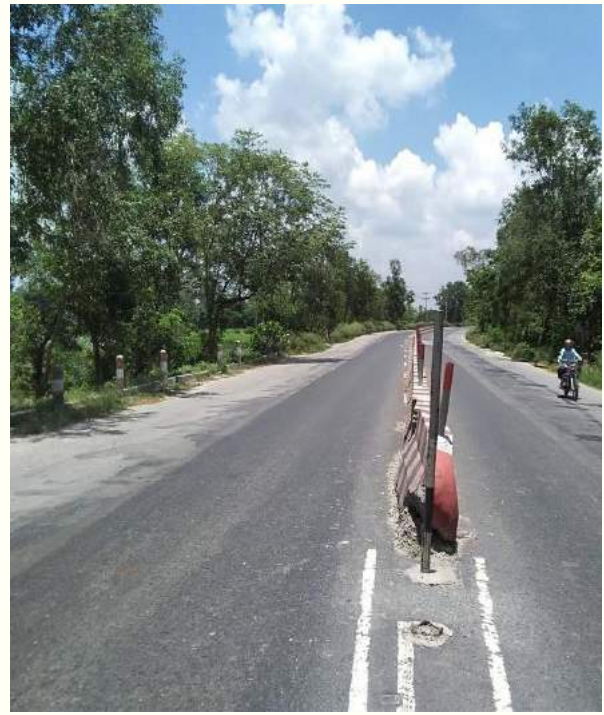
Disturbed warning sign within Ch.+66 to Ch.+68

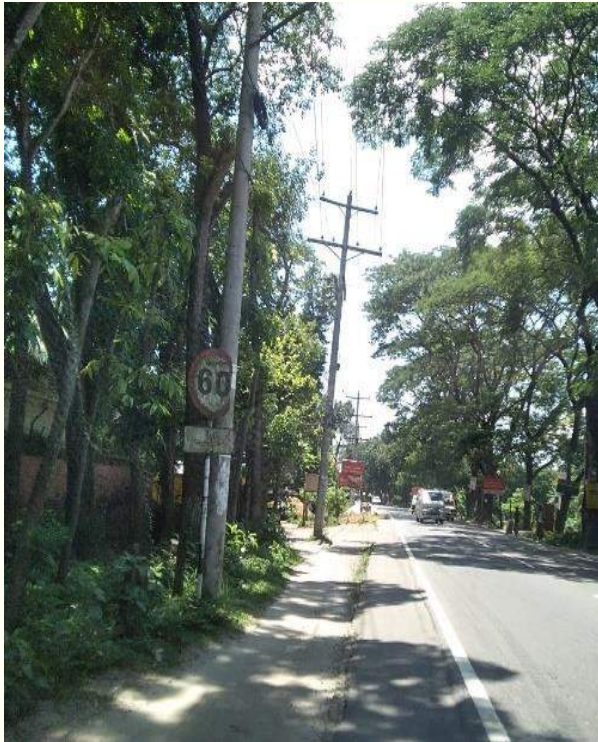
Faded road sign within Ch.+68 to Ch.+70

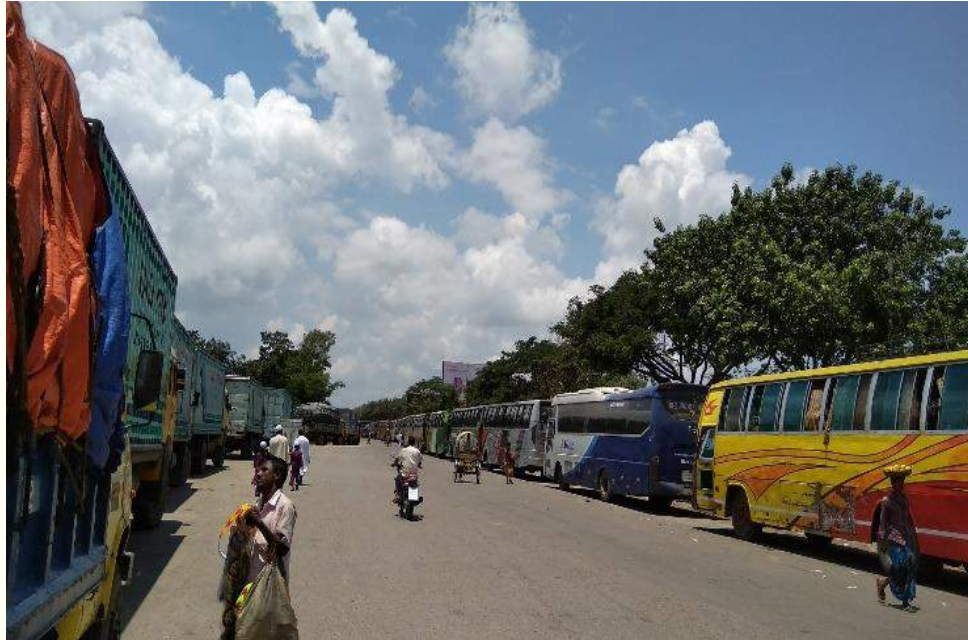
Illegal roadside parking at Ch.+78

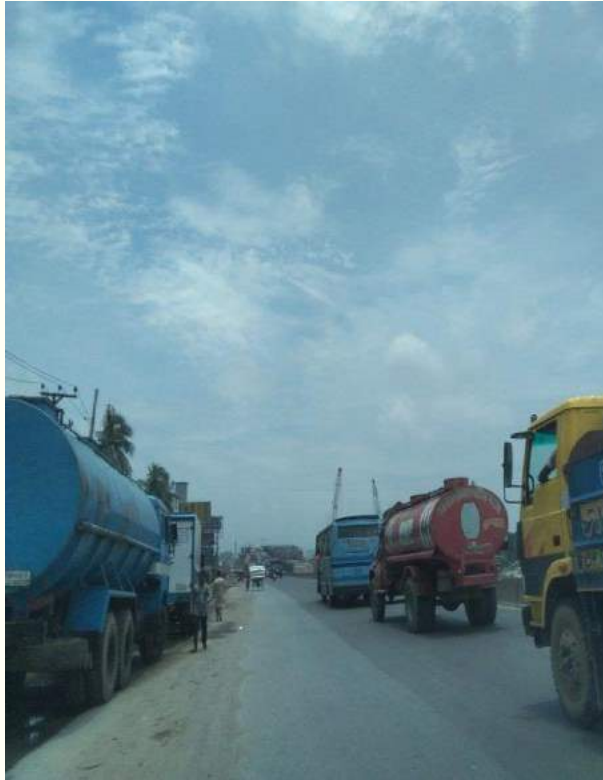
Unauthorized roadside activity within Ch.+ 7 to Ch.+9

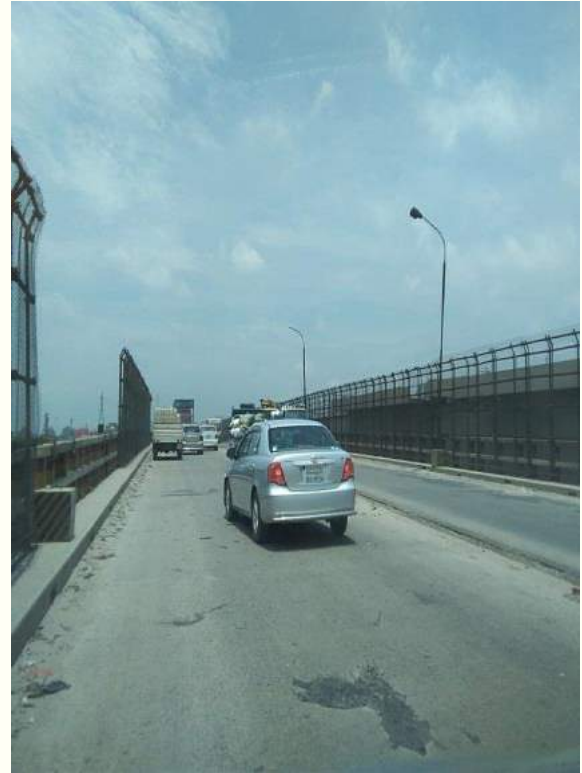
Blocks causing risk for pedestrian movement within Ch.+7 to Ch.+9

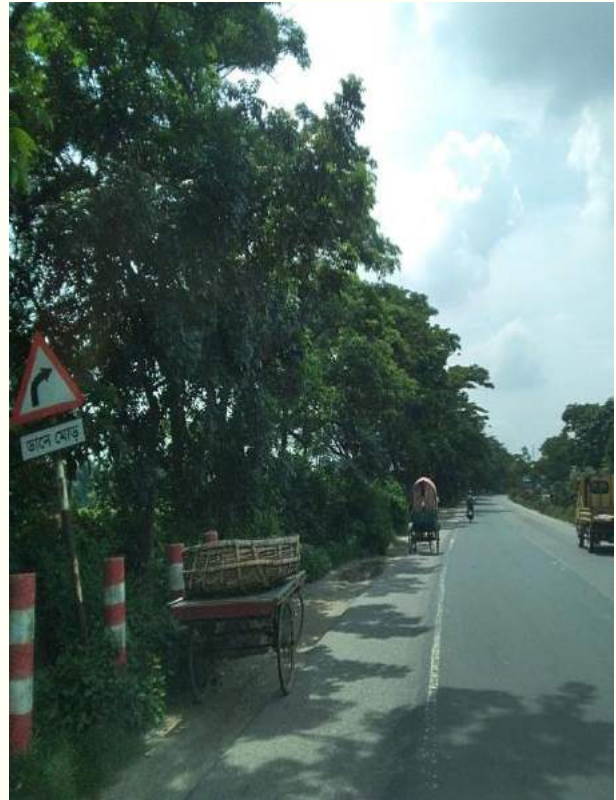
Disturbed sign within Ch.+15 to Ch.+17

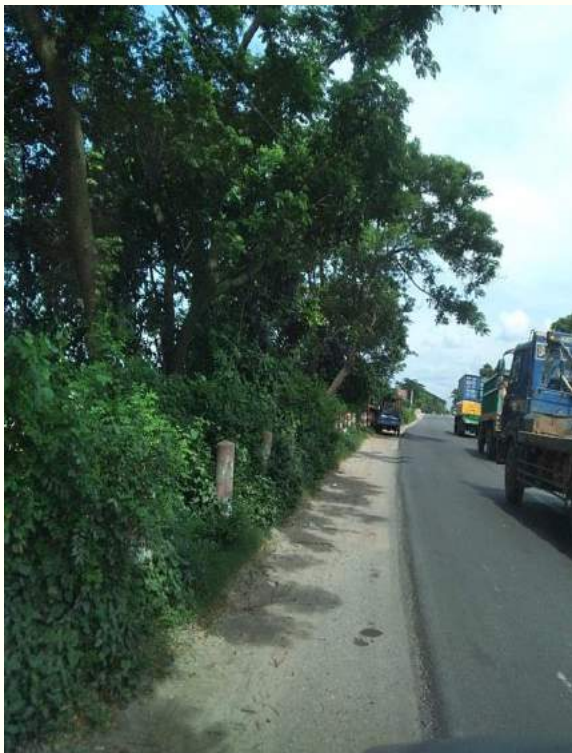
Invisible roadside posts Ch.+ 15 to Ch.+17

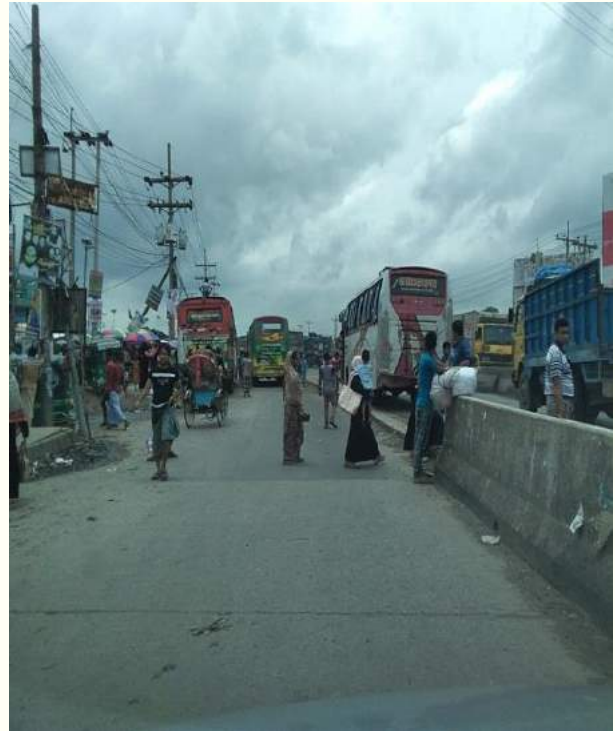
Illegal and risky road crossing activity within Ch.+ 19 to Ch.+21

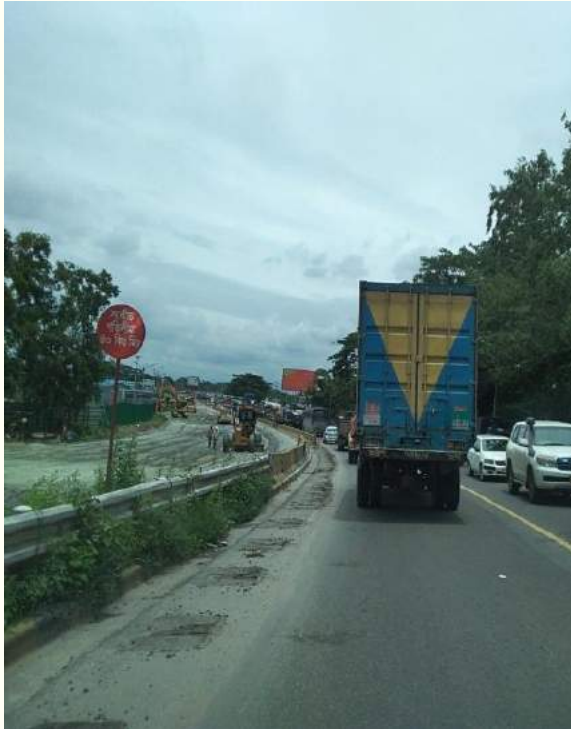
Wrongly designed sign within Ch.+23 to Ch.+25

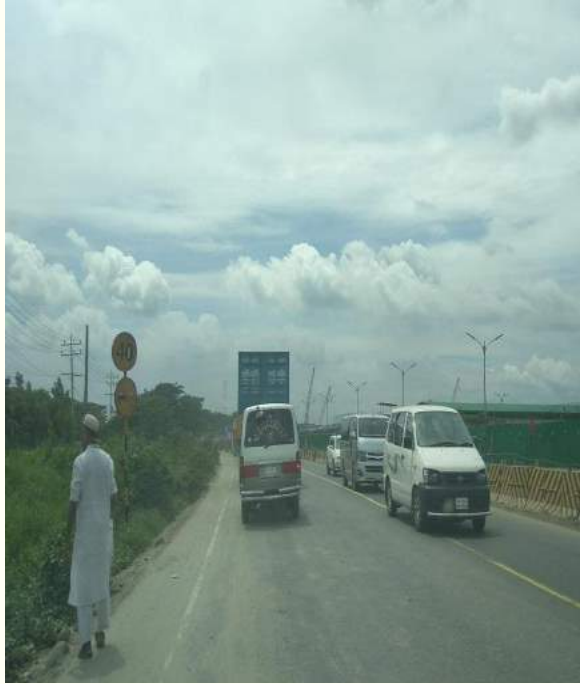
Pedestrian standing on busy road within Ch.+ 25 to Ch.+27

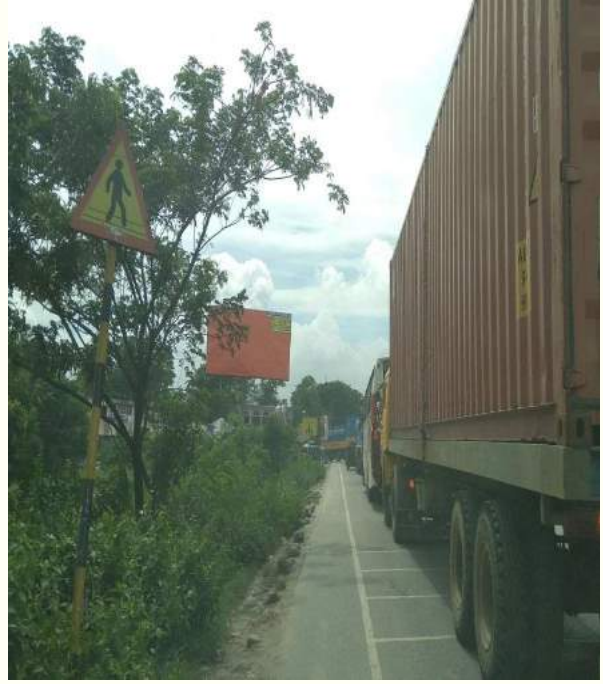
Wrongly designed sign within Ch.+25 to Ch.+27

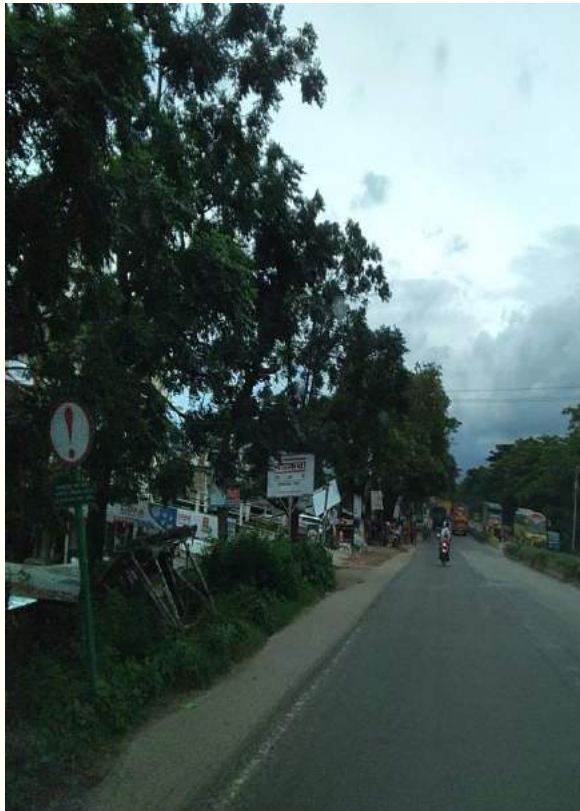
Wrongly designed road sign within Ch.+27 to Ch.+29

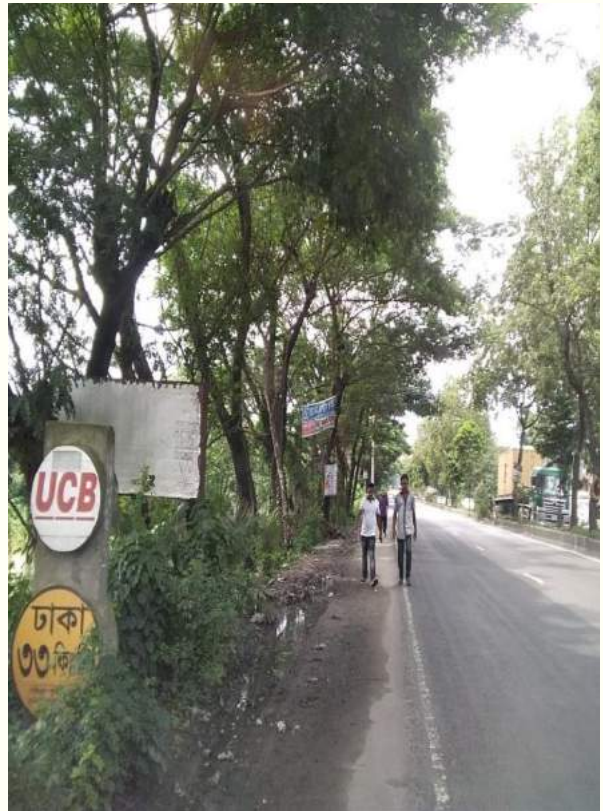
Pedestrians walking on road within Ch.+27 to Ch.+29

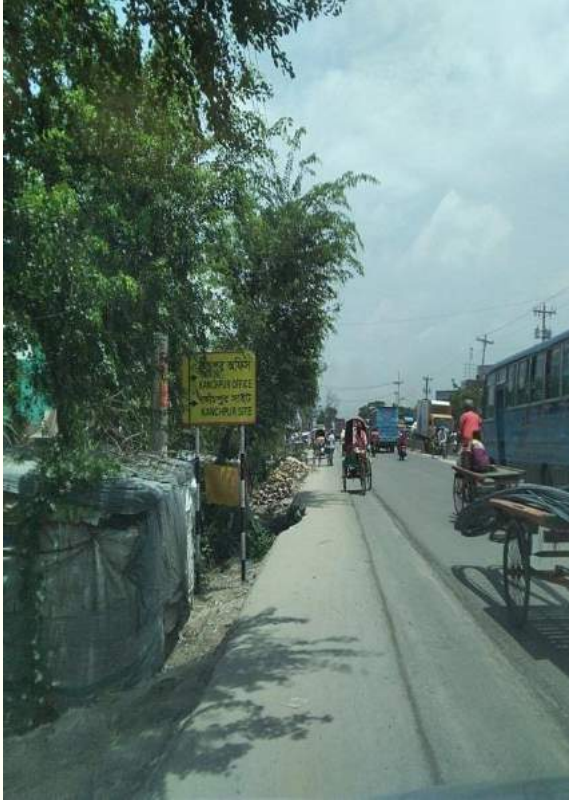
Risky drop and poor sign visibility within Ch.+ 9 to Ch.+11

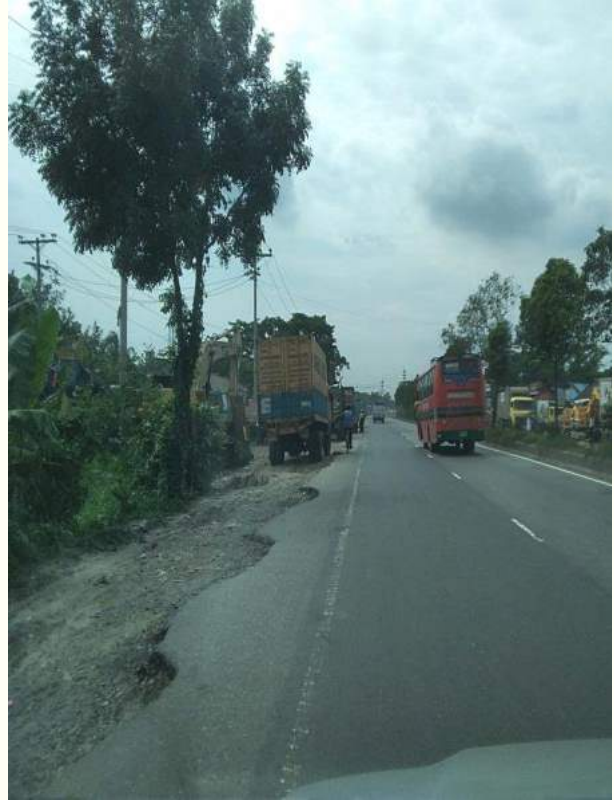
Poor and risky shoulder drop within Ch.+11 to Ch.+13

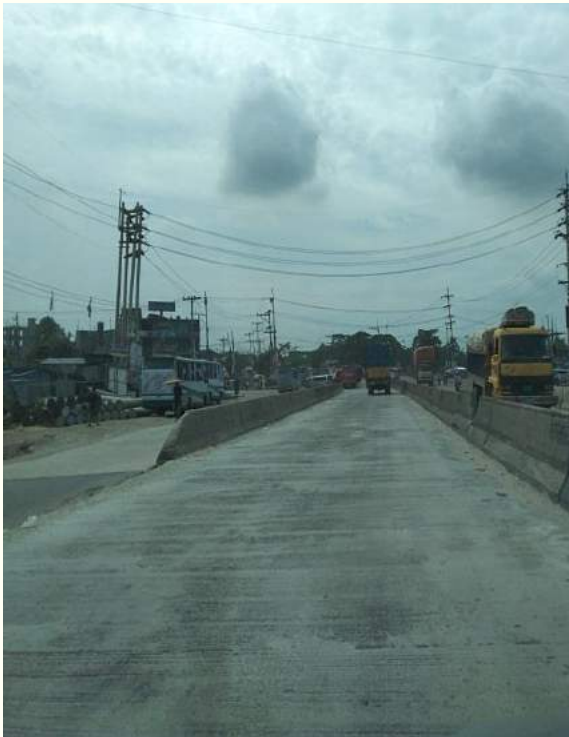
Median without proper protection within Ch.+11 to Ch.+13

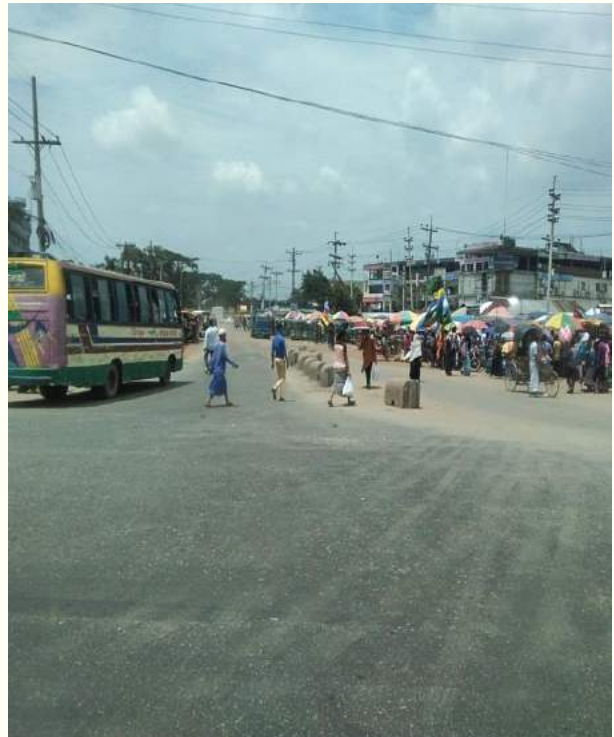
Lack of pedestrian facilities at Ch.+13 to Ch.+15

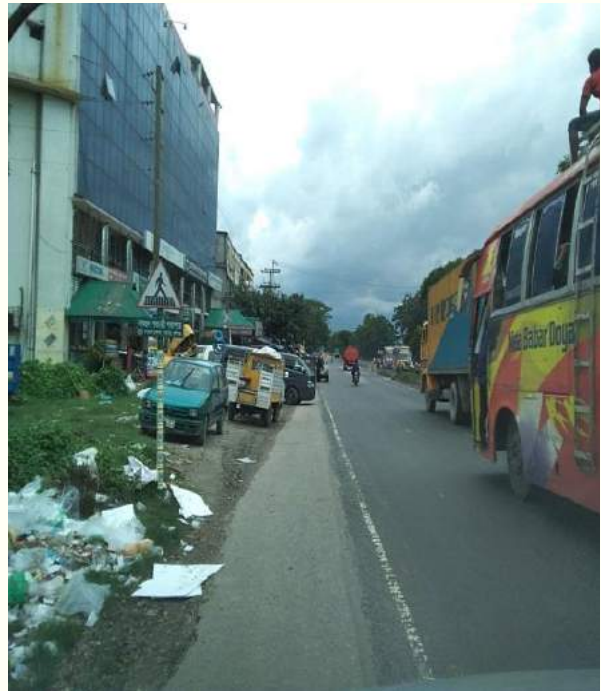
Wrongly designed road sign within Ch.+29 to Ch.+31

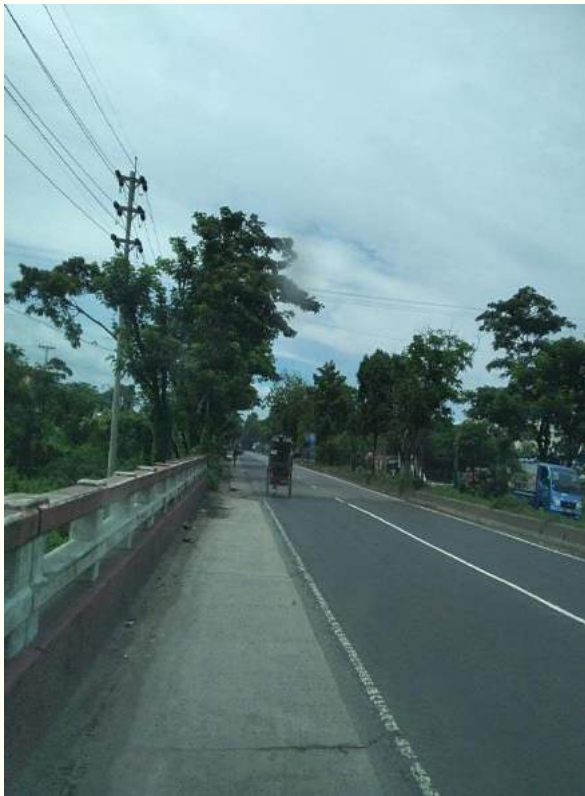
Unprotected pedestrian facility on bridge within Ch.+29 to Ch.+31

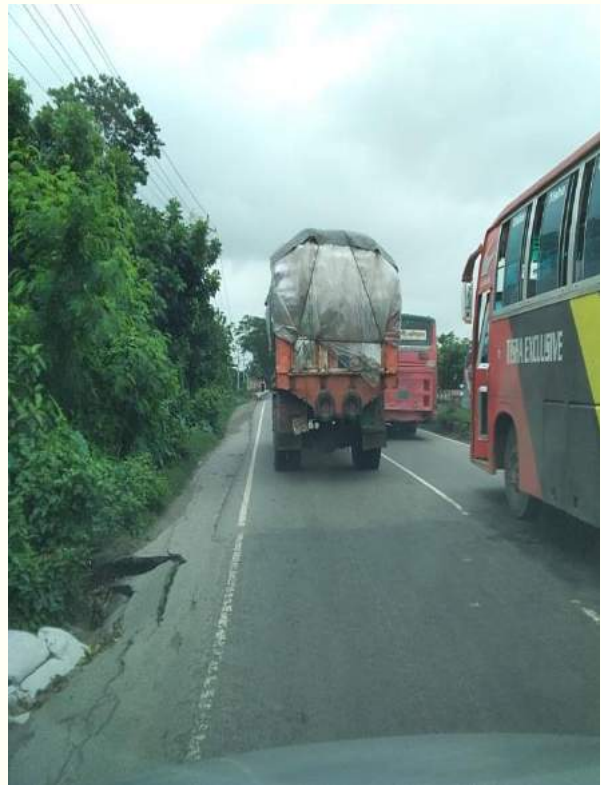
Risky edge drop within Ch.+31 to Ch.+33
