REPORT ON
DETAILED
ROAD SAFETY AUDIT
OF FIVE ROAD SECTIONS
(500 KM)

ROAD SAFETY AUDIT REPORT FY 2017-2018

Road Design & Safety Circle
Roads & Highways Department
Government of the People's Republic of Bangladesh
SARM Associates and HeptaTech Limited JV

Detailed Road Safety Audit of Road Sections of Joydebpur – Mymensingh (N3), Kanchpur- Daudkandi (N1) and Chattogram – Cox's Bazar (N1), Kashinathpur – Rajshahi (N6) and Dhaka – Aricha (N5) (Total 500 km) National Highway During FY 2017 -2018

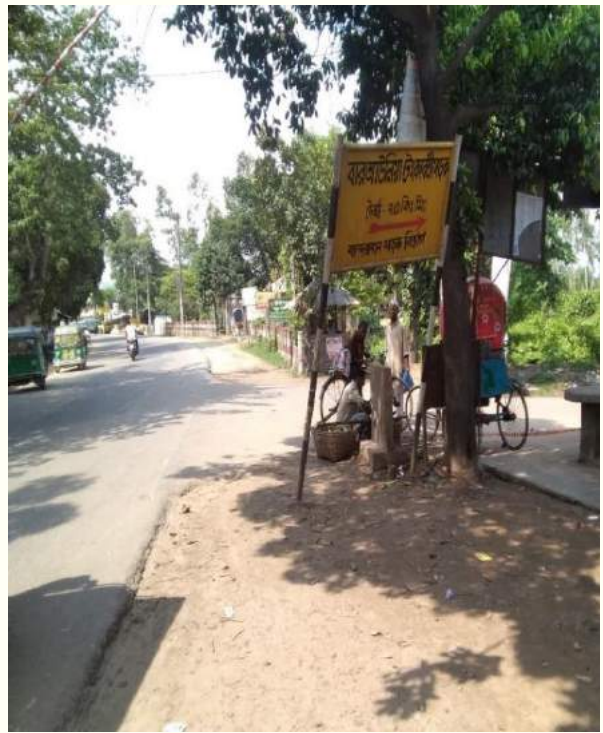
Unknown road sign within clear zone at Ch.+ 297 to Ch.+299

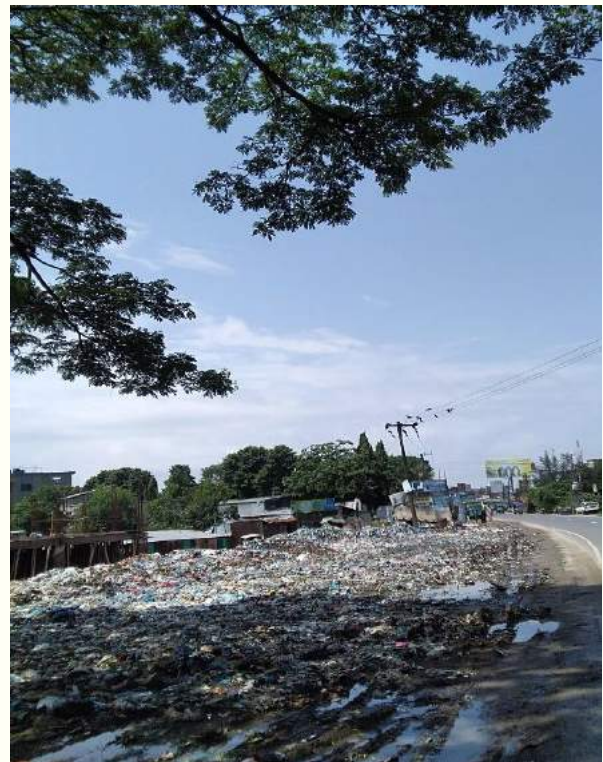
Unauthorized dumping within Ch.+331 to Ch.+333

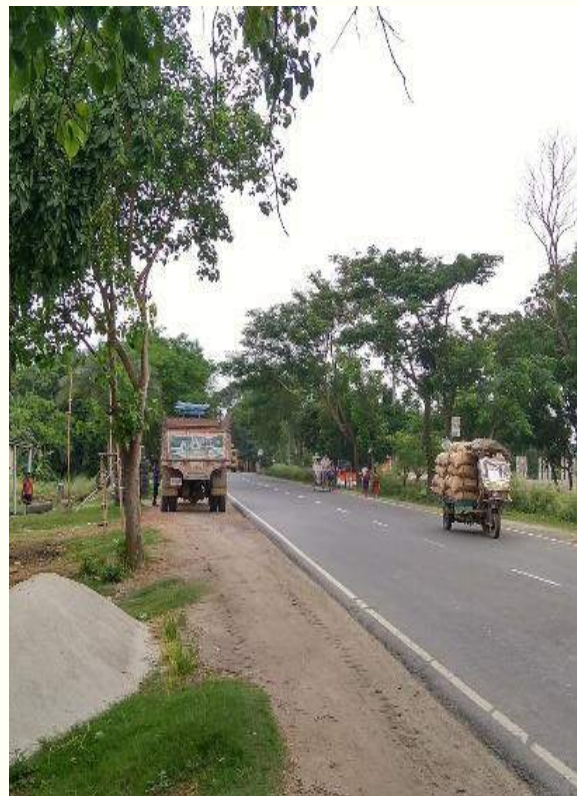
Unauthorized roadside parking within Ch.+72 to Ch.+74

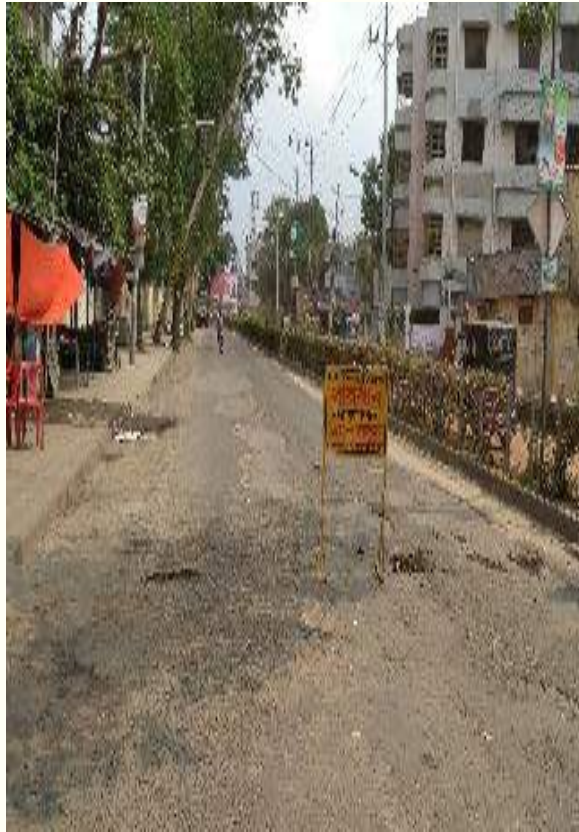
Wrong and risky construction practice within Ch.+142 to Ch.+144

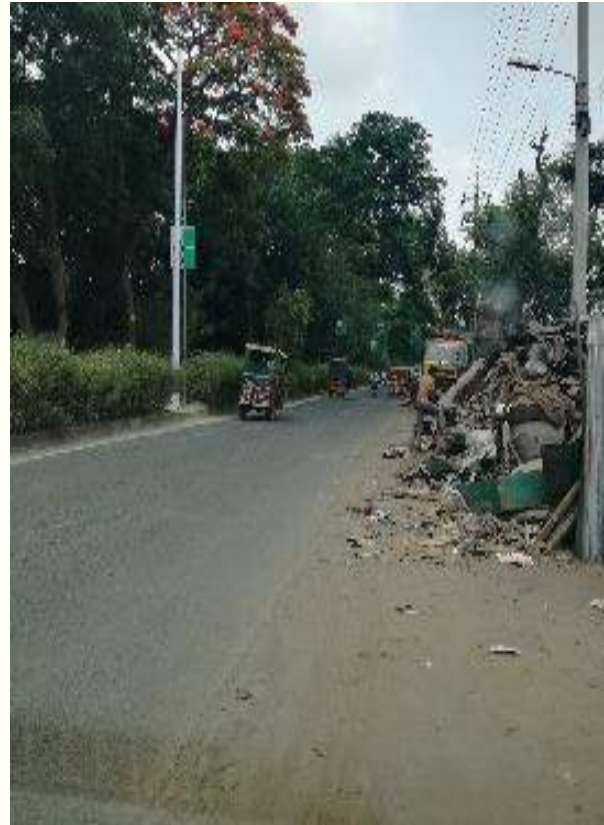
Illegal roadside activity within Ch.+144 to Ch.+146

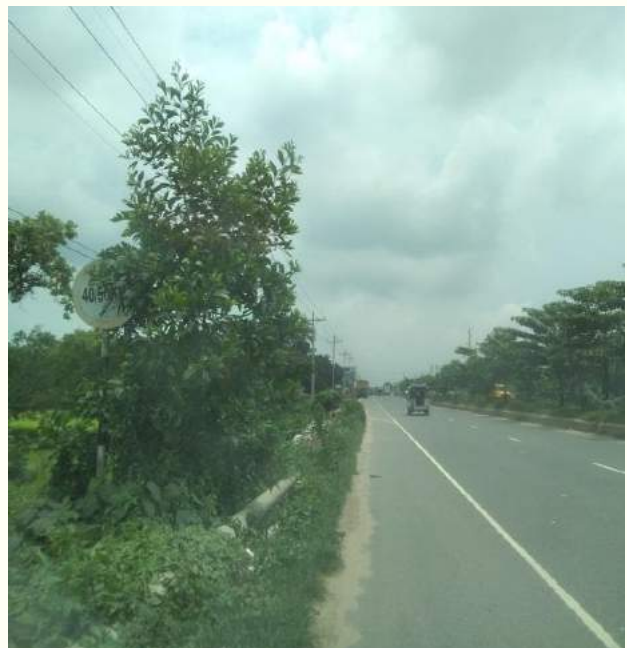
Invisible road sign within Ch.+37.8 to Ch.+39.8

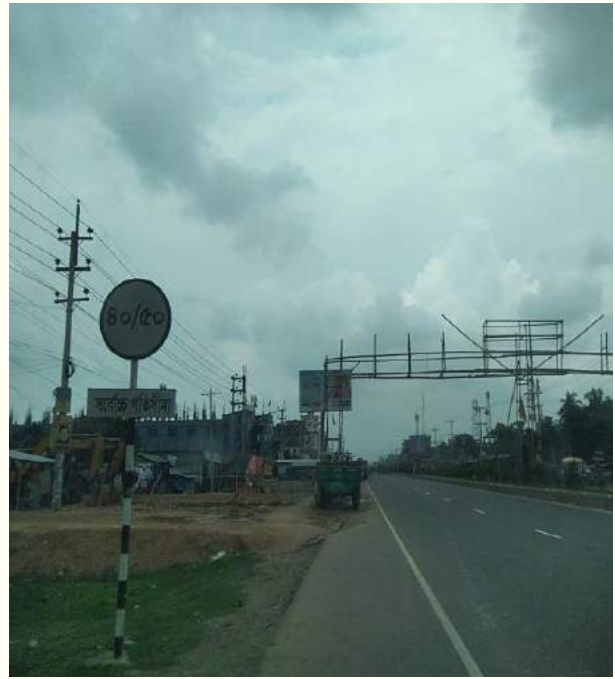
Unknown sign within Ch.+59.6 to Ch.+61.6

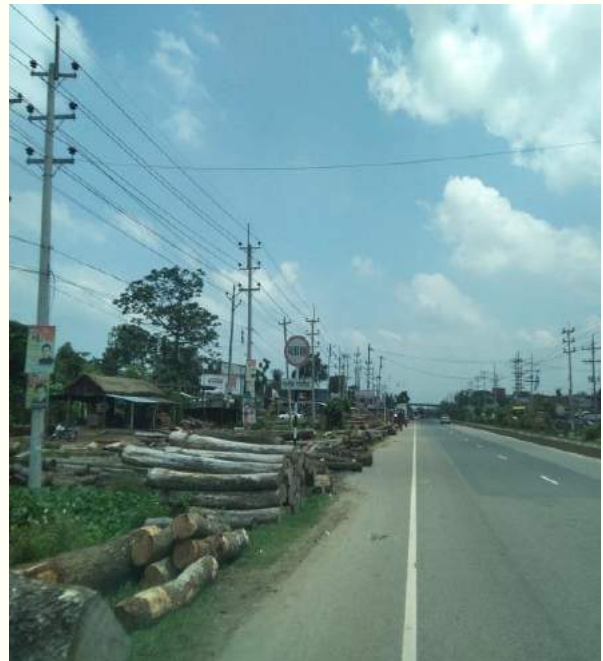
Unauthorized occupancy & unknown sign post within Ch.+73.5 to Ch.+75.5

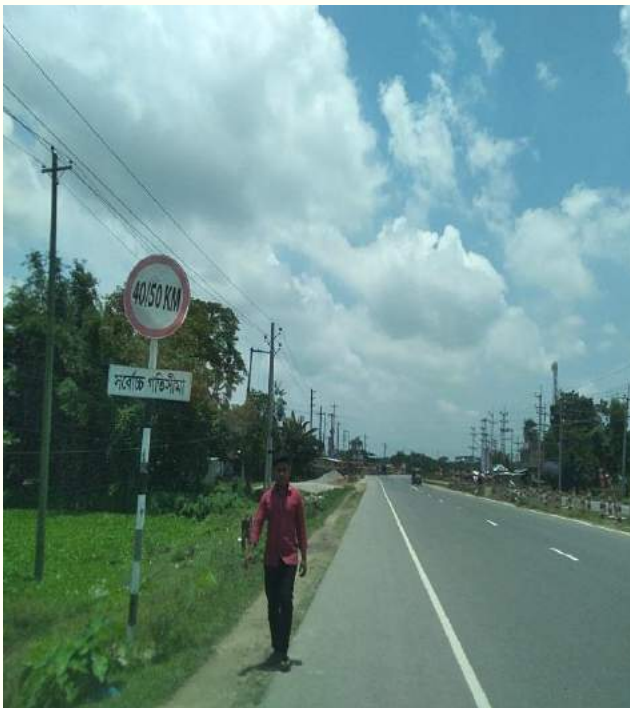
Unknown sign within Ch.+77.5 to Ch.+79.5

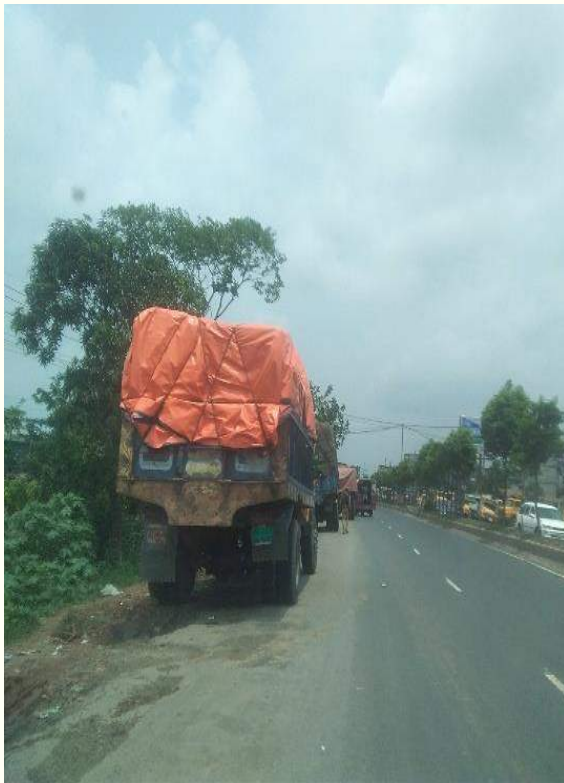
Unauthorized roadside parking within Ch.+4 to Ch.+6

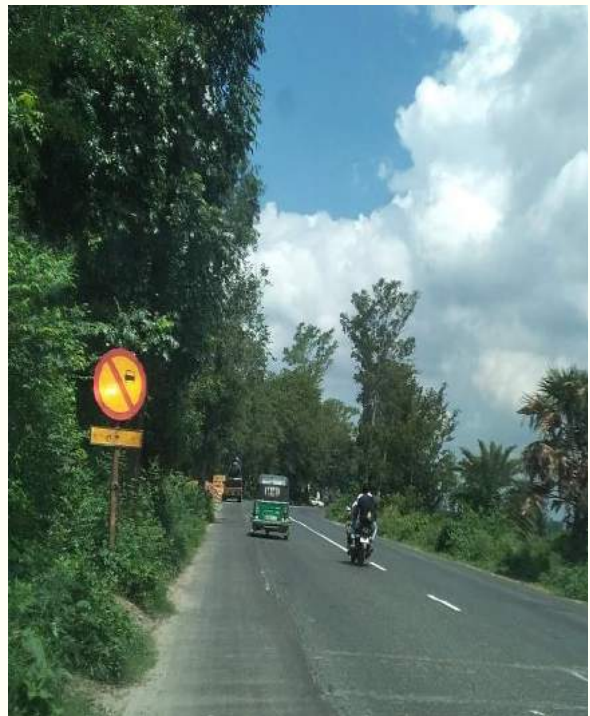
Faded and unknown road sign within Ch.+58 to Ch.+60

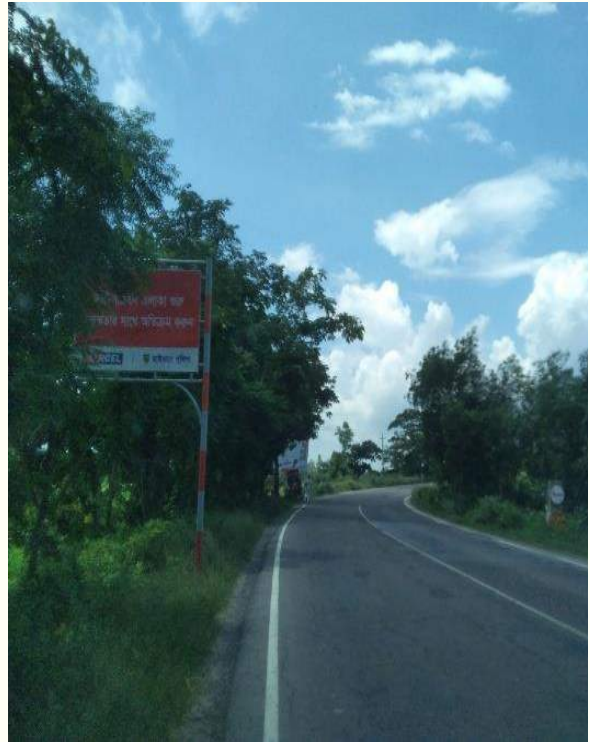
Unknown road sign at shoulder within Ch.+74 to Ch.+76

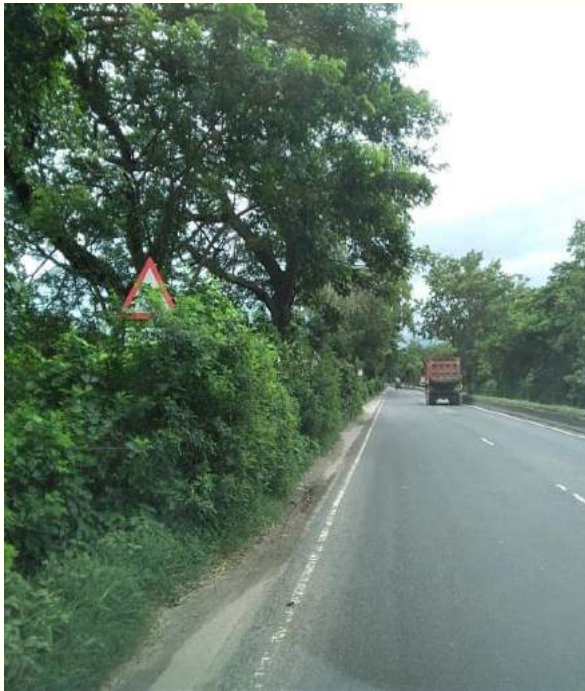
Invisible road sign within Ch.+29 to Ch.+31
